VOLVO AGING ISSUES

MECHANICAL VACUUM
PUMP LEAK (SI 6 3.2L
ENGINE 2007-2016)

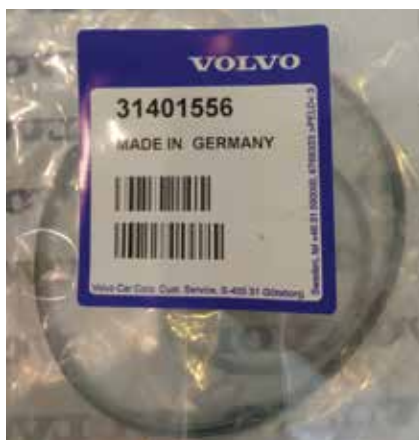
Opposite page: If the fuse box power supply cable harness is left to corrode, it can cause high resistance which can cause the harness to overheat and damage other wiring and electrical components.

If the fuse box power supply cable harness is left to corrode, it can cause high resistance and, as loads are applied, the wires will heat up. Over time, this condition can lead to wires being shorted and result in damage to other electrical components and systems.

You usually don't have to replace the pump; you can just re-seal it. Volvo has a re-seal kit for the pump, part number 31401556.

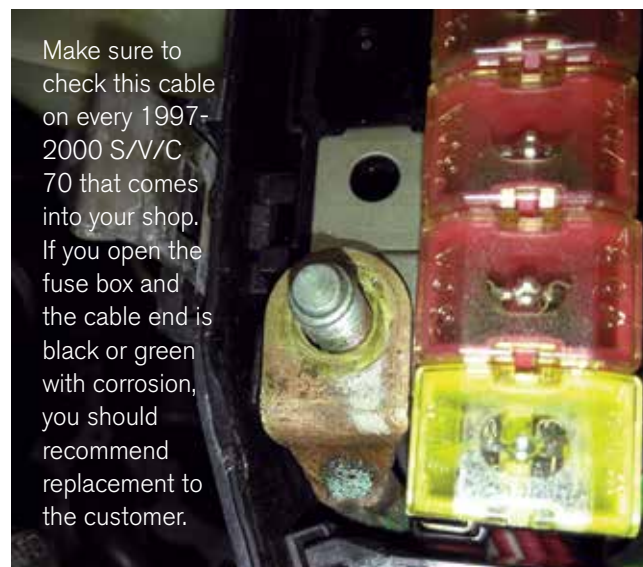
Make sure to check this cable on every 1997-2000 S/V/C 70 that comes into your shop. If you open the fuse box and the cable end is black or green with corrosion, you should recommend replacement to the customer.

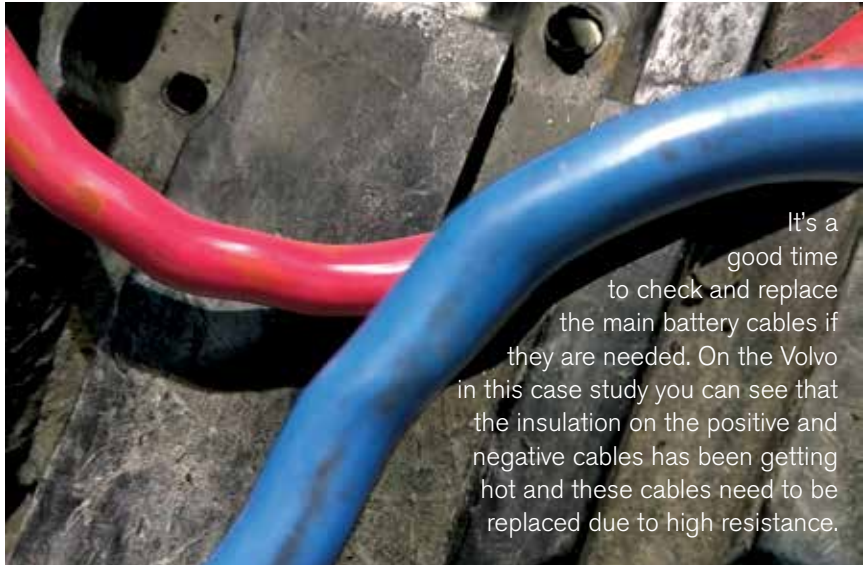
It's a good time to check and replace the main battery cables if they are needed. On the Volvo in this case study you can see that the insulation on the positive and negative cables has been getting hot and these cables need to be replaced due to high resistance.

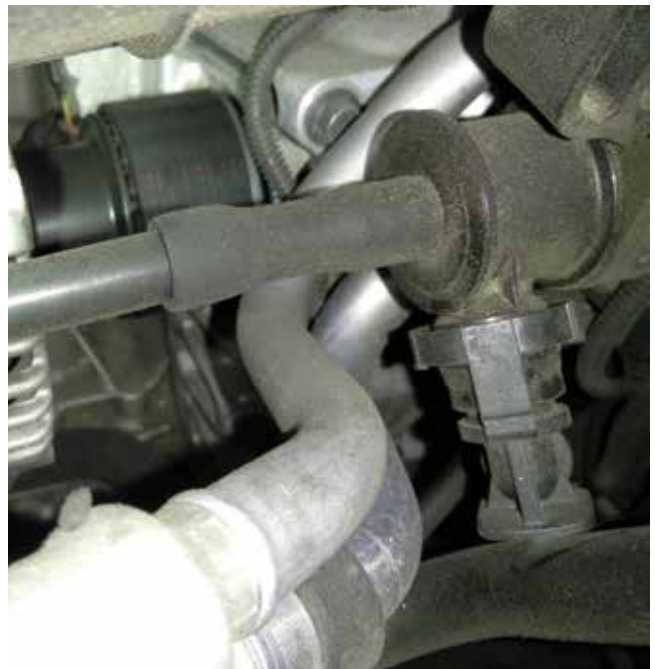
Use a flashlight to look through the gap in the intake manifold and you may see the pulley slipping or not spinning at all.

This symptom will usually correspond with a low or no voltage output reading on your scan tool.

If you have a Volvo with this problem, it is relatively easy to correct. You will have to remove the intake manifold and alternator to get to the drive pulley; it is connected to the alternator with a small toothed belt that should be replaced at the same time you do this repair.

Sometimes this little belt can get stuck on pretty tightly, but it will come off with a little finesse. In most cases, the bolt for the alternator's drive pulley will be finger loose. You should replace this bolt with the OE Volvo updated bolt (988566).

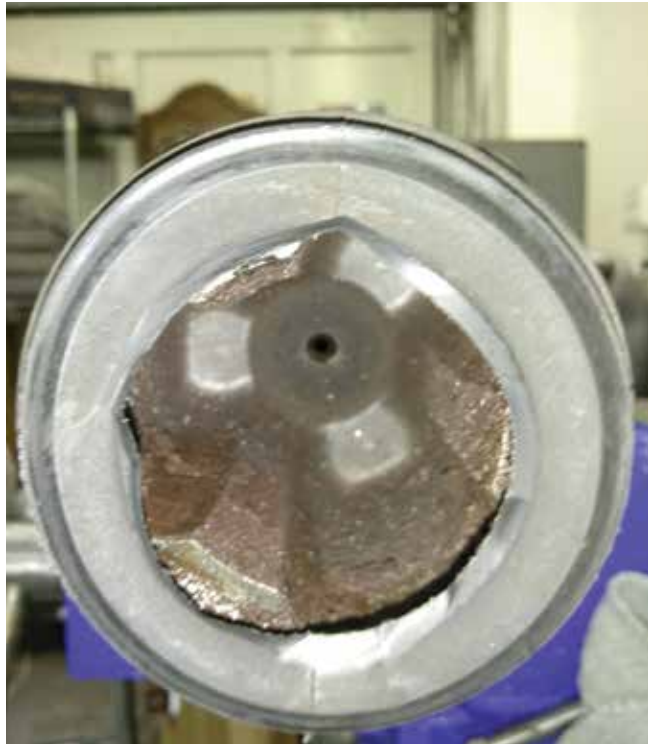
A lot of shops have replaced these axles and, after cutting open the CV boot, have found out that all the grease had somehow disappeared without any signs of leakage or damage to the boot.

If you end up replacing the CV axle on one of these P1 Volvos (TJ 19245), make sure to use only the latest version OE Volvo factory replacement parts.

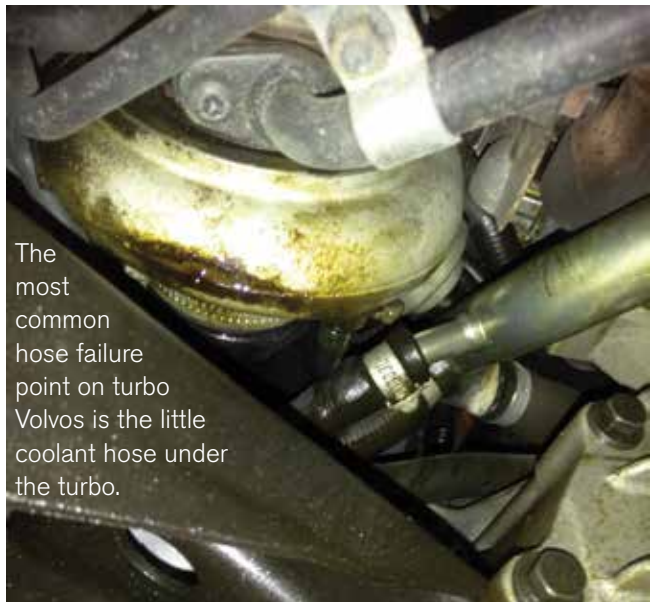
The most common hose failure point on turbo Volvos is the little coolant hose under the turbo.

The most common hose failure point on turbo Volvos is the little coolant hose under the turbo. When these burst on the freeway, the customer may only notice if the car comes to a stop or if the coolant level sensor is working. Since the coolant is leaking so low under the car, the customer may not notice until it's too late. So check and recommend replacement of the old coolant hoses. ●
