Impaired Automotive

2002 BMW X5 4.4i and Murphy's Law

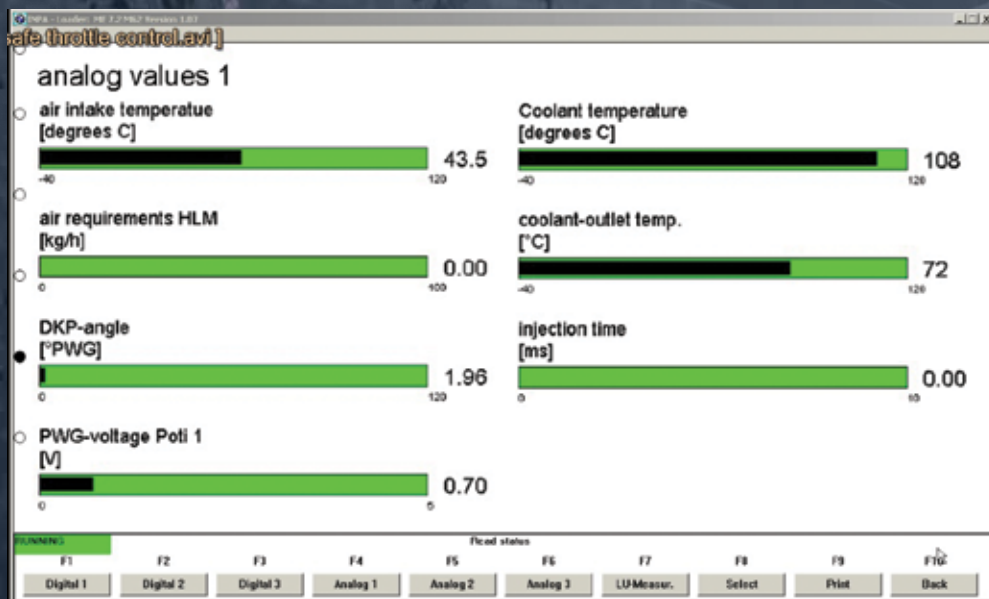
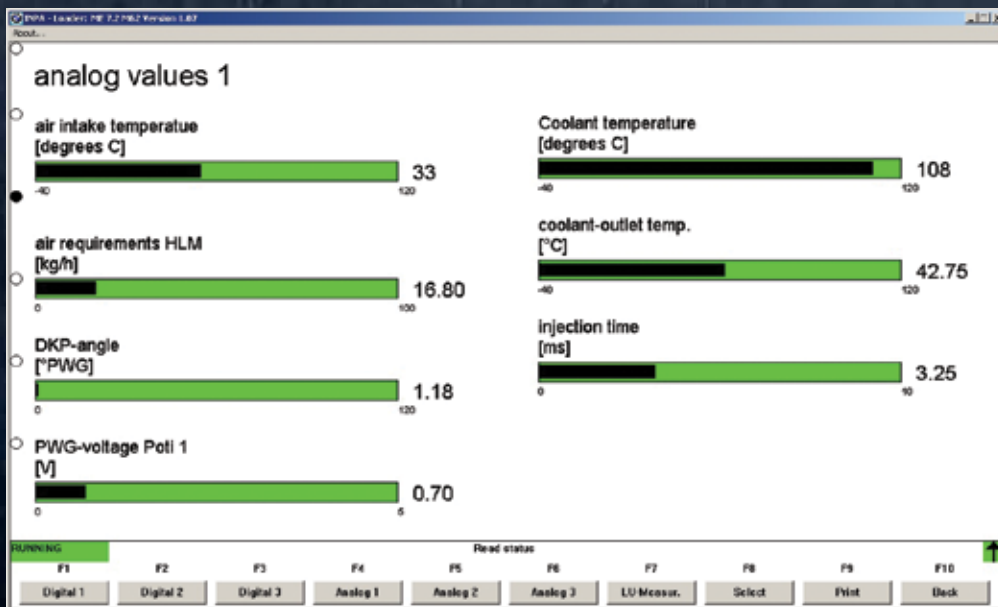
During the recording KOEO, there was a value of interest:

- DKP-angle would toggle between 1.57 degrees and 1.96 degrees PWG for no valid reason.
- WOT throttle worked to 100 degrees PWG when floored.

- At closed throttle, 1.57 degrees and 1.96 degrees PWG toggling resumed.
- This we considered in safe mode. The next image is a screen capture from a movie. 1.57 to 1.96 KOEO is not correct!

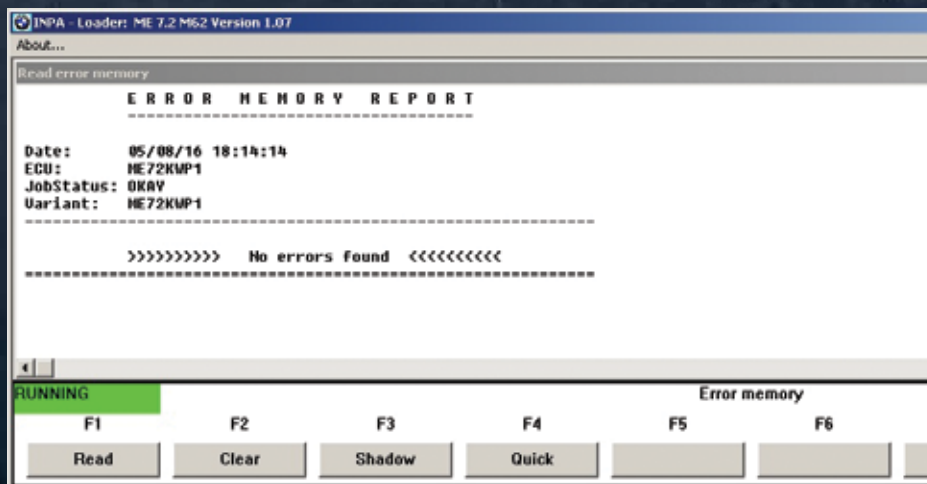
In the normal and cleaned operation, closed throttle is set to 1.18 degrees PWG with no load. That value remained stable.

If A/C was enabled, the setting would increase to 1.96 degrees PWG. If the rear defogger was enabled, the throttle degree increased to 2.35 degrees PWG. When consumers were turned off, the throttle returned to 1.18 degrees PWG.

The following image is a normal value/operation with no faults.

Note: These are values specific to this model at normal operating temperature and relative barometric pressure.

Once the cleaning was accomplished and the air inlet, air box and seals correctly assembled with a proper road test, the results were no faults, and the customer still maintains their trust in us. The image above is at normal temperature and idle.
