VW 01M SPEED SENSORS

We had this unusual case with a 2000 Beetle 2.0L with the 01M 4-speed automatic transmission. This particular transmission is also used in the Golf/Jetta versions and we still see them in service. The “unusual” part to this transmission mystery isn’t the transmission itself; it’s how it ended up at the repair facility.

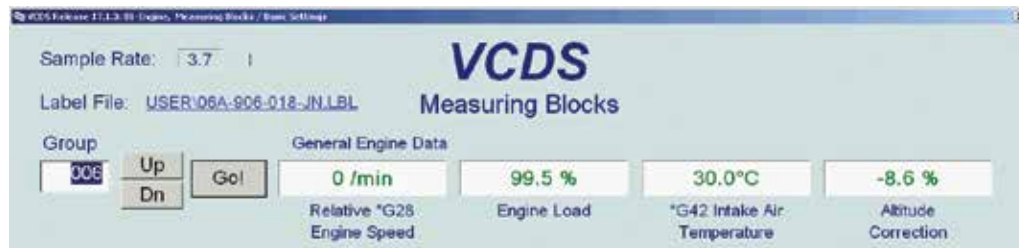
One of the very first pieces I wanted to look at is Altitude Correction. Since we were close to sea level, a small minus number was expected.

-8.6 percent was not expected. With other tested proof, the true value should be close to -3.1 percent. The value in the ECM is more than twice what it should be.

Marie Antoinette ran out of cake and so did I. On a side note, the MAF question, Lambda Control and Altitude Correction issues were repaired with a MAF sensor that fit the correct year, make and model. ■

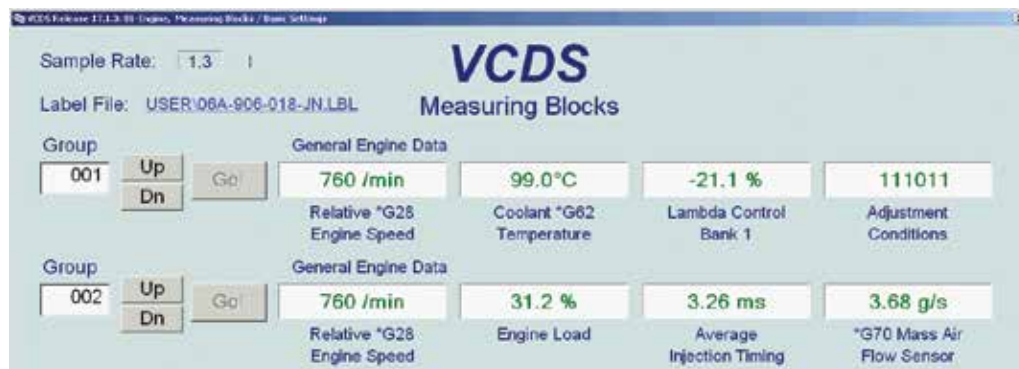
Have a look at the earlier complaint 16486 for MAF; Lambda control is skewed to a large minus number but MAF is reasonable for the moment.

At the same time, we looked at running parameters for the engine up to normal operation temperature. In view are groups 001 and 002 for Mass Air Flow and Lambda Control.

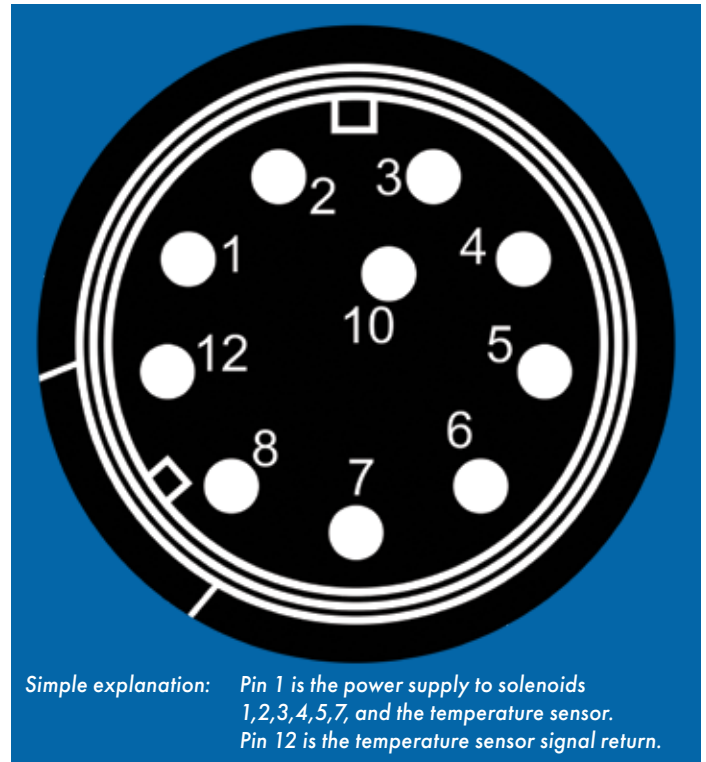
Simple explanation: Pin 1 is the power supply to solenoids 1,2,3,4,5,7, and the temperature sensor. Pin 12 is the temperature sensor signal return.

The best explanation for that issue is the "green monsters" left behind when the customer also mentioned on a subsequent phone call, "I power washed the transmission." Piece by piece, the mystery comes together.

We cleaned the harness on both ends and used a high quality synthetic grease to re-assemble the harness and bracket with a new bolt. Do you think this may cause the unusual transmission temperature readings at idle? Definitely for sure and if the transmission reads the temperature hotter than it should be, this transmission will definitely go into limp mode for self survival. There is so much more to this.

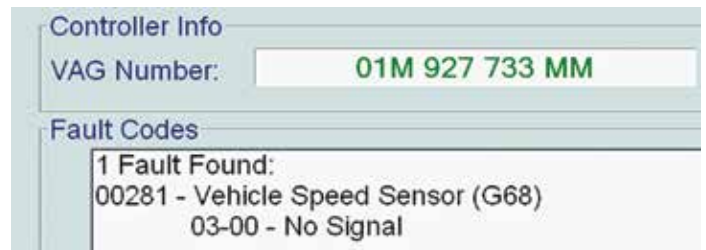
This fault was never recorded earlier and is immediate. The following images lead us to believe that the transmission was missing "road speed."

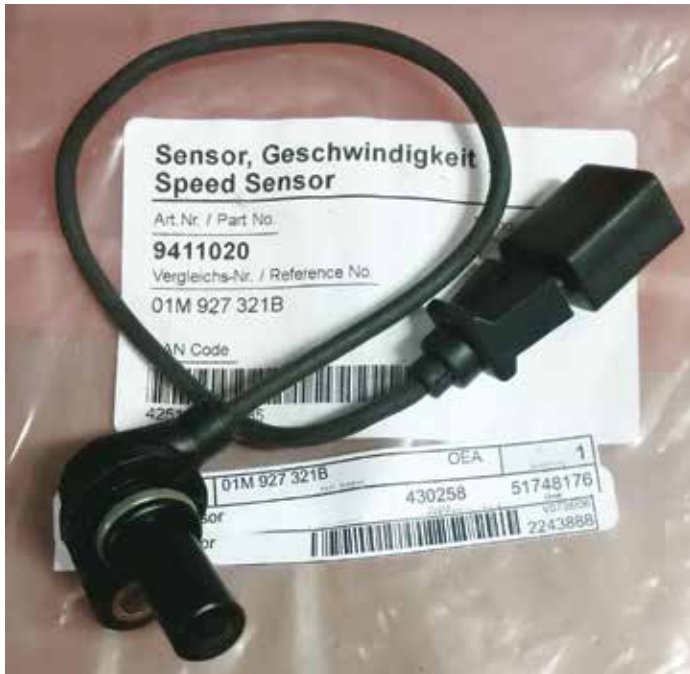
The fourth field is road speed. It is the output shaft speed at G68. With an open circuit and since the output shaft speed is not being read, the transmission sets limp mode, harsh gear engagement and starts out in 2H while in D with the wheels spinning at about 10 mph for a short period. The view is TCM group 004, field 4 and also found at TCM group 003 field 1.

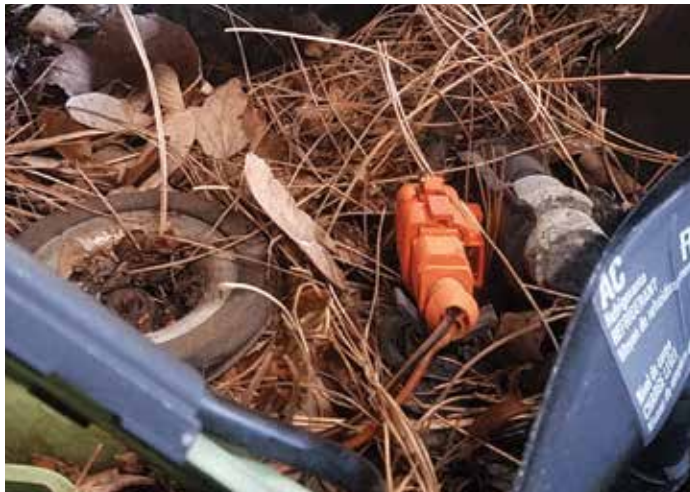
With the new speed sensor in place (removing the mount) the speed signal returned and so did the correct voltage in at the TCM, group 002, field 4.

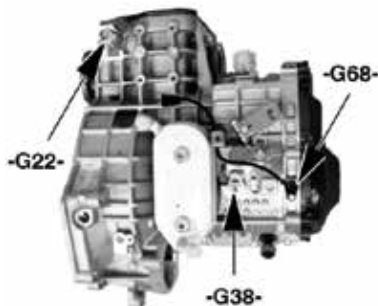
This image shows the correct name and position of speed sensors.

G22 - Instruments road speed - NOT connected to the TCM

G38 - Transmission Input shaft speed Min. 0.8 K Ohms Max. 0.9 K Ohms

G68 - Transmission Output shaft speed Min. 0.8 K Ohms Max. 0.9 K Ohms

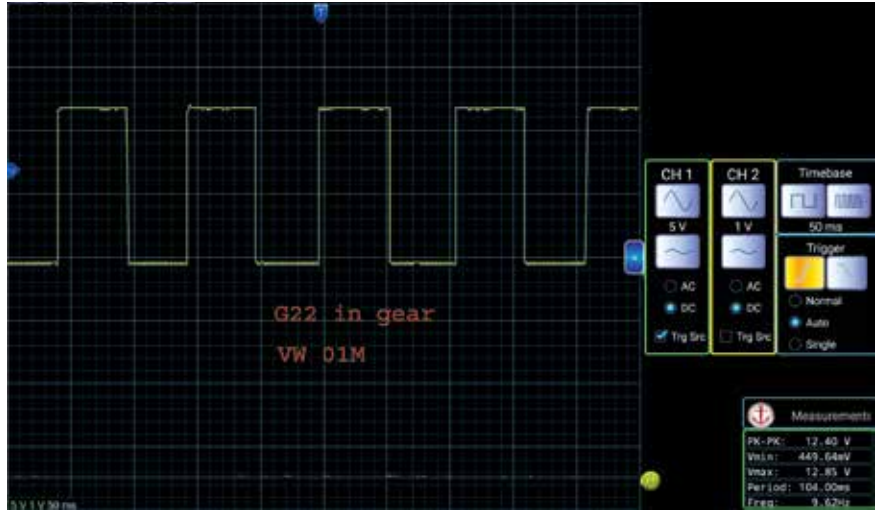
Engine running, in gear and at idle speed.

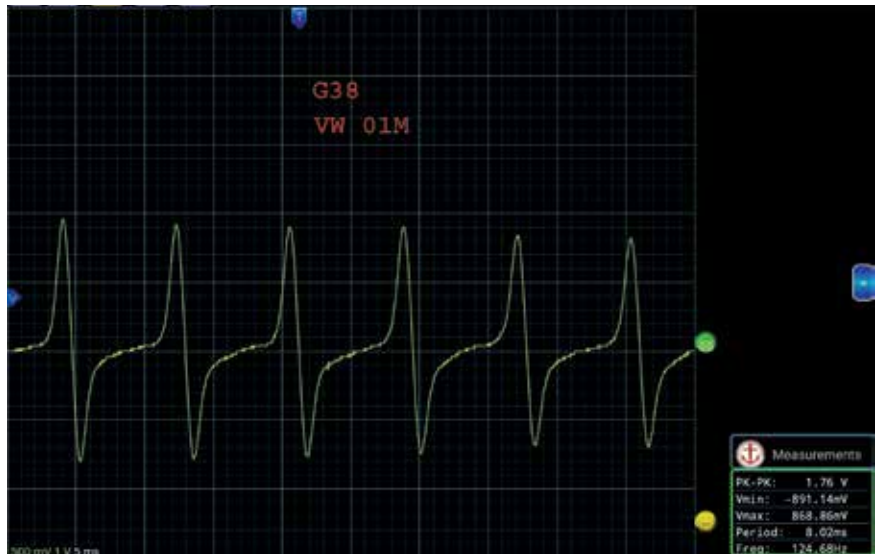
Engine running, in neutral, applying slight throttle will change the amplitude.

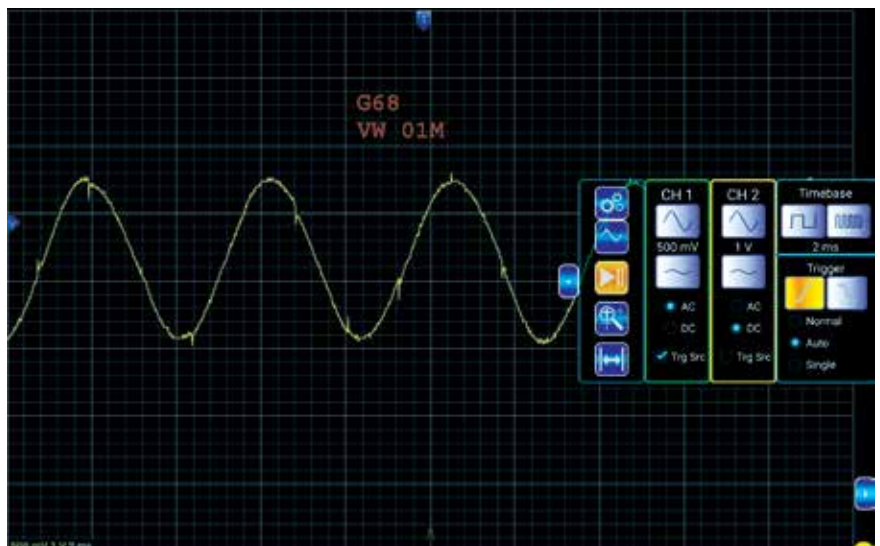
This is the one the transmission uses to measure road (vehicle) speed. Measured in D at idle.
