# SQUEAKING NOISE FROM SUBFRAME BUSHINGS / REINFORCEMENT PLATE

**NO:** TJ 17644

**FUNC DESC.:** RUBBER CUSHION

**PARTNER:** 3 US 7510 VOLVO CARS  
NORTH AMERICA

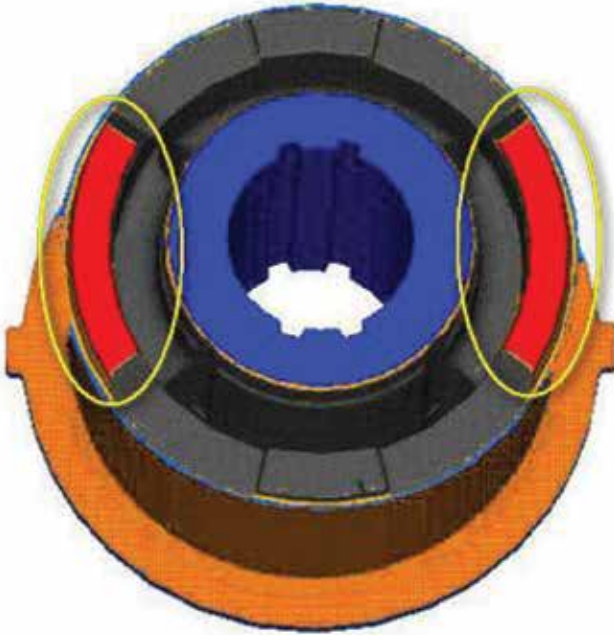
ORANGE BUSHING

The noise usually comes from the rear bushings in the front subframe due to axial travel resulting in a rubbing or squeaking noise between the reinforcement plate and the bushings' front and rear axial movement limiters.

Once the rubber material on the bushing is worn out, the underneath plastic material may cause a soft knocking noise instead. The contact points are illustrated in the attached pictures: TJ 17644 -1.jpg; TJ 17644 -2.jpg

If this customer's complaint is verified, replace both right and left side reinforcement plates, refer to image "TJ17644: Contact Points," on the next page.
