# VOLVO SUNROOF CASE STUDY: 2007 V50 WAGON WITH SUNROOF STUCK IN THE 80 PERCENT CLOSED POSITION

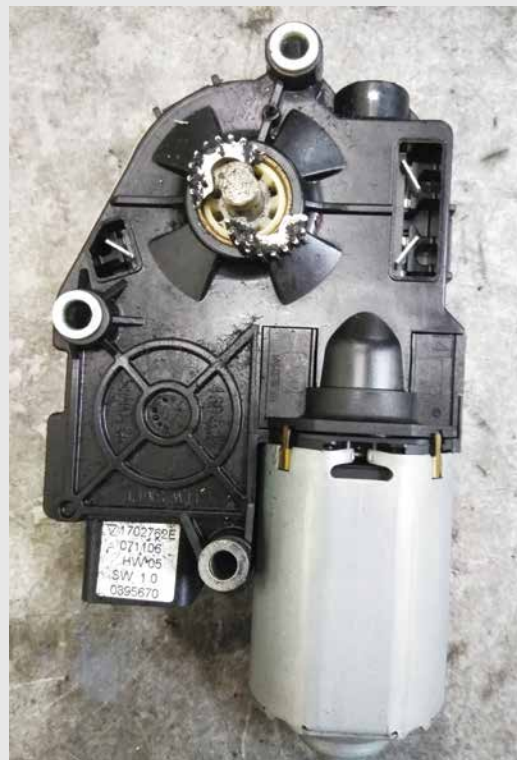
When the technician pulled the motor from the cable track, the drive gear dropped out in two pieces.

The sunroof motor drive gear had split in half; this is not a common problem in Volvos.

The cables moved smoothly and the tracks were fairly clear of debris except for the right side track which had some ground up rock chips lying in the channel.

So the theory is that a small rock popped into the sunroof rails and, when the customer tried to close the sticking sunroof multiple times, pop snap bang.

The technician cleaned out the debris and lubed the tracks and hardware and then lined up the cables and guides into the vent position and reinstalled the glass.

The technician then installed the new sunroof motor assembly and reassembled the headliner and dome light assembly.
