VIN: 3VWJM31K68Mxxxxxx

Part No SW: 07K 906 032 BJ Component: 2,5l R5/4V

3 FAULTS FOUND

HISTORY

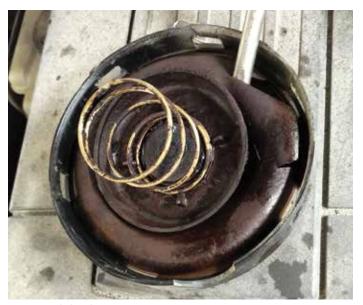
This view of the air filter leads to the assumption that the previous service facility was a little "rough" with the cover that was housing the air filter.

An attempt was made to use a two part metal epoxy to repair the cover and minimize the damage to the air filter. The attempt included affixing the rubber grommet to the stays/pins on the valve cover.

More epoxy layers

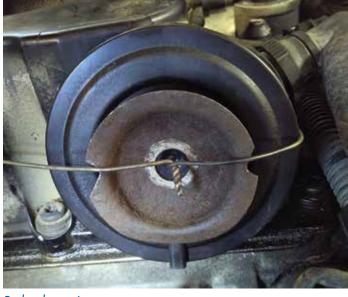
Damaged diaphragm

The repair to the engine cover will not address the lean or improper idle condition. The lean/idle condition is attributed to a vacuum loss and has to be identified as either internal (engine mechanical components) or external (engine vacuum connections).

As with anything, sometimes a replacement part is found that will solve the "torn diaphragm" syndrome. With some cleaning and re-assembly with a replacement, the fuel trims and faults were deleted and idle quality returned to normal. Note the replacement is an aftermarket part.

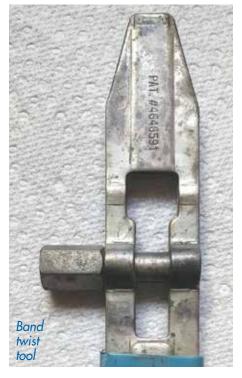
Cap and band

This kit offered a perfect solution to keep the replacement cap in place.

- 1. Calculate the length needed.
- 2. Use the correct clip to attach the length of band.
- 3. Push or have the cap tied firmly in place.
- 4. Use the correct tool to squeeze" the clamp onto the cap.
