2009 TIGUAN 2.0L FUEL PRESSURE ERROR

By: Augie Ferron

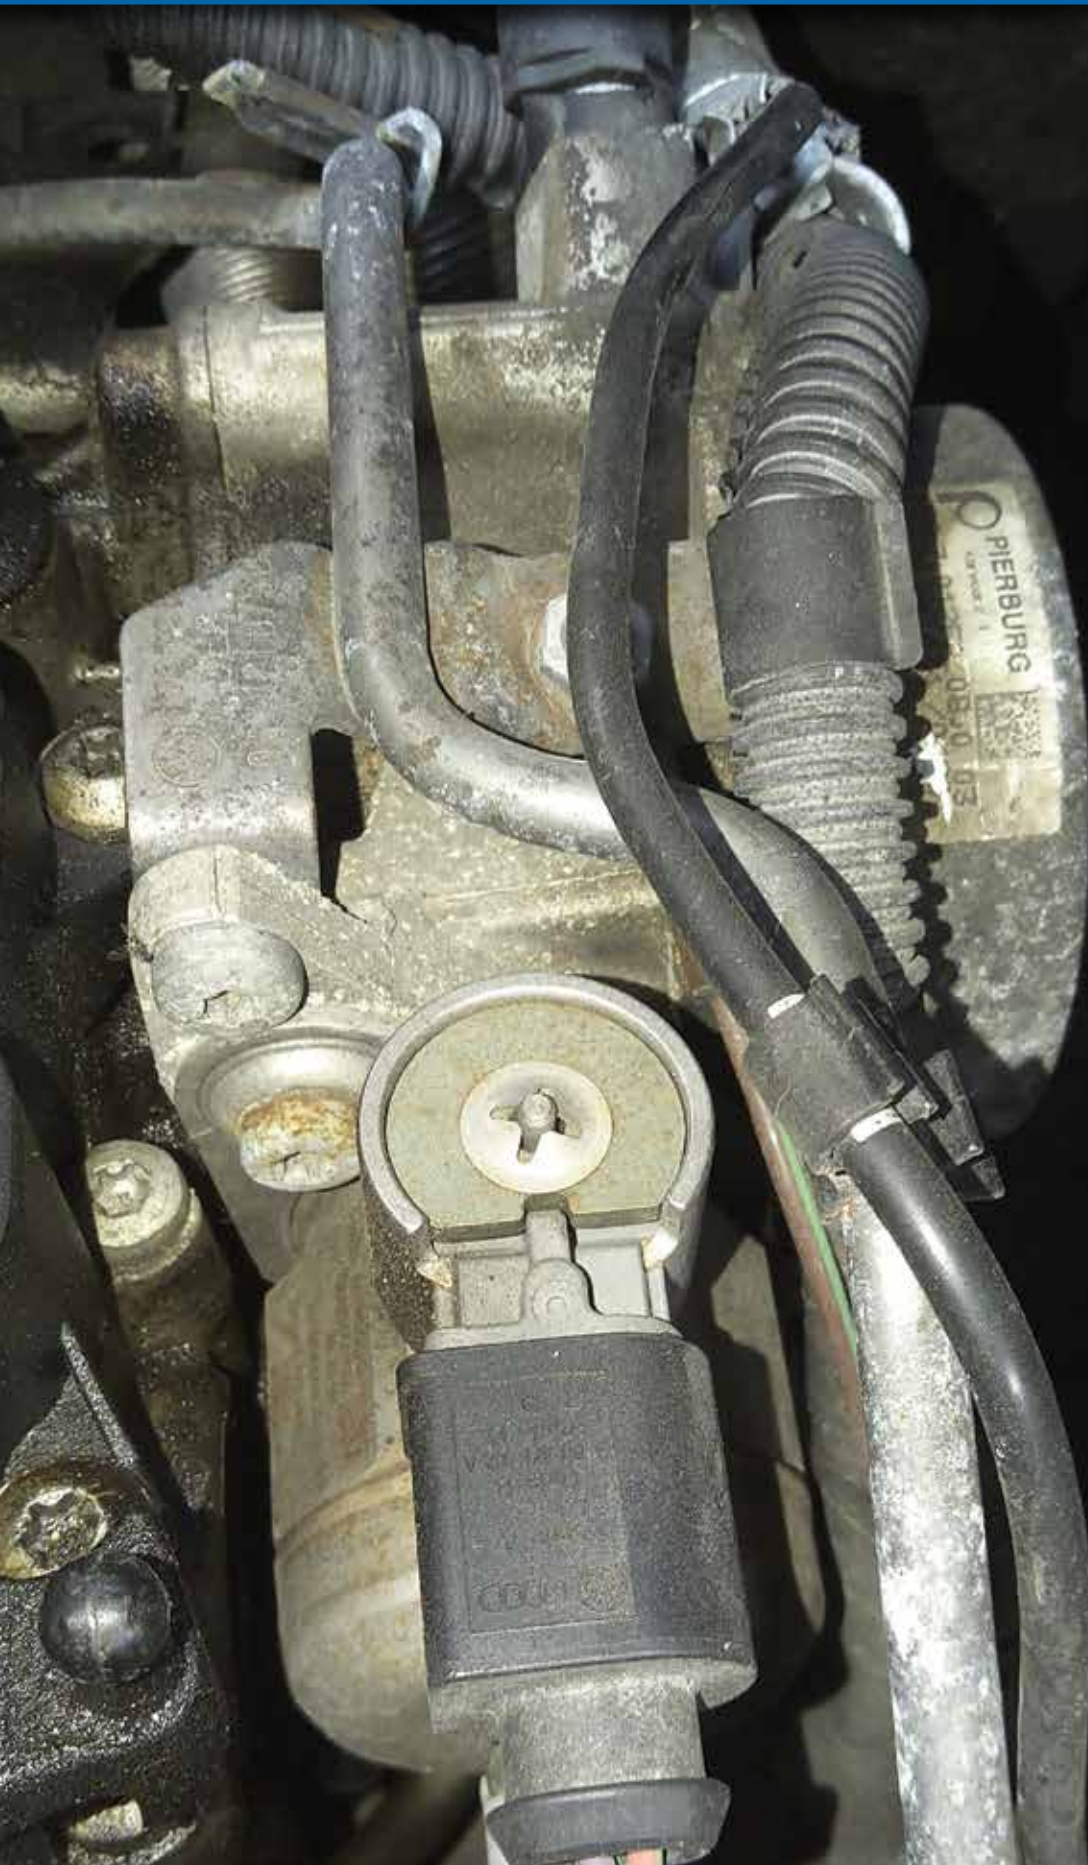
Defective pump

Group 106 field 1	The ECM is requesting 40.00 bar
Group 106 field 2	Actual fuel rail pressure is far too low at 6.50 bar
Group 106 field 3	The in tank fuel pump is commanded at 64.7 percent
Group 002 field 3	Mean injection time is 3.57 ms

(This is looking more like a port injected model.)

Where is the original part and where was it purchased? The search was on and within a few minutes the original part was found. The original appeared to be defective where the seal resides, and we also found the original cam follower inside the original fuel pump. The follower or cap rides the camshaft, pushing on the spring loaded shaft that creates high pressure. The four lobe design reduces the piston stroke compared to the earlier three lobe design.

The follower or cap is missing from the replacement. No comment and keeping it clean! Reassemble again with the correct parts and measure.

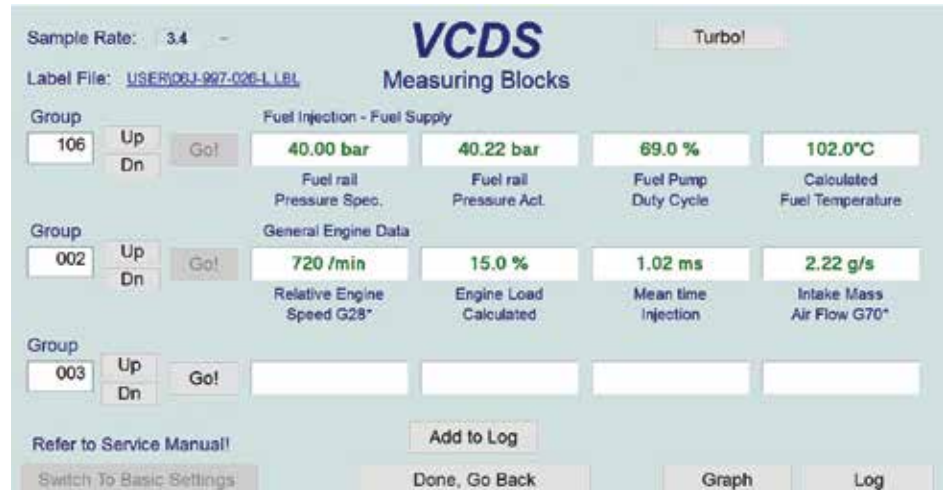
Warm engine

Group 106 field 2	Is close to specification
Group 002 field 3	Looks normal for a cool FSI engine
Group 106 field 4	The warmer engine is demanding more in-tank ON time
Group 002 field 3	Engine management requires less injection time (warm)

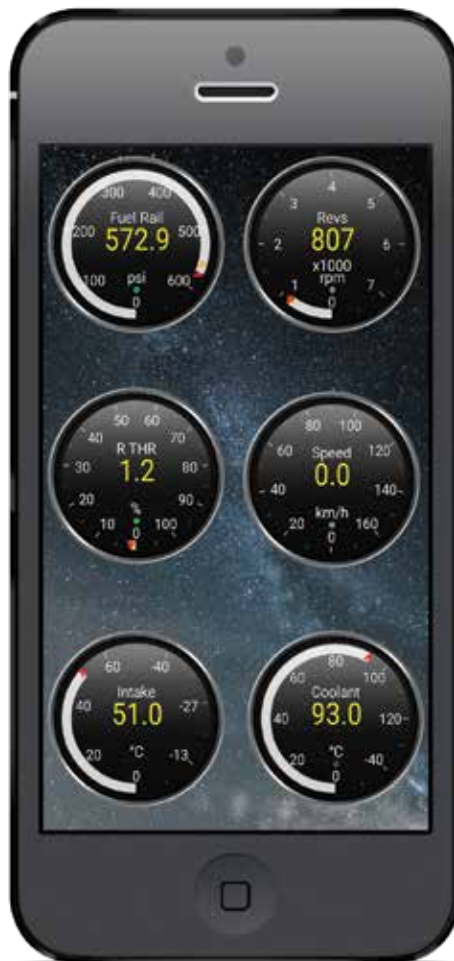
Android psi

VCDS is the “go to” tool with many features comparable to a factory version, but one day I was experimenting with an Android device. 572.9 psi or 3880.0 kPa = **dangerous**, plus conversion from degrees C to degrees F. ■
