Part 1: This is what happens to vehicles when repair facilities do not have the proper tools and training when addressing customer complaints. The vehicle in question is a 2006 Jetta 2.0L TFSI BPY engine with DSG transmission. The question asked in addition to repairing multiple issues was, "Can you get the high beams to work?"

Part 2: This part of the article examines small mistakes that created larger headaches and fortunately, all of the participants were in sync to correct a problem that should have never been created.

This all began as a theft recovery through an insurance company and the greatest damage was the instrument cluster. How difficult can this be? You would have to pay attention to the “investigation.” The model is a 2008 Jetta S with the 2.5L R5 and 09G Automatic Transmission.

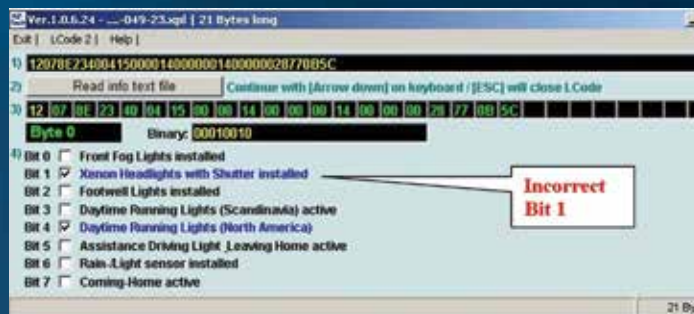
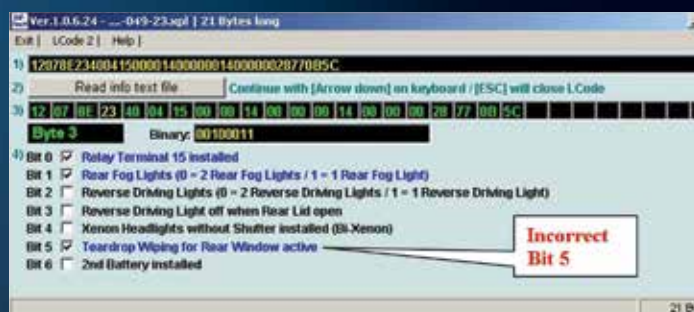
Coding was incorrect at address [09] Central Electrics.

Incorrect coding:

12078E234004150000140000001400000028770B5C

The next two images indicate the incorrect coding with explanations to follow.

Bit 5 is also incorrect for this model

(A) This model did not have the Xenon Headlights with Shutter option.

(B) This model did not have the Teardrop Wiping for Rear Window Option

The reason is because the used controller came from a Jetta wagon. The model being repaired is a sedan.

Therefore, the incorrect coding was left or attached to this controller.

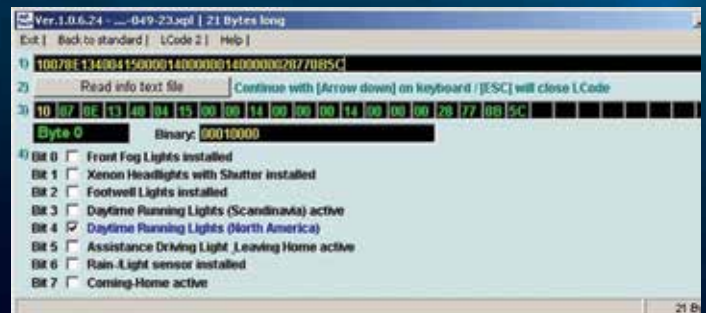
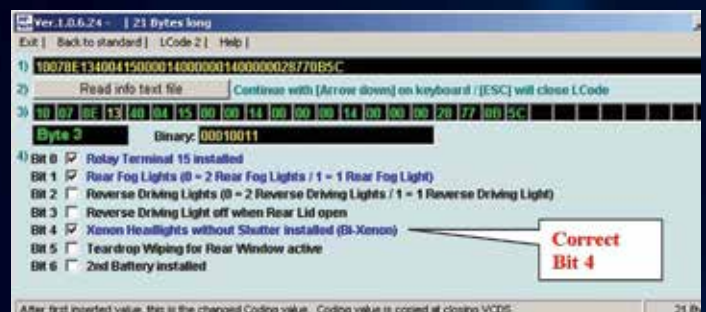
Notice the difference with the coding now when the model is identified with the correct equipment at Byte 0. Take the time to notice the differences between the two set of images {Correct and incorrect}.

At Byte 3, the last change was made and saved.

Correct coding:

10078E134004150000140000001400000028770B5C

- The next two images are correct.
- The coding is saved and now the high beam function works correctly.

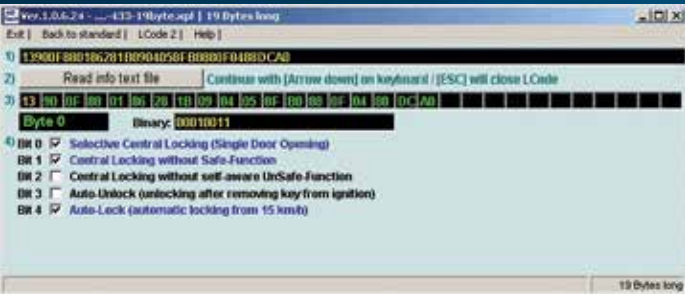
Byte 0 (Hex 13)

Here is the exact example for this controller of what the coding tool looks like with the correct and incorrect string.

The following is the corrected version and final scan of Address [46] Comfort Control (aka Central Conv.) and the FINAL result
Address 46: Central Conv. Labels: User\1K0-959-433-CT.lbl
Part No SW: 1K0 959 433 CT HW: 1K0 959 433 CT
Component: A_ KSG PQ35 RDK 052 0221
Revision: 00052000 Serial number: 00000000000000
Coding: 13900F887F86081B0904058FB0880F0488DCA0 (Incorrect)
Recoded at dealer during the first repair
Coding: 13900F880186281B0904058FB0880F0488DCA0 (Correct)
Corrected code at dealer and final repair
Shop #: WSC 2250x 444 102980
Component: Sounder n.mounted
Component: NGS n.mounted

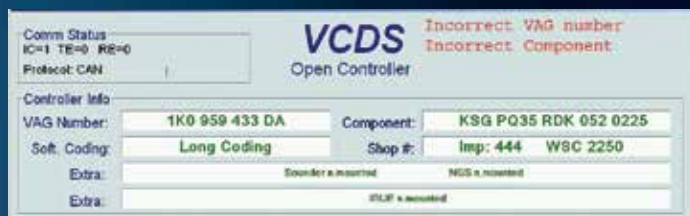
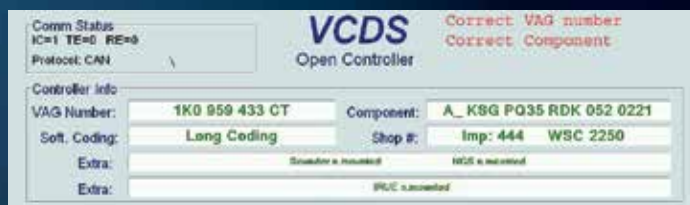
The last digit of five of the WSCs (Work Shop Codes) is removed from each image.

Imp: 444 is a US importer code.
