Technical Knowledge for Volkswagen®, Audi®
and Porsche® Service Professionals

VW COOLING SYSTEM CONUNDRUM

How a Seemingly Simple Radiator Replacement Leads
to Three Weeks of Technician and Customer Frustrations

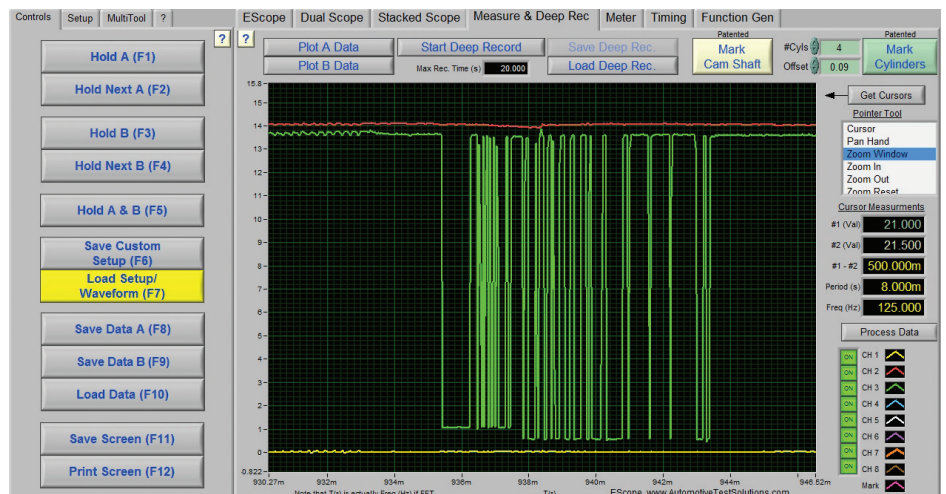
Upon scope checking the physical sensor again, you notice that the power and ground circuits are working properly. You have full voltage, no voltage drop on the ground circuit, and then the signal circuit catches your attention. It seems that the "sensor signal" circuit is actually signaling more like a communication line, rather than an analog sensor return circuit. Huh? Interesting!

Note the power, ground and signals are occurring properly, the sensor seemingly works fine.

Here we see the oscilloscope waveforms for the Golf's DOR sensor mounted in the radiator.

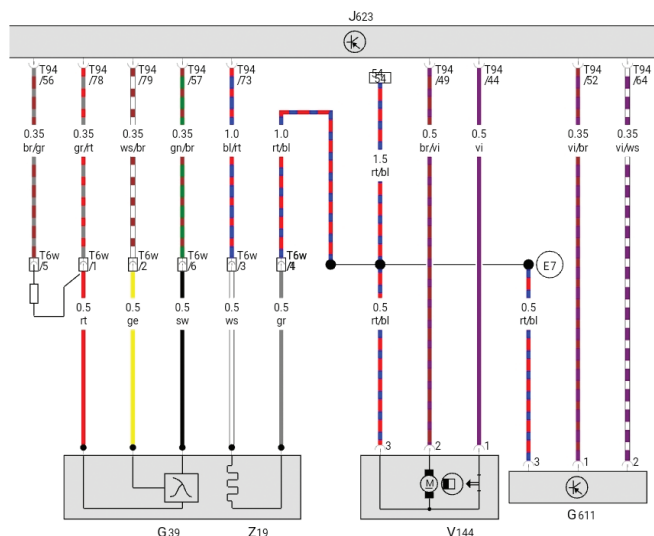
This graphic shows the schematic for the G611 radiator sensor, wired to the J623 ECM.

A look at the wiring schematic for ATD Radiator Sensor G611 shows a three-wire sensor circuit.

Pin 1 of this sensor is a violet/brown wire, which on this Golf GTI/CBFA engine, goes to connector T94 at pin 52 of the ECM. This wire serves as sensor ground at the ECM.

Pin 2 of the sensor is a violet/white wire, which is a LIN bus communications line, going to connector T94 pin 64 of the ECM.

Finally, pin 3 of the sensor goes to a splice, which connects directly to the O₂ sensor heater power circuit and carries battery voltage; this wire terminates at a splice point. (note: These pin assignments are for this particular vehicle; consult schematics for different years/models).

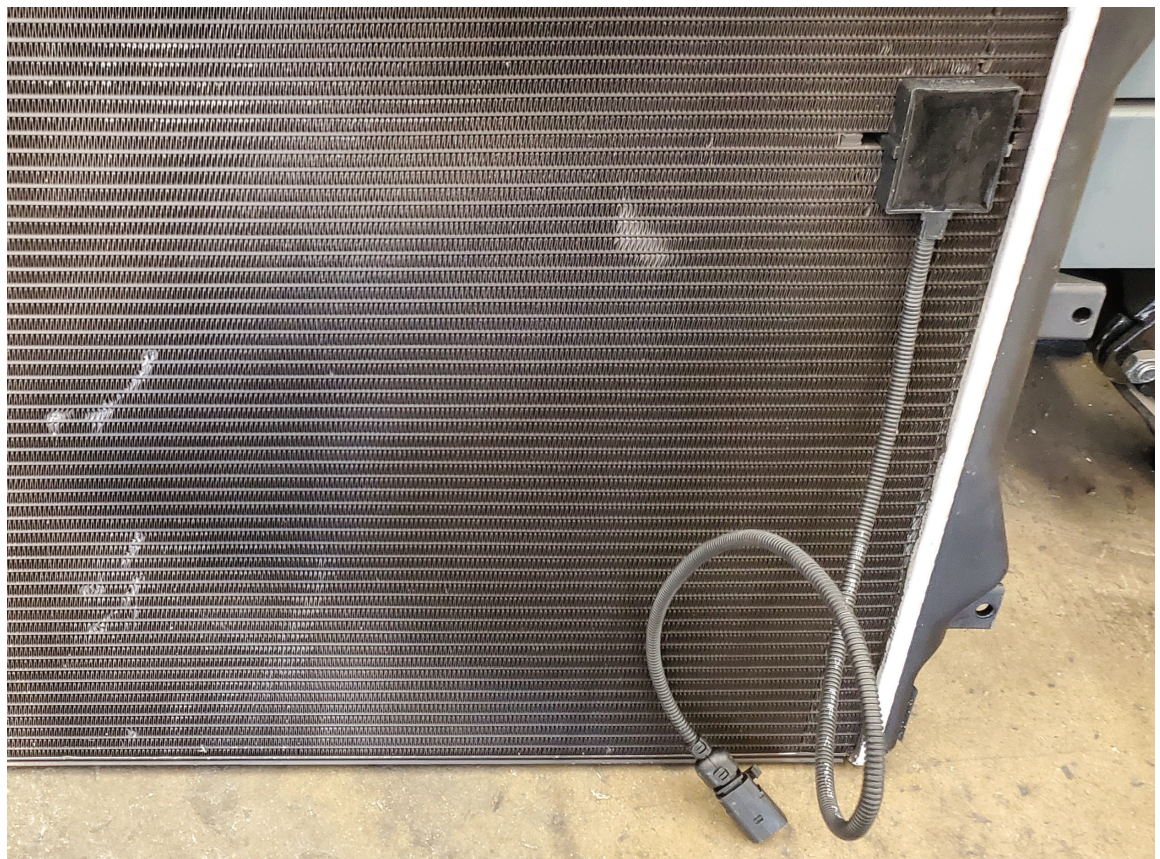
You will notice that there are three distinct contact points on the heat sink. This is where the second internal coolant sensor is close-coupled to the heat sink, so as to be able to sense the temperature of the heat sink. The first sensor is in the probe tip that goes into the heat sink hole and measures the coolant temp in the radiator.

The heat sink area where sensor G611 mounts to the Prem-Air radiator.

What was happening was that the technician was applying the adhesive to the face of the sensor body, not the probe. This created a solid film barrier between the close-coupled sensor body and heat sink.

The additional glue barrier provided increased insulation and distance between the sensor and heat sink, skewing the temperature curve during warm-up by greater than the allowed 5 degrees C, thus setting the plausibility code.

Der Fix? Glue the new sensor carefully according to directions, and there are generally no further problems, provided that one does not crack or break the new sensor while pushing it into the heat sink and engaging the clips.
