Module Updates Do Fix Shifting and Slipping Problems

Don't rush to replace that transmission, check for service bulletins and updates first! We present some cases where problems were solved with control unit updates or replacements.

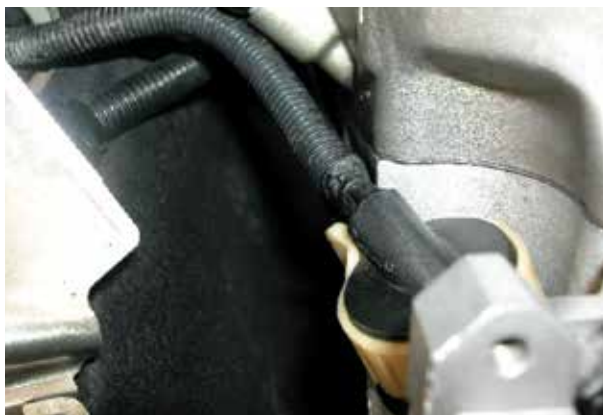
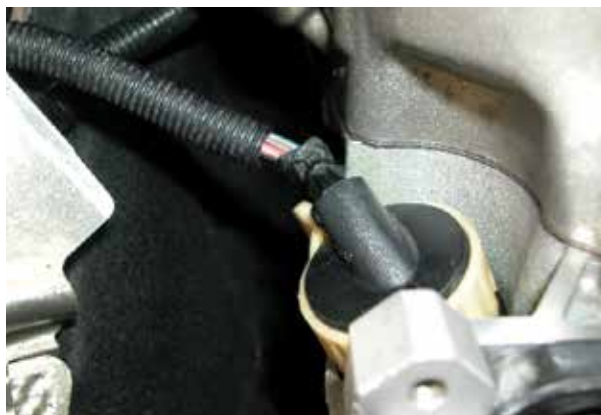
Leaking connectors may be the reason your scan tool won't communicate with the VGS. New connectors are inexpensive and easy to install if the old one is leaking. Note that the o-rings are not available separately. Note also that the 722.9 connector has only five pins, while the 722.6 transmission plug has 13 pins. When routing the wiring harness for this connector, be sure to allow free play in the harness so it is not stressed.

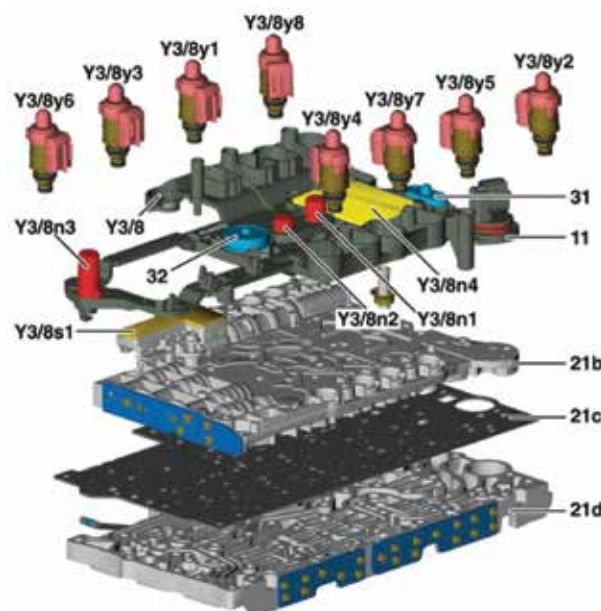
Don't mix up the solenoid valves, they must be replaced in their original position. Otherwise a complete adaptation will be necessary.

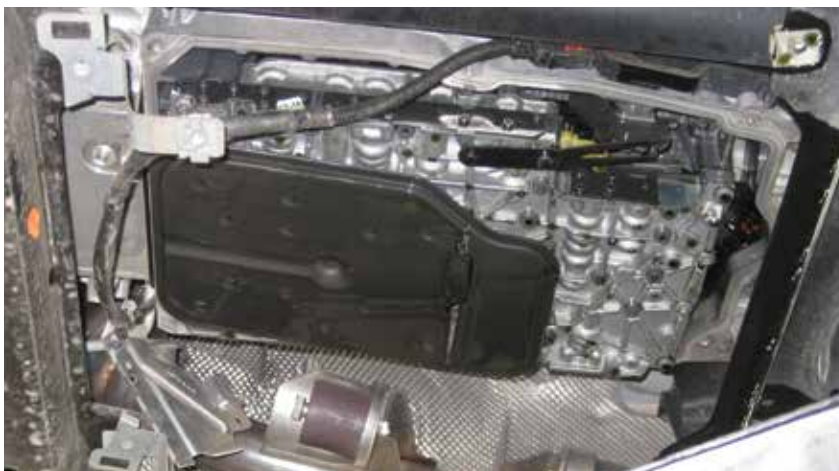
This is the transmission with the oil pan removed. Be sure this area is surgically clean before removing the pan or replacing components.

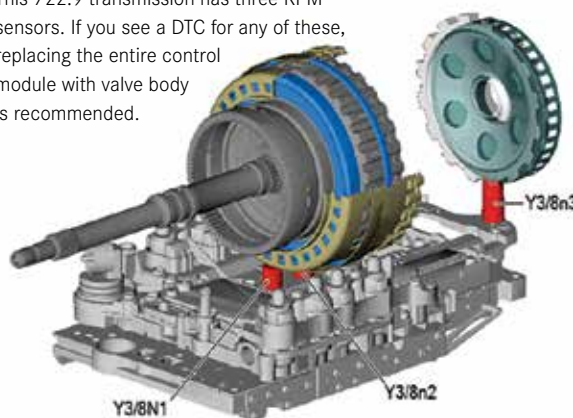
This 722.9 transmission has three RPM sensors. If you see a DTC for any of these, replacing the entire control module with valve body is recommended.
