Technical Knowledge for Volkswagen®, Audi®
and Porsche® Service Professionals

TOUAREG 09D WITH TIPTRONIC SHIFTER

By: Augie Ferron

The victim
is a 2008
Touareg
with VR6
FSI, 09D
automatic
with
4-wheel
drive

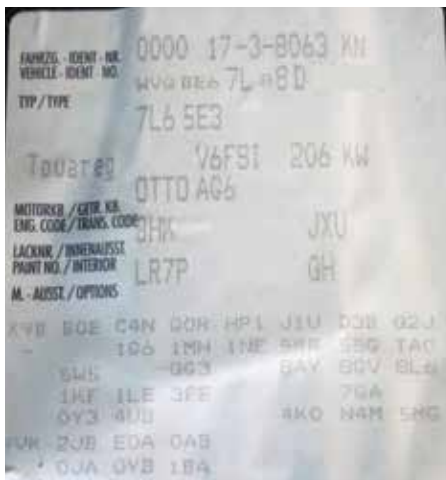
Scan results

Fault Frequency: Indicates the number of times the conditions that caused the fault have repeated during all driving cycles. This specific frequency occurred once and the customer called immediately, having the fault addressed the next day. The fault counts from 0 to 254 and increases with each drive cycle occurrence.

1 Fault Found:
01045 - Tiptronic Switch (F189) 008 - Implausible Signal - Intermittent
Freeze Frame:
Fault Status: 00101000
Fault Priority: 2
Fault Frequency: 1
Reset counter: 197
Mileage: 148117 km
Time Indication: 0

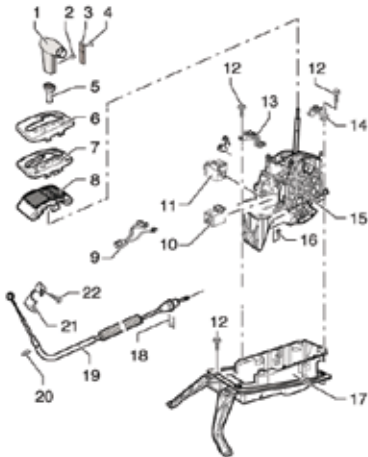
F189 location

F189 is indicated at number 7 and referred to as a "Printed Circuit" board. At number 8 is the rubber sliding cover with two embedded magnets. The magnets move with the rubber sliding cover, activating microswitches within the printed circuit board. The

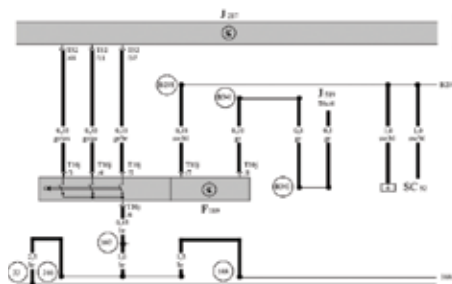
F189 schematic

- SC52 is battery power
- Pin T10j/6 is the ground connection
- J519 is commonly referred to as Central Electrics
- T52/48, T52/11 and T52/37 are the inputs to J217, the TCM
- Input data with VCDS indicates the TCM can recognize F189 as operational
- No faults were found at J159 Central Electrics
- F189 inputs are magnetic (non-contact)

Since there were no power or ground interruptions and F189 seemed to operate "with a mind of its own," the decision was made to replace F189 after repeating its faults.

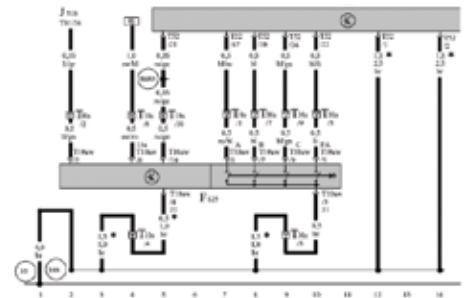
F125 circuit

The TCM recorded no F125 faults or shift solenoid faults.

F125 inputs are mechanical contacts.

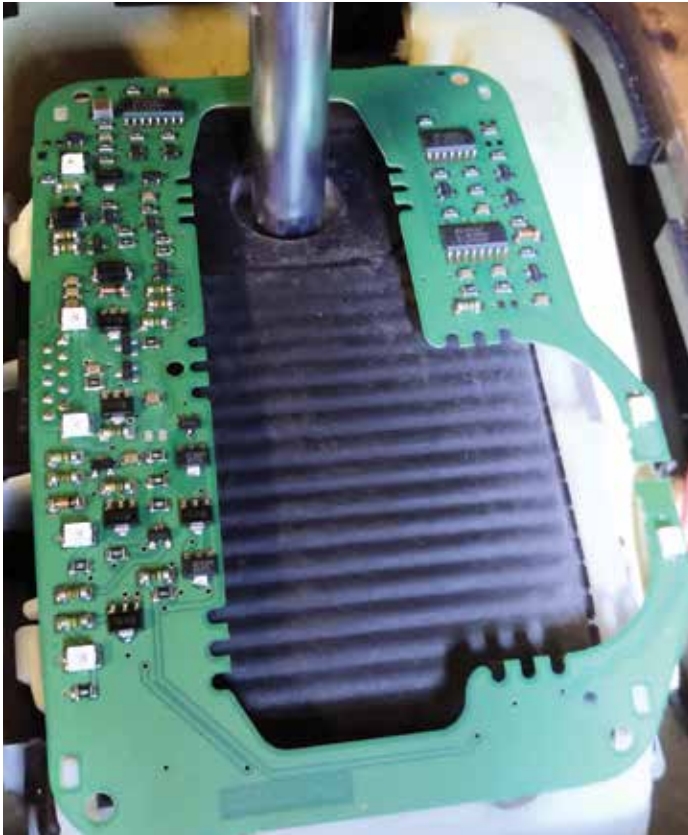
Circuit board F189

The "Circuit board F189" image above is of the NEW circuit board in place and, with it removed, the rubber sliding cover should be inspected and cleaned.

The replacement was the cure — no faults returned, and no abrupt shifts were evident.

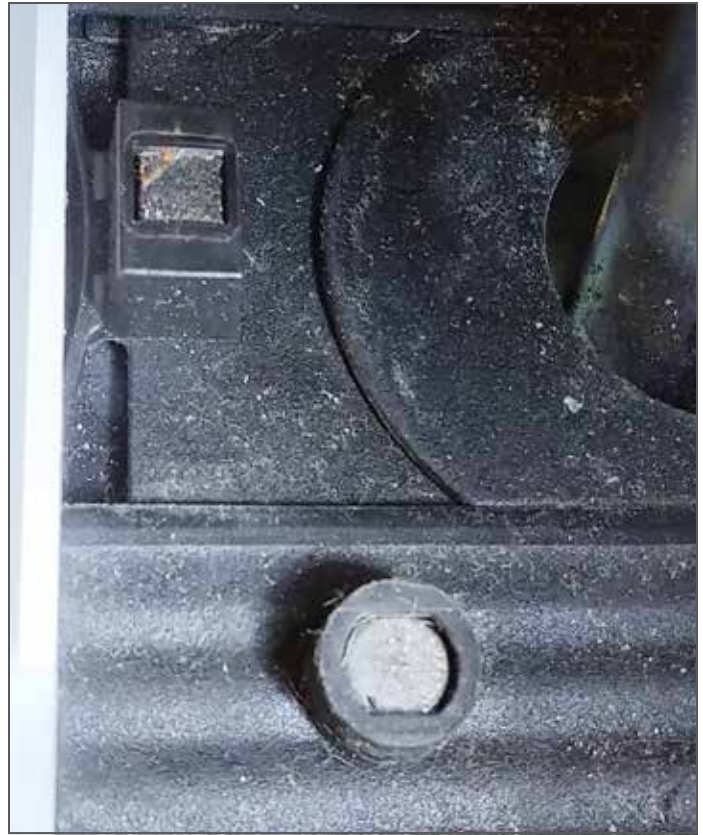
Embedded magnets

Pay particular attention to the magnets. The magnets should be firmly in place, clean, with no debris attached to the entire assembly. There should be no tearing of the rubber cover and it should be free to move. That warning will also include the plastic inserts wrapped around the shifter lever for Tiptronic Mode.

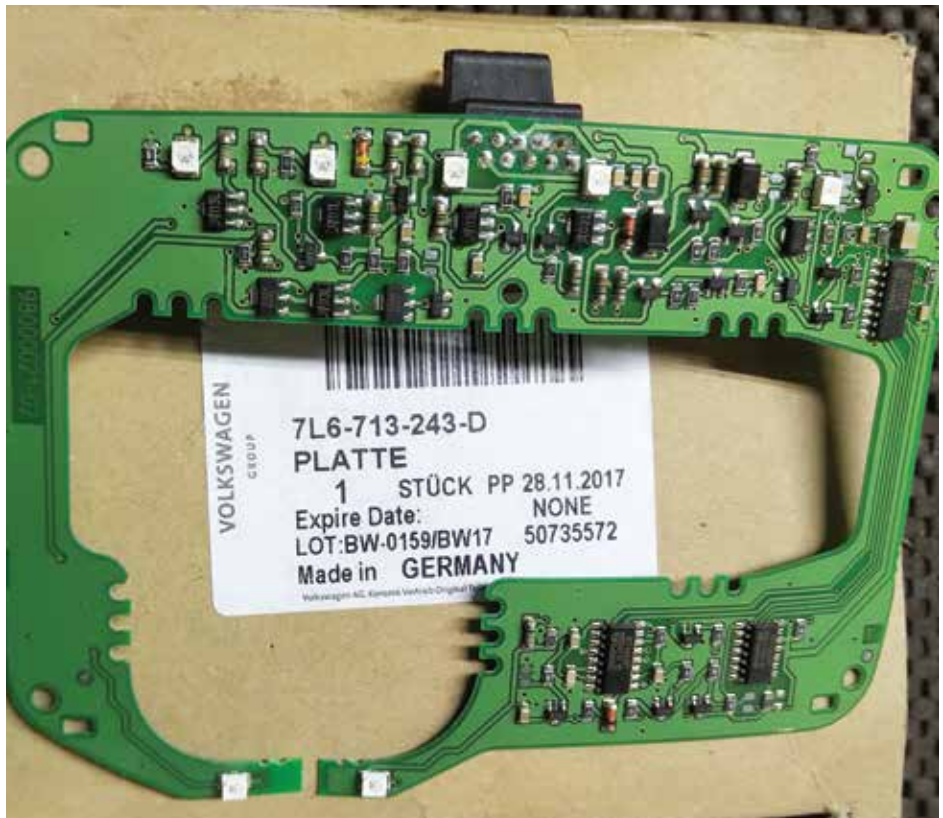
Original circuit board showing the magnetic sensors, from right to left: Park - Reverse - Neutral - Drive - Sport

Notice the oxidized soldering points near the top center section. With a magnifying glass, it was evident something may have been spilled onto the board OR, and we have seen this before, a chemically strong interior cleaning solution.
