## **BODY SHOP MISTAKES - As If, PART 2 & 3**

**The Victim: 2008 Touareg  
with VR6 FSI**

## BODY SHOP MISTAKES – AS IF! (PART 2)

## REAR LIFT GATE HARNESS – AS IF! (PART 3)

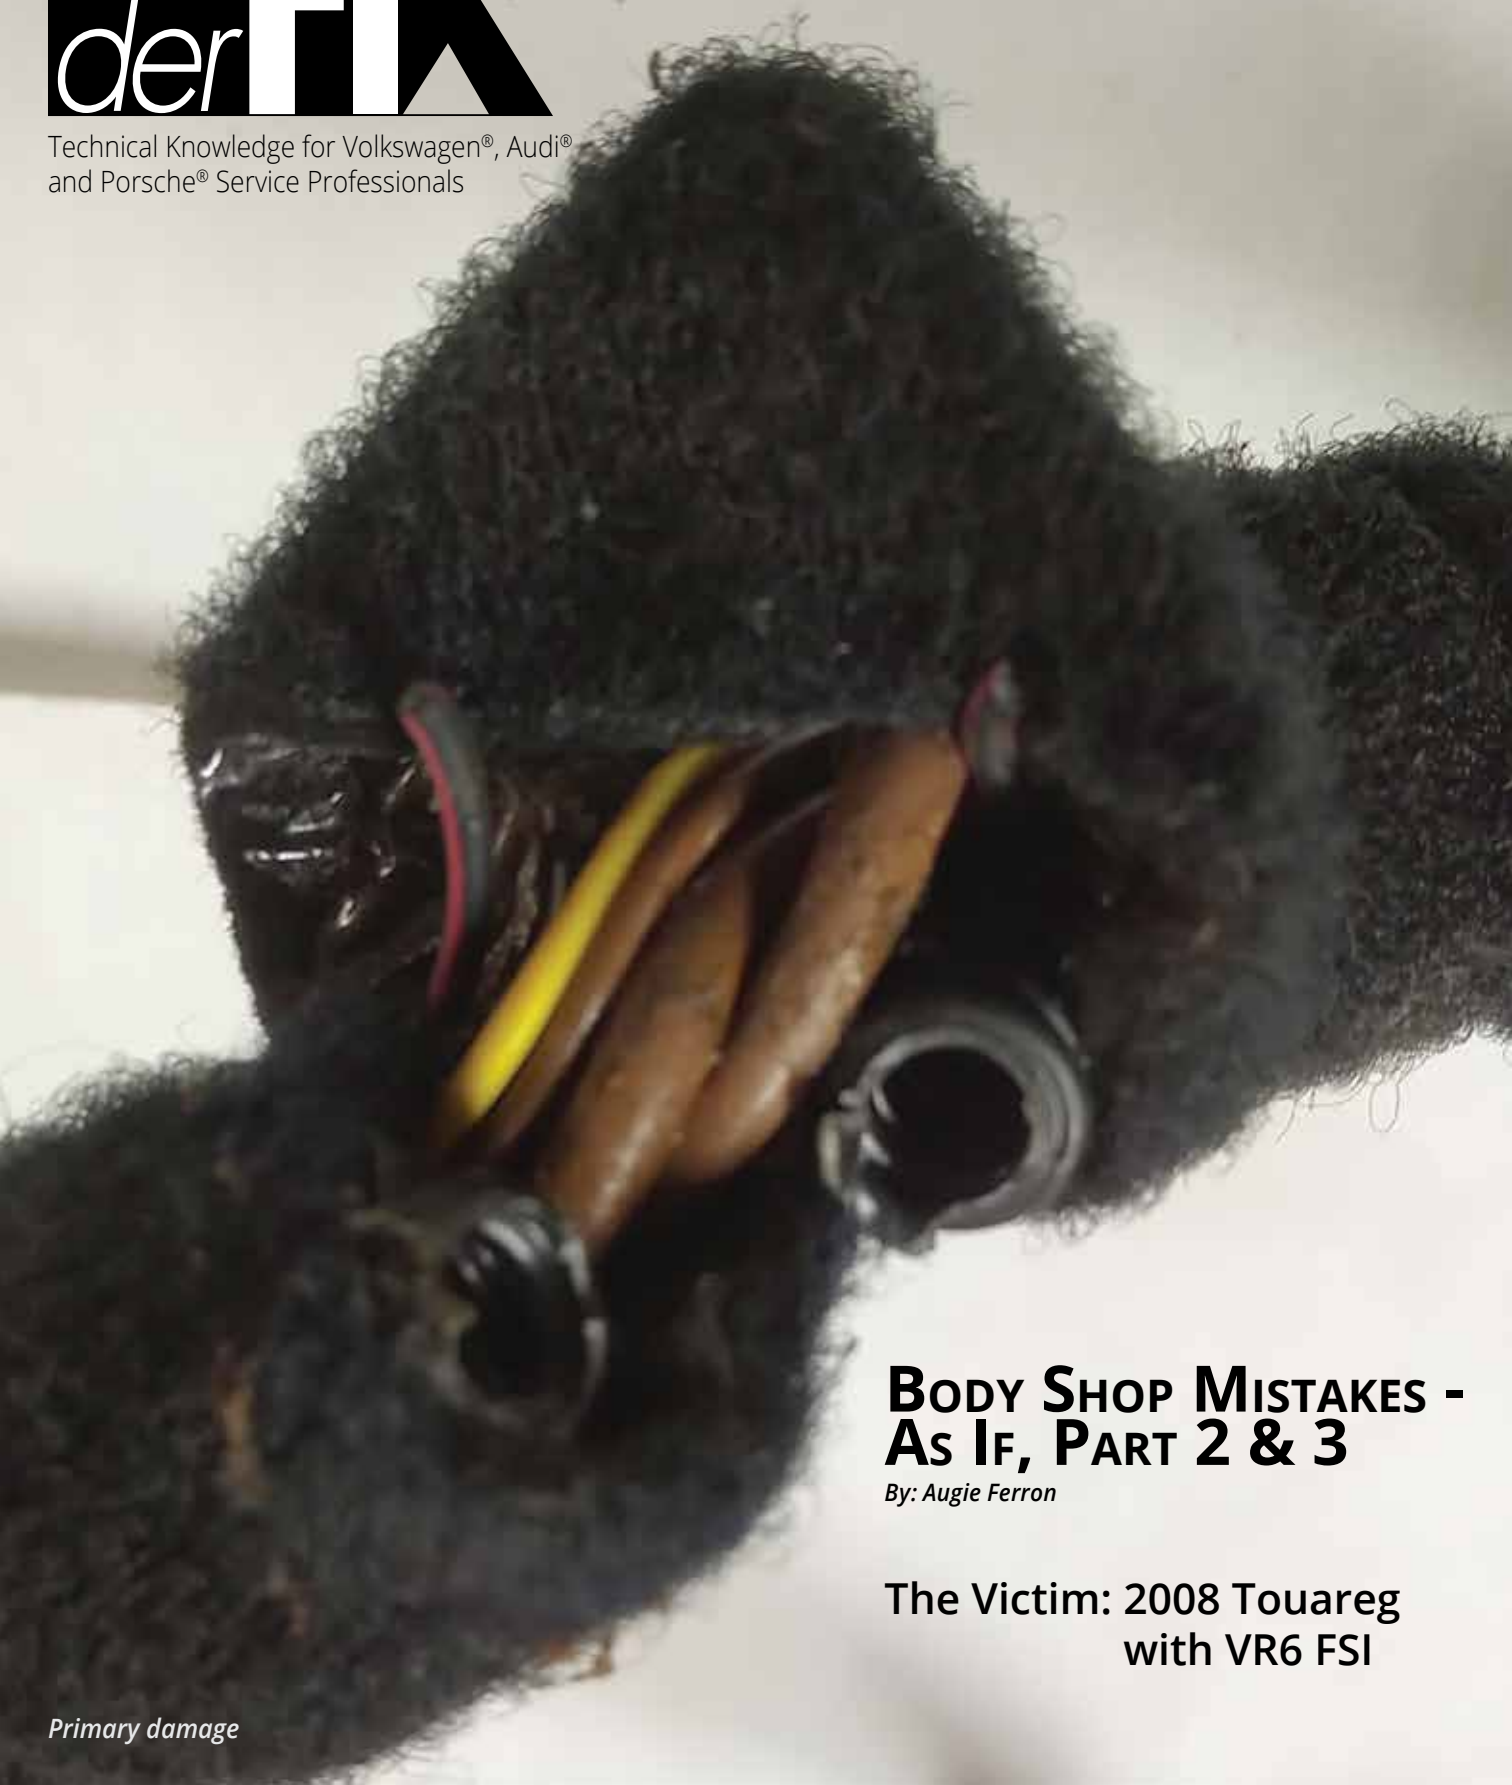
*Primary damage*

The washer hose cracked on the way out but, with a closer inspection, the power B+ wire for the rear window heater, brake light B+, and the Convenience Antenna were also damaged. (See "Primary damage," on page 1.)

With any repair of this type that moves around a hinged assembly, replace the wire(s) before and after the movement of the hinged assembly. Use crimp and shrink connections on the harness for a perfect and robust repair.

Luckily, the cutting wasn't at the hinge, the damage was to the interior side of the roof panel just before the hinged curve. It was still prudent to replace the major wiring front and rear of the hinged assembly with new wired splices.

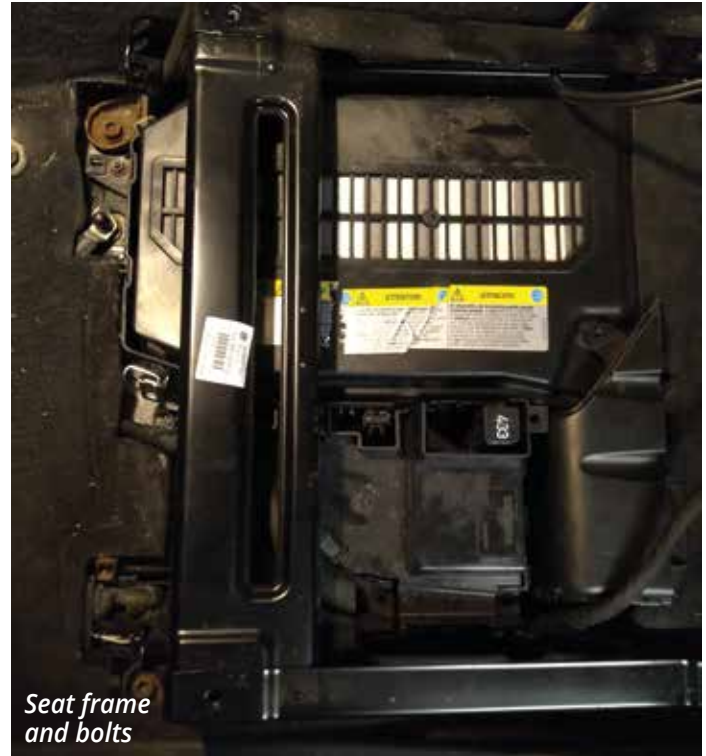
*Seat frame and bolts*

What about the photos and what is missing? View the front "Triple Square" (spline drive) seat frame bolts that are covered in rust.

Know that it was a chore to remove them.

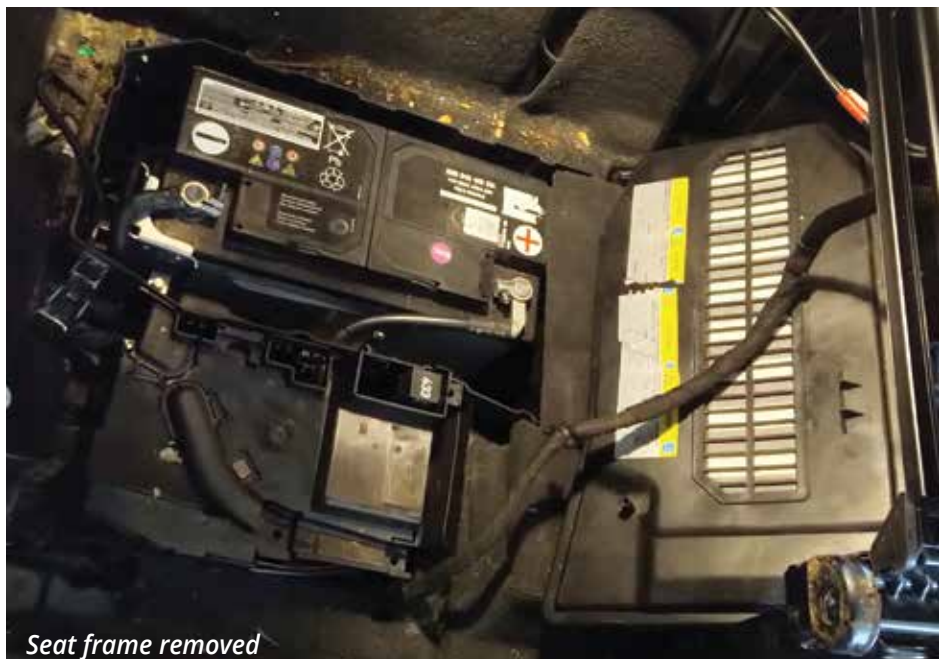
*Seat frame removed*

With the seat removed and frame out of the way, the entire fuse panel and battery were exposed for easy access. Unfortunately, there were some plastic parts damaged when someone attempted to remove the battery from the floor with the seat partially in place.

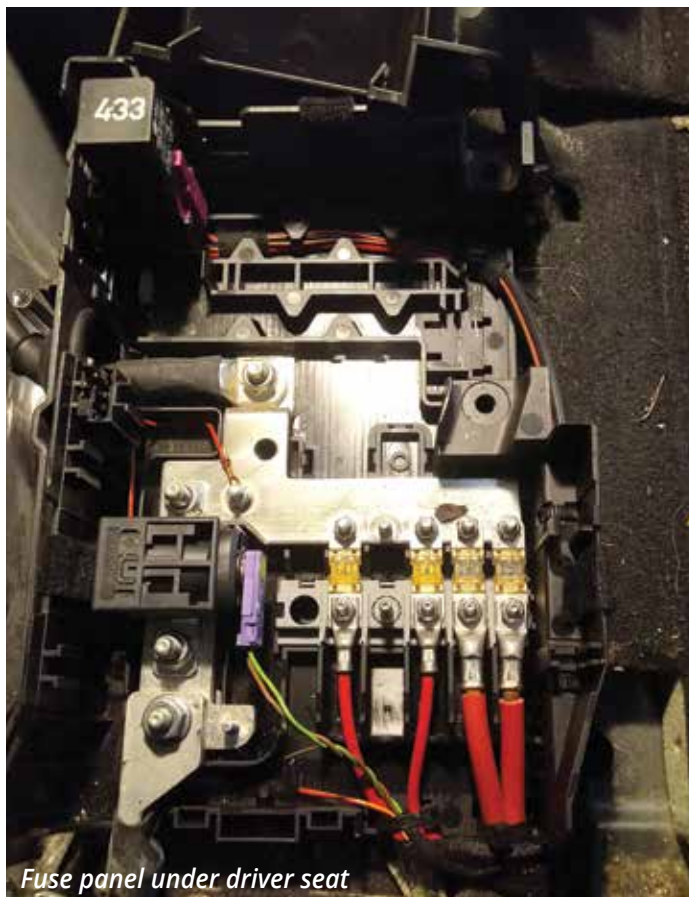
Fuse panel under driver seat

What is with that fuse holder and why would VW allow a hot connection to be exposed in that manner? What does that fuse circuit control and what was its designation?

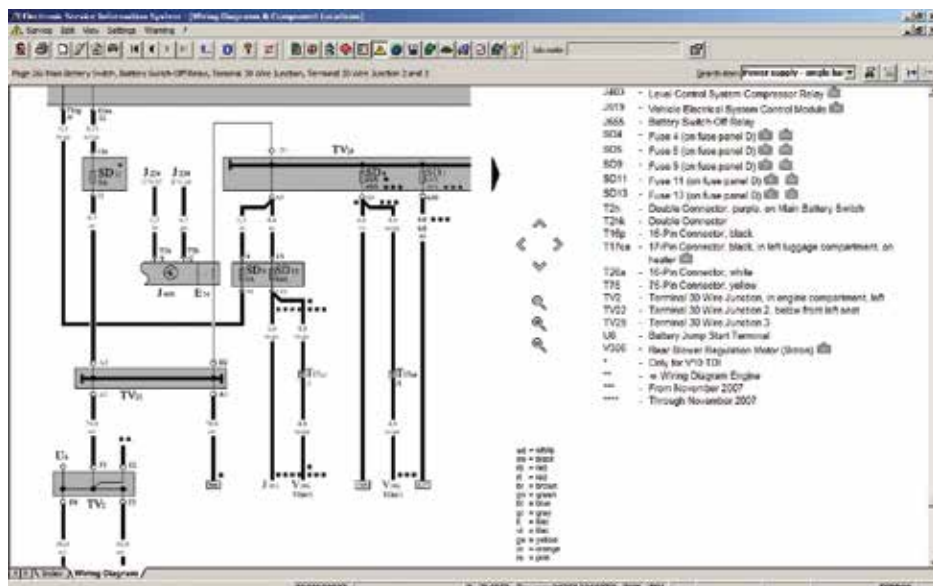
SD9 fuse schematic

SD9 is designated as a 5 amp fuse for J519 Vehicle Electrical Control Module Terminal 30.

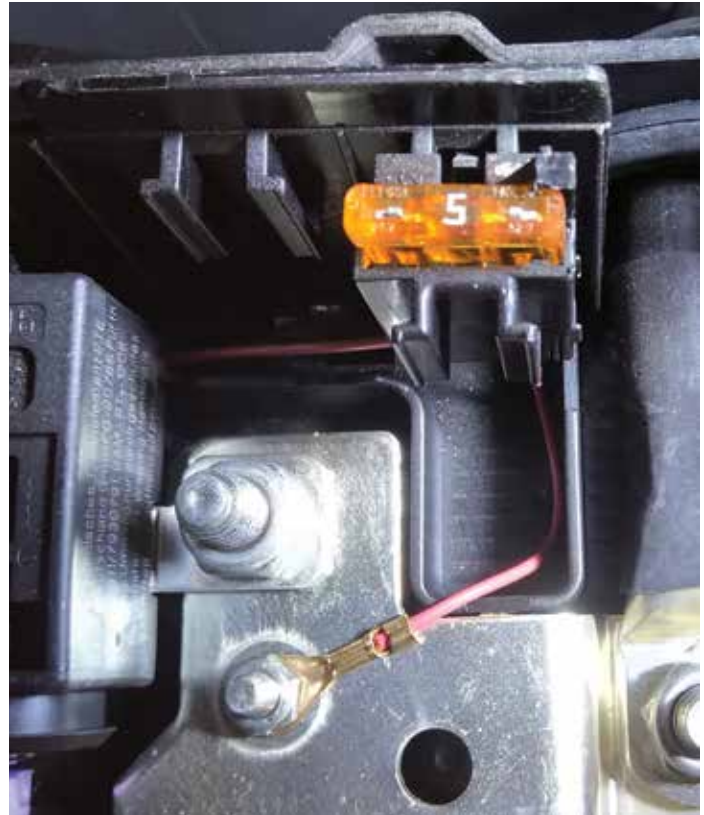
This time the fuse panel was lifted and carpet peeled back slightly. There it was — this 5 amp fuse well hidden from view and the epiphany took another turn. It certainly took a lot of work at the body shop to dislodge a hidden fuse from under the driver's seat while shielded with a plastic protective cover.

*A 5 amp fuse – As if!*

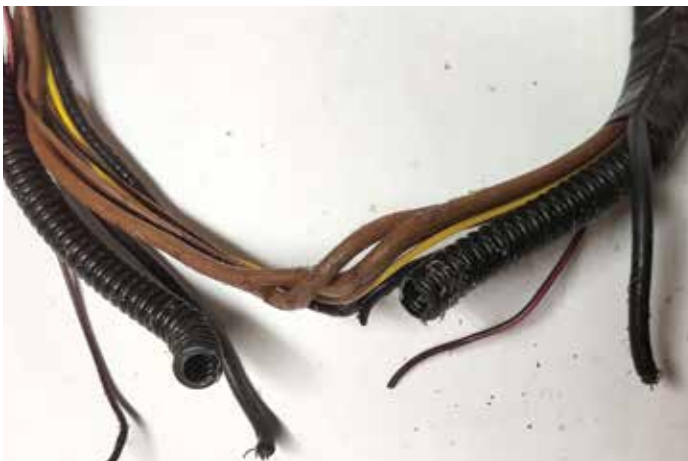
*More damage found*

Why did this harness become damaged? At the hinge there is a rounded plastic protector clipped to the hinge, but it also has an exterior cover that keeps the shape of the harness and holds it in place. That plastic piece was lodged between the protector and the hinge.
