der **FiX**

BODY SHOP MISTAKES - As If, PART 1

**The Victim:
2008 Touareg
with VR6 FSI**

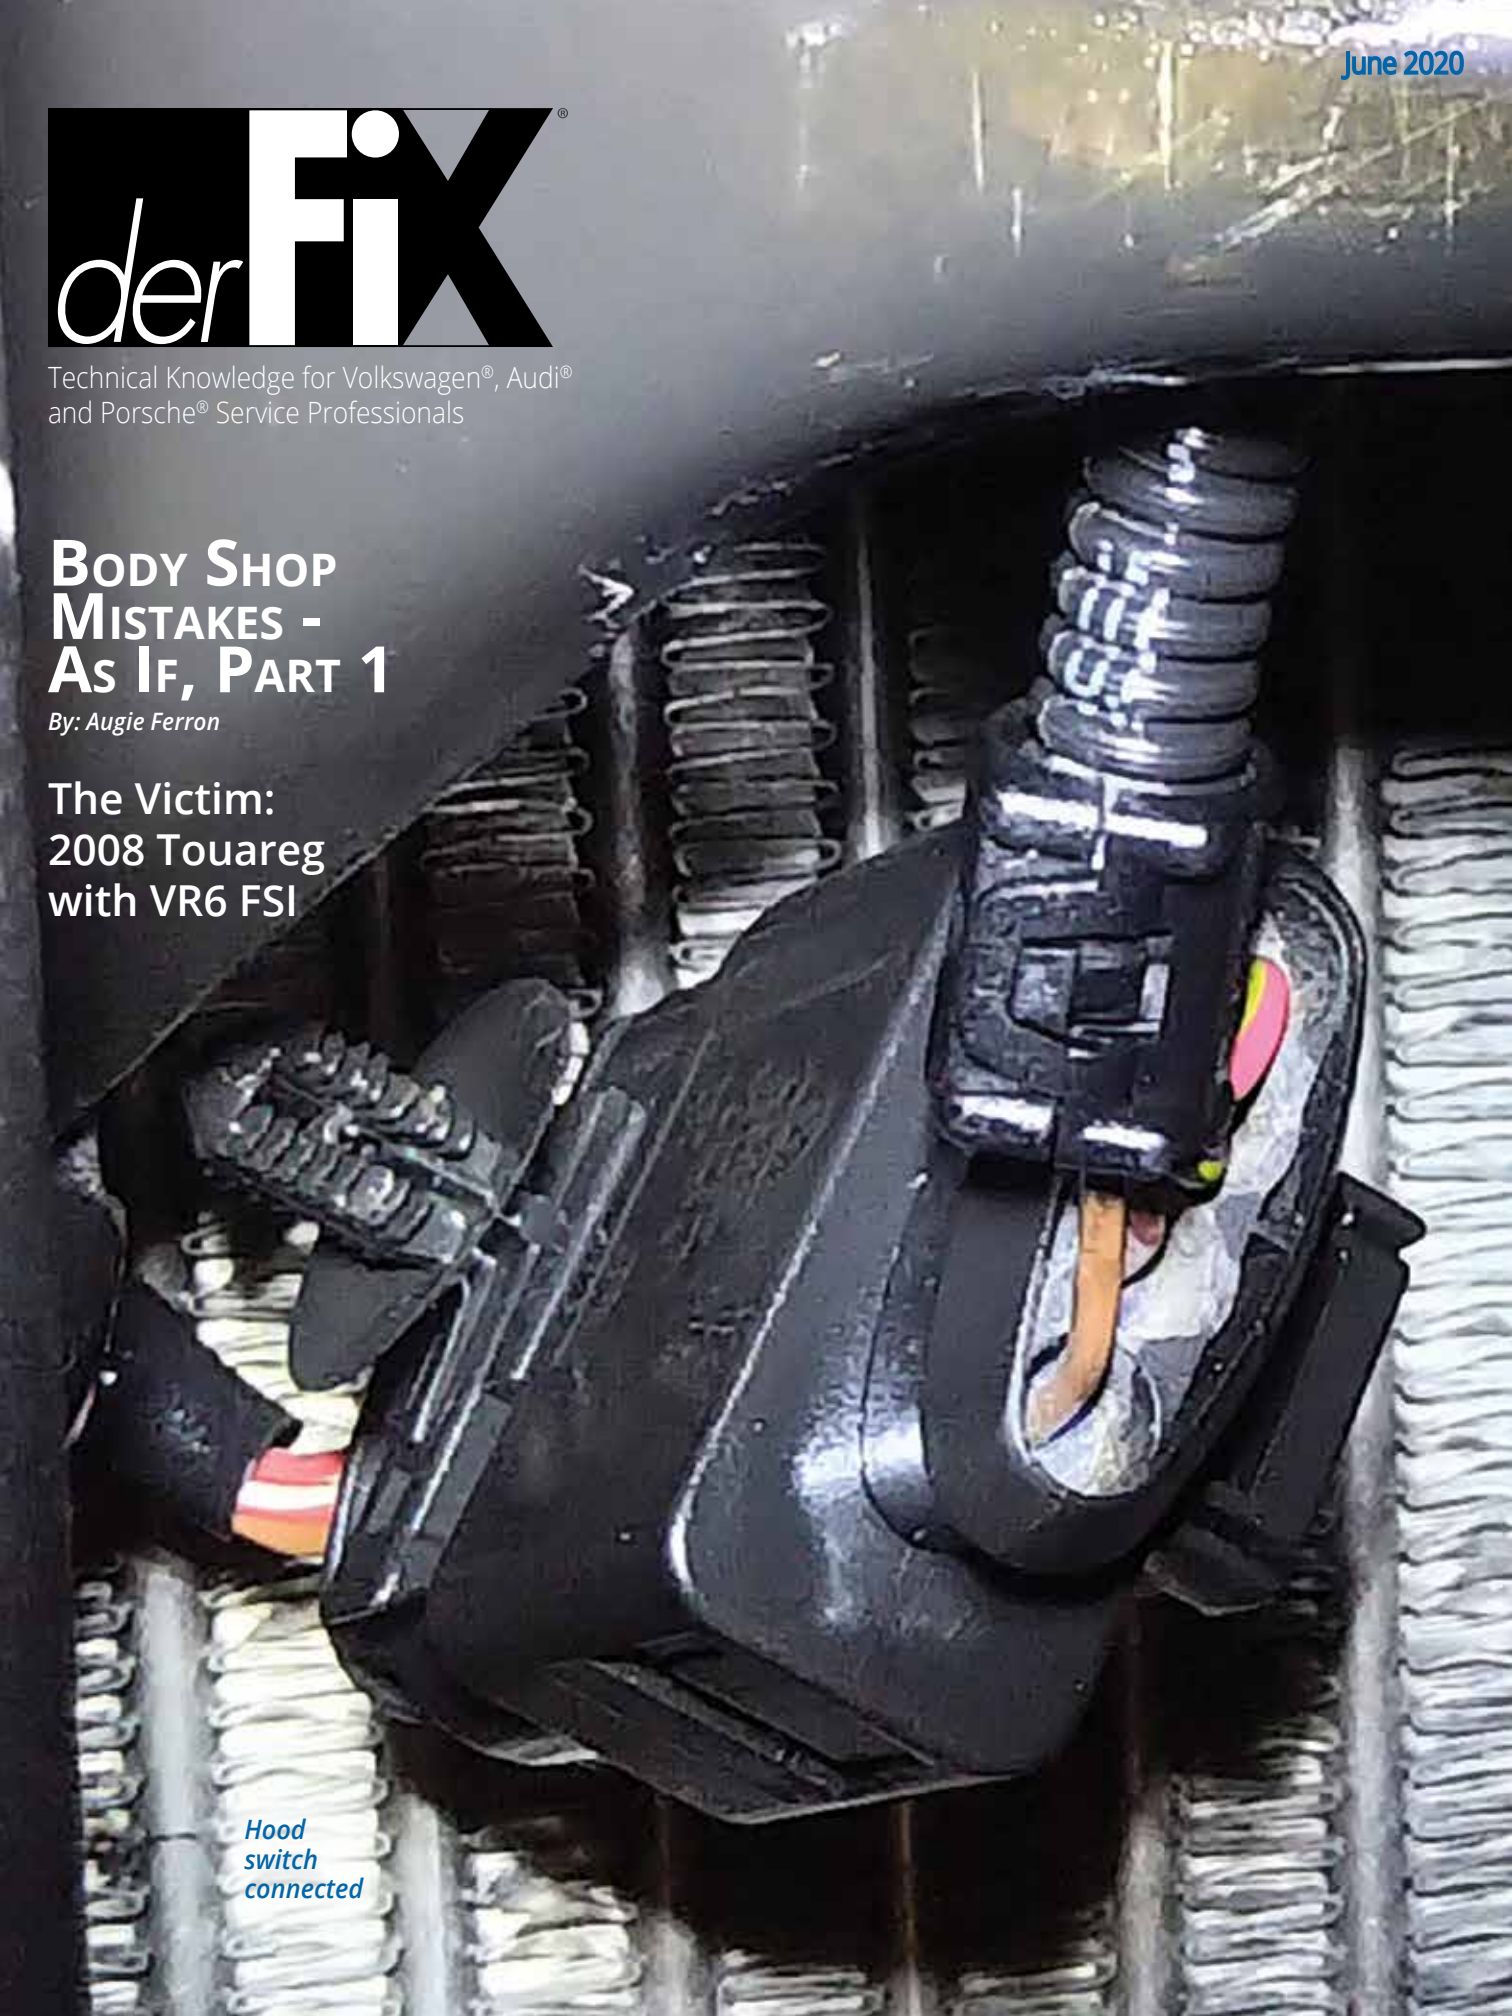
*Hood
switch
connected*

the front wipers are NOT supposed to operate. The wipers did operate and the hood latch wiring was found to be disconnected (accident victim). The green connections were properly cleaned and sealed and the hood switch operated with the correct status at the following Address 09 Central Electrics:

- Measured value 006 field 1, front hood switch status conditions are: "Open or Closed but a Closed Hood = OPEN." **This is normal.**
- Measured value 006 field 2, front hood switch status conditions are: "Open or Closed but a Closed Hood = Closed." **This is normal.**

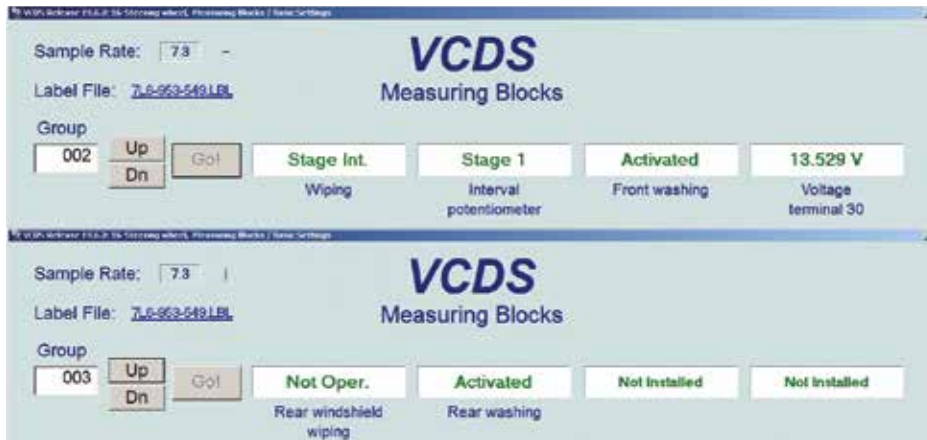
Non active pump(s)

In this case, the display is "Activated" but the pump is not operating.

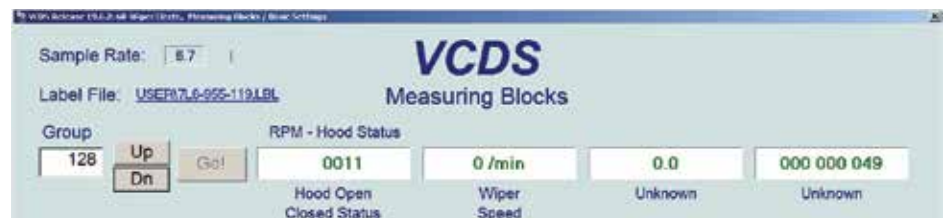
Measured value 128 field 1, switch status conditions are: Hood Open or Closed

Status is 1011 = Open and 0011 = Closed

Hood and wiper status

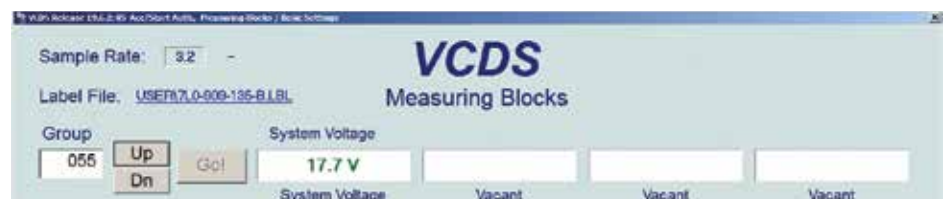
At Address 05, the voltage within the display fields didn't match the volt meter readings at the "jump start" posts.

Incorrect voltage

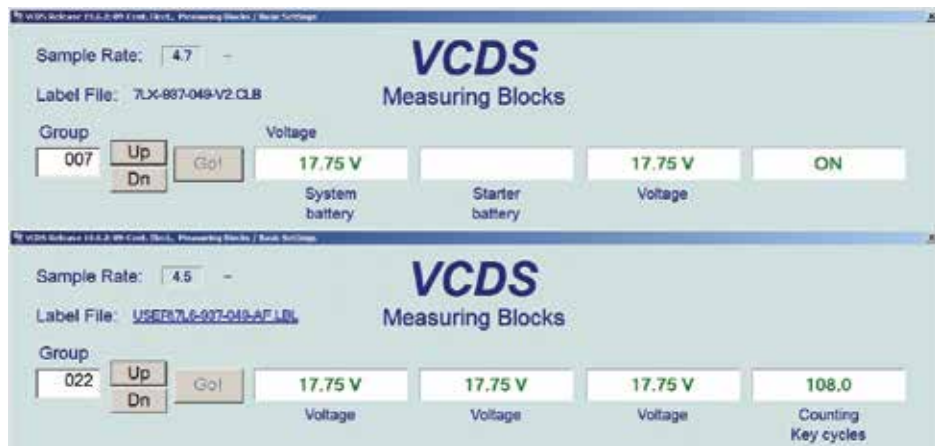
System voltage fail

This is an anomaly that indicates a voltage reading far higher with a power supply attached to the “starter or battery jump” posts and volt meter attached in parallel with the power supply.

17.75 V at two controllers? As if!

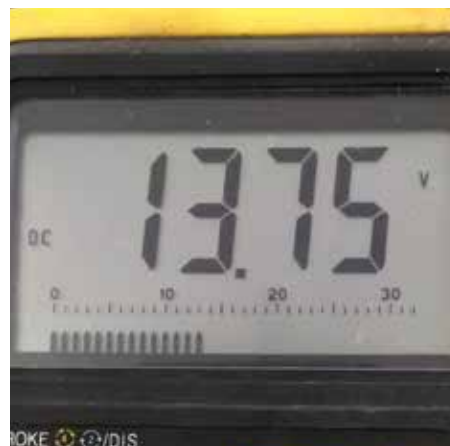
Actual meter reading

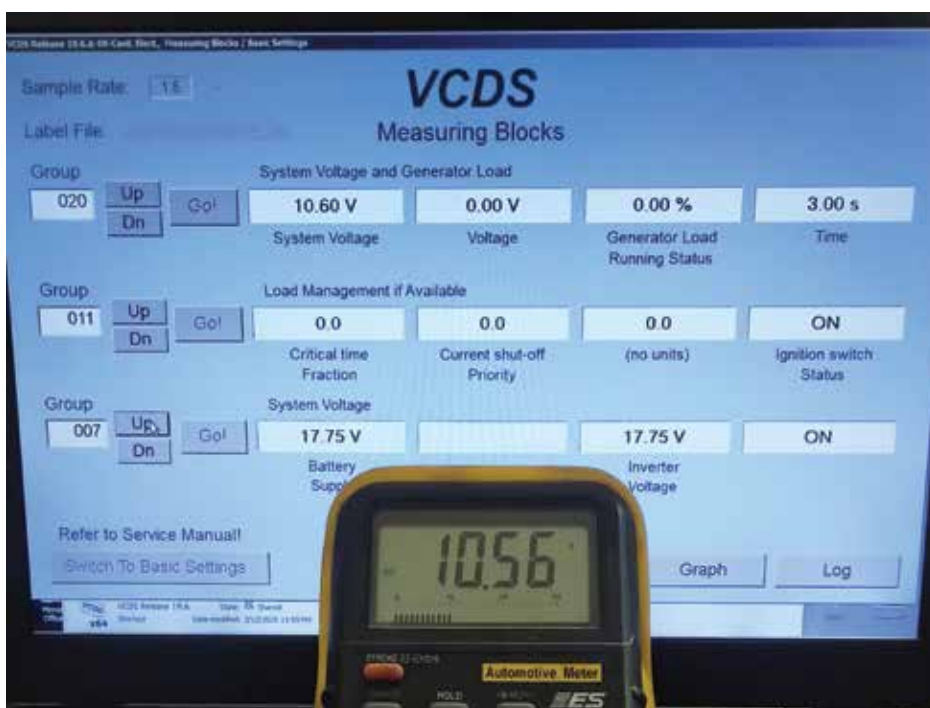
Management test 1

This test failed dramatically.

The anomalies remained and the diagnosis appeared to be a defective Central Electrics Controller. The voltage created is NOT possible with the fields when matched to the multimeter. The VW dealer mentioned a back order for a replacement controller for more than three weeks but searched for a used and identical matching part number. There was a belief that something was misleading during these tests. Writing, testing, and editing the Label Files were a great

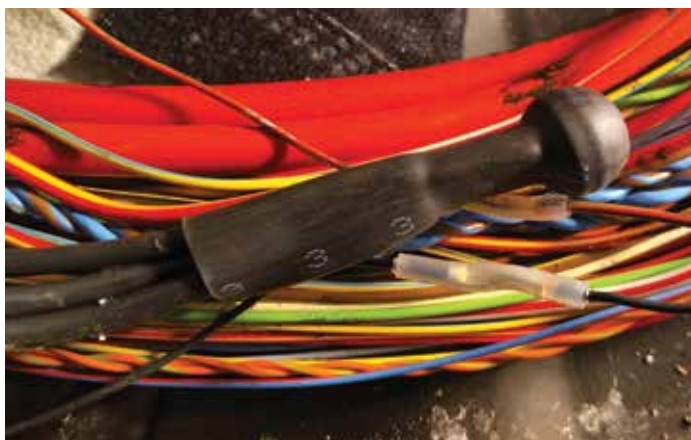
Touaregs are well known to have wiring issues under the carpet near the driver's left foot.

Harness repair

That was promptly addressed and the floor was dried. The repaired harness was covered and secured. The retest offered nothing new.

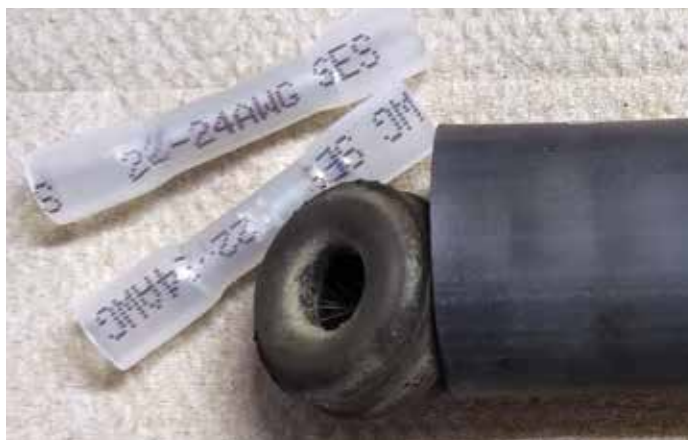
Shrink tube and cap

Crimp/shrink splices have been used for quite some time and are the perfect connection compared to solder. Normally the yellow, blue, and pink are used. Much smaller gauge harness

repairs are performed with clear/white 22 - 24 AWG crimp/shrink splices. The technician capped the large shrink tube with a brake bleeder cap.
