der **Fix**

MISLEADING VALVE TIMING FAULTS

GO DEEPER AND FIND THE MYSTERY

By: Augie Ferron

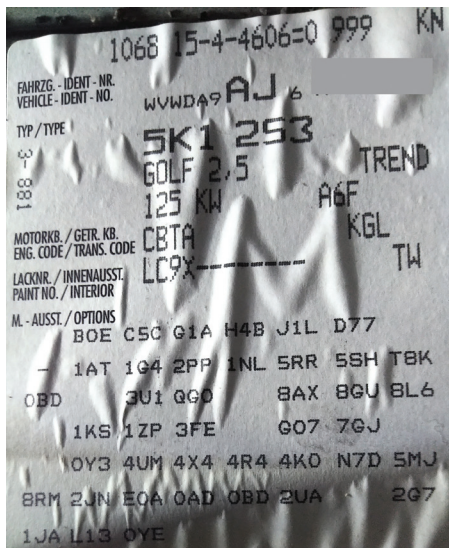
Original PR code

First was the need to access the PR code and, using ElsaWin, narrow the specific model for repair information and electrical schematics. Sales code: 5K1 2S3

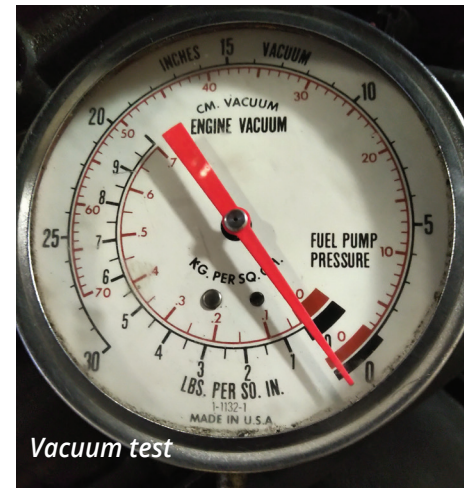
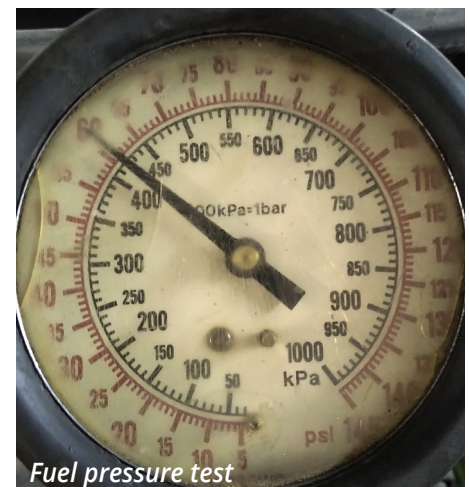
One simple yet quick test was with a vacuum gauge to ensure the crankcase ventilation system (PCV) was not damaged. The need was to ensure there was no internal vacuum leak. Remember the Jetta article with the damaged diaphragm on the valve cover? Go back and read that article.

The reading here was well within a normal range.

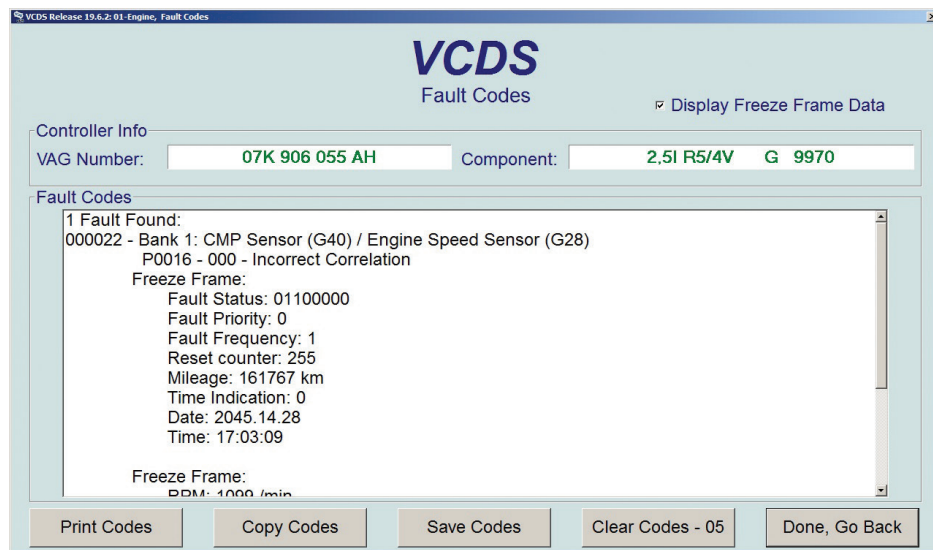
Correlation fault

000022 - Bank 1: CMP Sensor (G40) / Engine Speed Sensor (G28)

P0016 - 000 - Incorrect Correlation

The misfires certainly didn't return and this specific fault repeated numerous times. In one respect, this would appear that the upper and/or lower timing chain is out of alignment and could possibly explain why the ECM recorded multiple misfires with the "new and improved" P0016 - 000 - Incorrect Correlation.

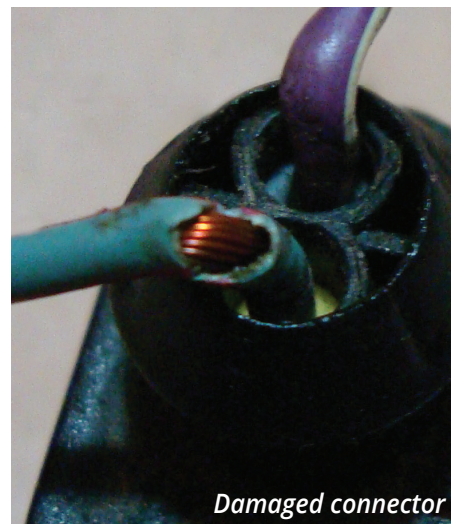
Part number

Second was that shiny new camshaft solenoid with the damaged harness connection and bent/damaged wires.

With the replacement shell (1J0 973 702) and personal stock of the correct diameter wires with crimp/shrink connections, the final test is the three basic settings that are required to have the engine run in factory condition.

Using the crimp and shrink connections and making sure the harness is taped/tied away from the engine cover, we continued with Basic Settings.

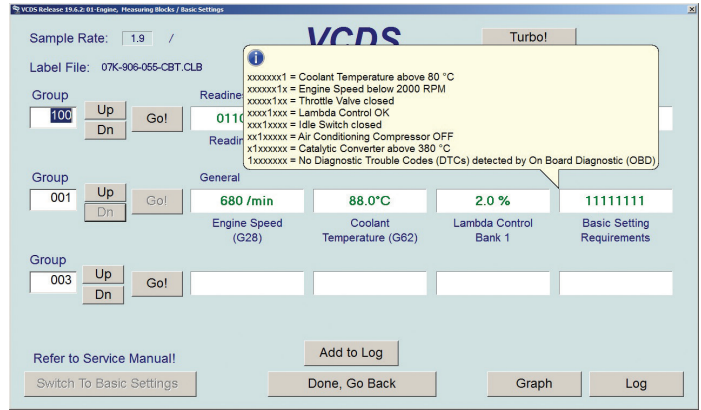
Requirements

Look at the differences in Group 001, field 4, Basic Setting Requirement. Notice the changes applying the throttle and how the scan tool displays the "requirements" the engine management system is reading.

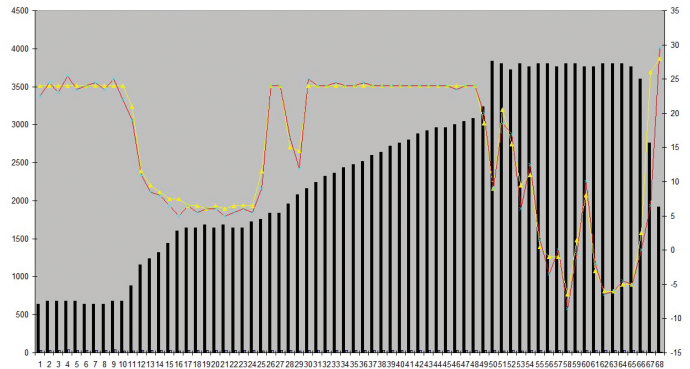
Plot data for 30 seconds

Using Microsoft Excel, only the columns in group 091 were chosen in this example to highlight the transition from low to high rpm for 30 seconds.

- (1) is rpm in the black vertical lines.
- (3) is Cam Adjustment Specified in crank angle degrees colored in red.
- (4) is Cam Adjustment Actual in crank angle degrees colored in yellow.

The data plot is another feature that provides proof that the engine management system is in complete control and the symphony is in total harmony.
