# der **FIX**®

## AUDI A6 LIN

By: Augie Ferron

### PART 1: ALARM FAILURE

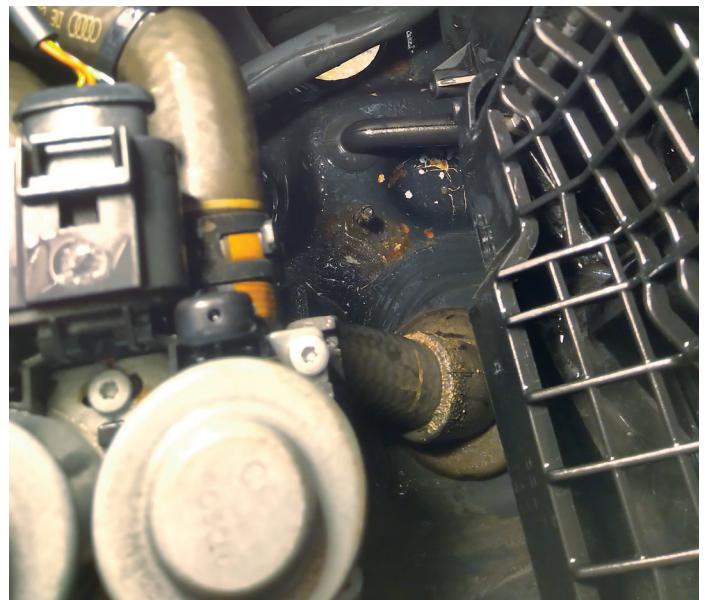
Body drain hole

While amazed about the water, an interest was the plugged rubber drain with "soggy decomposing material." The plenum contains items such as the brake booster, master cylinder, wiper motor, access panels to electronic controls, wiring harness, ground connections, etc. etc.

The two illustrations indicate the location of the body drain under the LIN horn sounder. Since the drain itself was completely plugged; we opted to trim the closed portions to allow more water and debris to escape. We washed out the remaining debris and reinstalled the rubber drain when complete. Double checked were any ground connections or water intrusions within the plenum area.

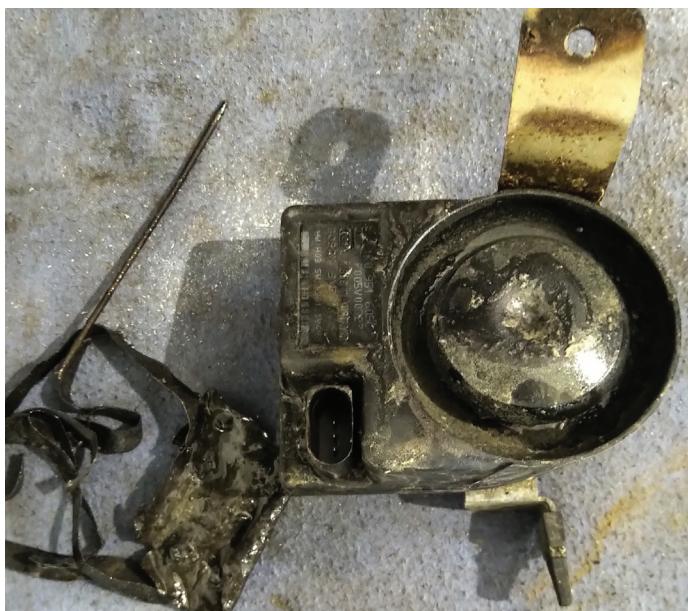
With previous histories of VW and Audi LIN alarms, the plenum cover was lifted and inspected (noticing the green debris similar to pollen), it looked like water was captured within the plenum under the windshield. We were all amazed about the amount of captured water from the area.

The water and debris left a distinct water line across the entire region of the plenum. Simply, the LIN Sounder was the parasite on the network.

LIN soulder damage

The replacement is VWC Siren, part number 1K0951605F.

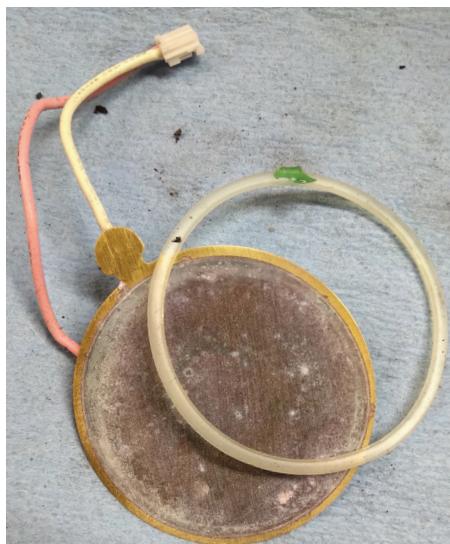
*Piezo element*

This element is a Piezo speaker. The LIN sounder will activate the speaker with a "chirp" when locking the A6 with the remote, or scream when the A6 is opened without a key or, if the A6 is tilted "stolen or towed," the systems are monitored for theft or intrusion. Applying battery power to the element made it sound like a strangled chicken. No offense to chickens!

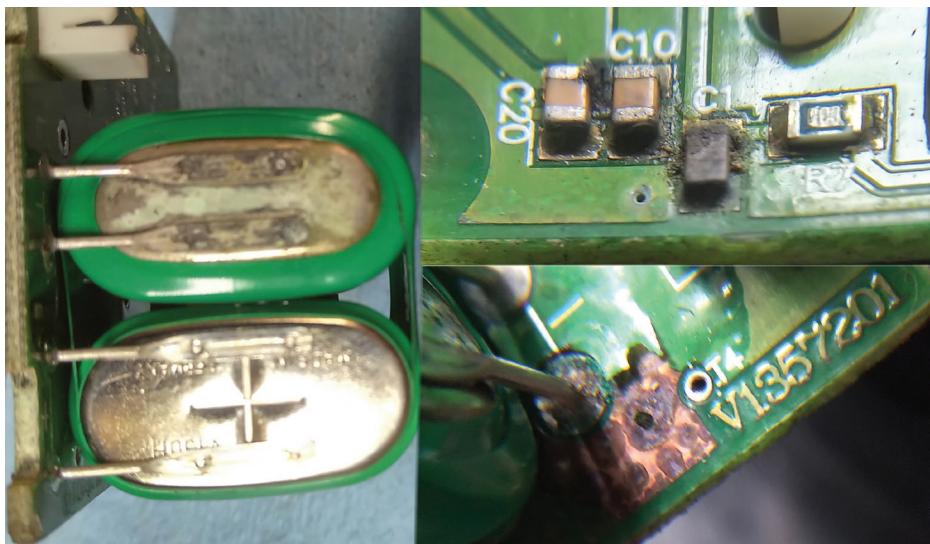
The battery is a VARTA version 2x3.6V 140 mAh Ni-MH.

De-soldering the battery provided a near dead voltage reading.

*Circuit board damage*

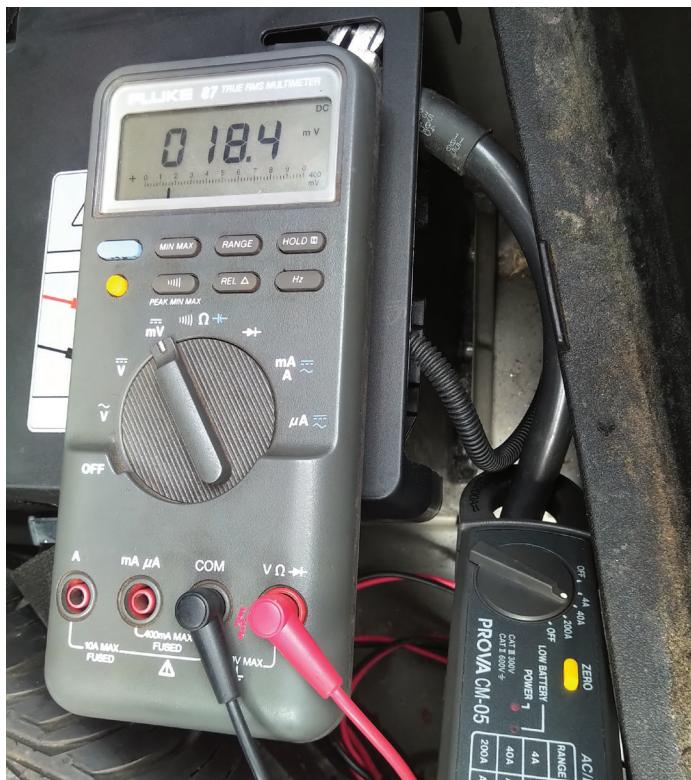
Meter A reads the amperage draw except in the wrong direction. Meter A reads the amperage on the positive scale. This model has only ONE ground connection. Correctly orient the direction of the amp clamp.

*Meter A Incorrect*

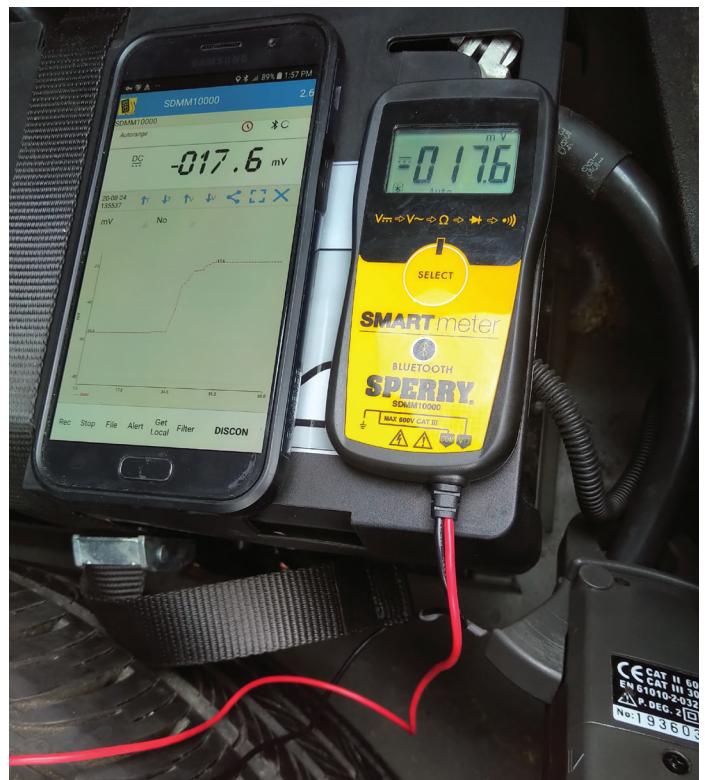
Meter B amp clamp is oriented correctly and reads the amperage draw on the negative scale. With the Meter B reading the added Android device connection can be moved about 30 feet away.

*Meter B Correct*

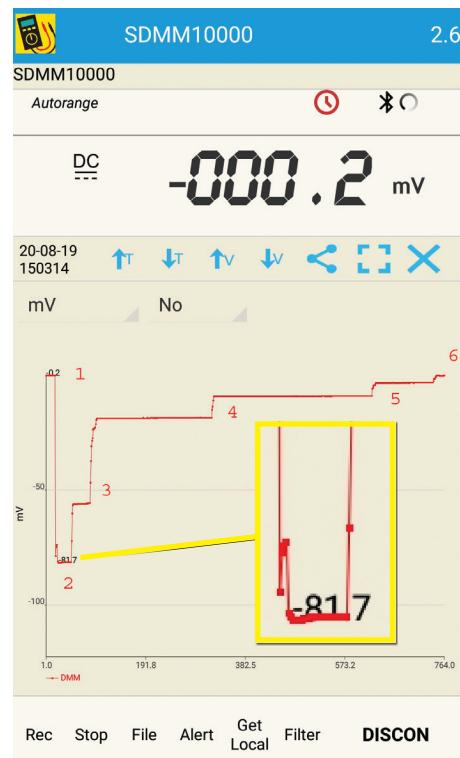
1. The vehicle already in sleep mode with the Android and amp clamp attached to the B- cable. Trunk and hood have been opened for some time.

- The moment the driver's door was opened and closed

- Indicates the network dropping/shedding current draw over time
- Follows the time to offer the parasitic load/shed reading
- Again drops/sheds current over time
- Now indicates sleep mode again at -000.2 mV

Near the bottom right of the image, offers the total test time as 764.0 seconds equaling 12.73 minutes. This tool/application recorded and graphs at one second intervals, including different time lengths.

One controller(s) or network structure at a time is shutting down in a timed fashion to place this A6 in sleep mode.

*Sleep mode over time*
