der **FIX**®

Audi A6 LIN

By: Augie Ferron

PART 3: ENERGY MANAGEMENT

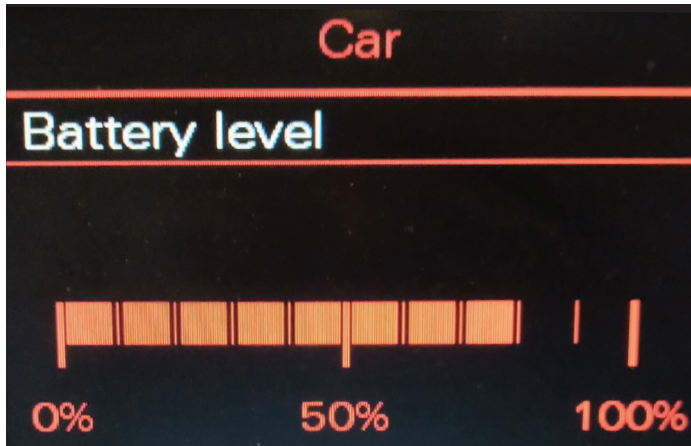
80 percent level

The condition of 80.0 percent was the result of NO power supply attached and reading/testing the groups of Address 61 for approximately 15 minutes.

The following two MMI images coincide with Address 61 group 003. With VCDS and the MMI in view to monitor battery percentage level, both images will match. That data between VCDS and the MMI is all shared via CAN messaging between the Energy Management system and the MMI.

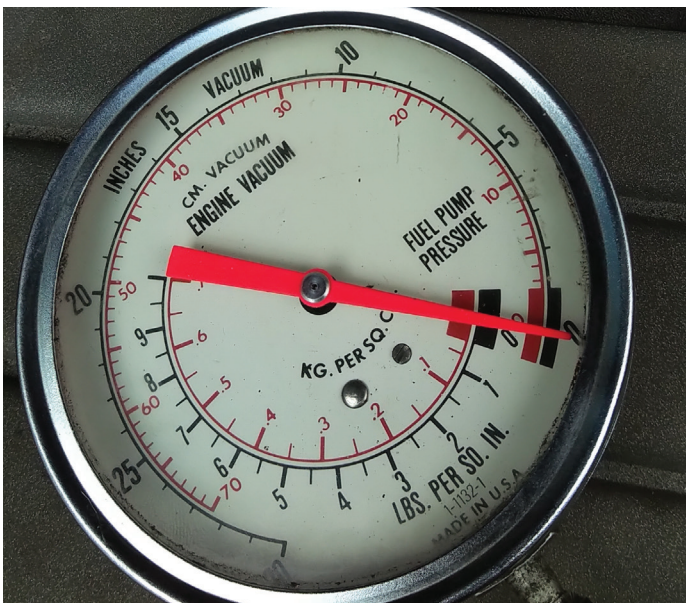
Dipstick test

The first step is to measure vacuum at the dipstick opening (if there is one).

This simplified test indicates a healthy ventilation system, near "0".

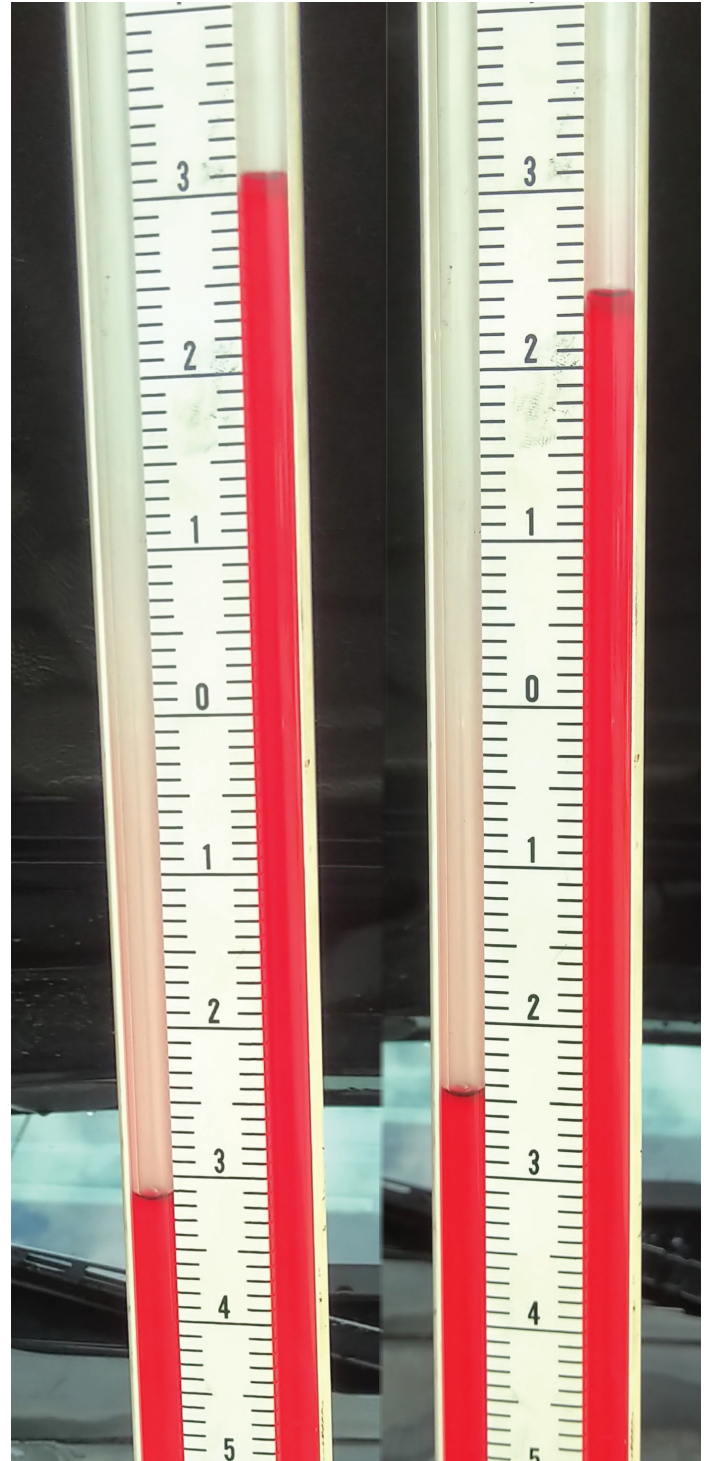
Manometer

Keeping things simple and having ready access to this type of tool may offer un-noticed conditions that may require a repair, especially lean or rough running startups. High readings for this system indicates an internal leak.

The glue used is the two part JB Weld. With the slack tube manometer attached, one side is open to the atmosphere; the other is attached to the oil filler test cap.

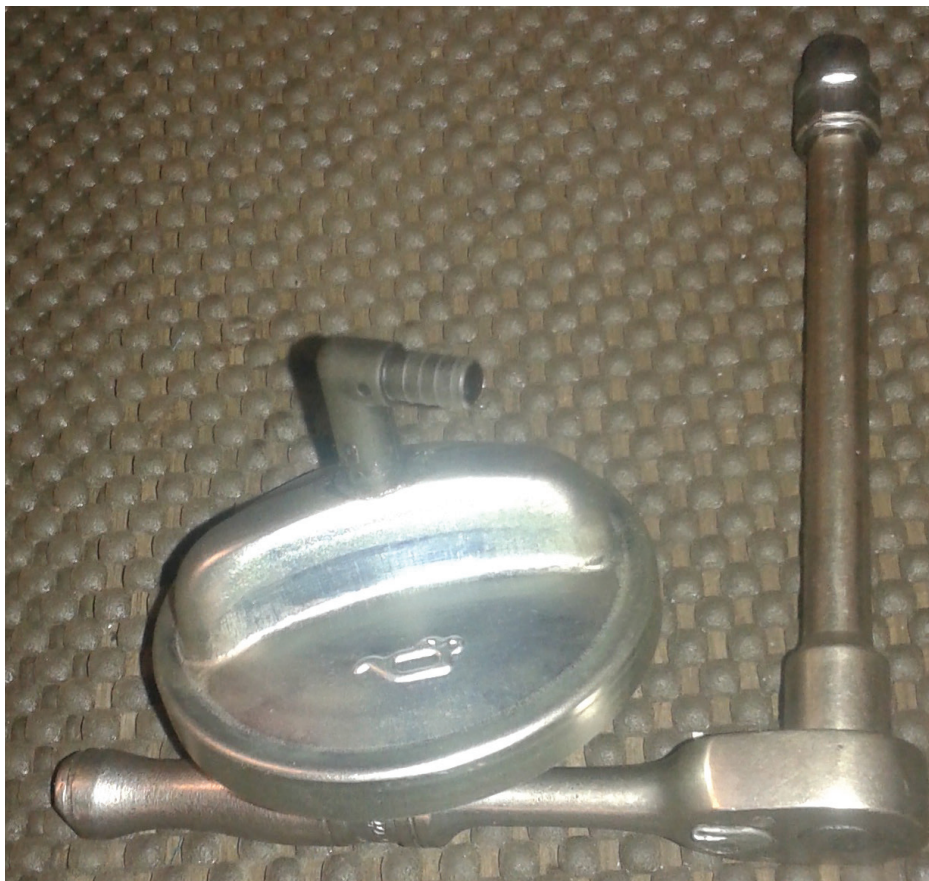
Test cap

The oil filler cap was a purchase at the local import parts supply house and the only change was to drill a tight fitting hole to accept a new battery vent elbow. Any positive or negative pressure at that glued port must be open to the engine for measurements.

This particular test will offer the condition of the oil separator system. Large amounts a vacuum may explain these lean running conditions on startup or constant circumstances

while running. This simple test also indicates the possibility of future engine management repairs.
