A IMPORTA SERVICE

testing with HDS with parasitic battery tests and generator AC ripple

Shown here: EGR stuck open A co-worker made a mention about a rough running 2006 Honda Accord, 2.4L DOHC 16V and 5-Speed Automatic and added the comment, "The car seemed hard to start." Hard to start didn't mean the battery or starter had a defect; rather, the engine speed took a short while to climb to normal. It was time for a lesson for the learning technicians.

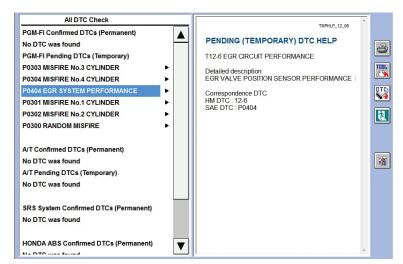
Identification

At idle rpm, EGR lift was recorded at 2.90 mm

That value was not what was expected and the EGR value should be 0.00 mm at idle. The next step was to test the EGR connection by disconnecting the harness at the EGR and viewing live data.

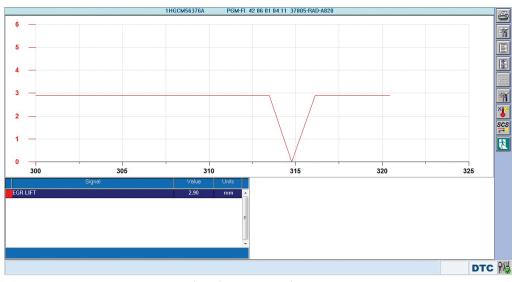
Primary faults

The primary indicator was how the engine seemed to start and gather rpm slower than usual. It would also idle slightly higher than normal. The data was gathered to look at the EGR at idle. It appeared

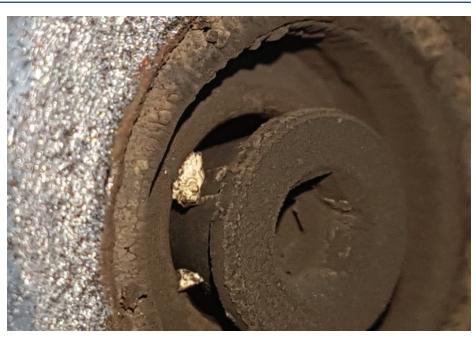
EGR stuck open

On the opposite end, there was more debris holding the pintle open.

The origin of the particles is a mystery, especially the color. Do notice how those particles jammed the pintle in an open position. Consider the vacuum leak while cranking and at idle.

The solution was to gently lift the EGR with a co-worker, clean the valve with compressed air and brush off the carbon particles with a wire brush.

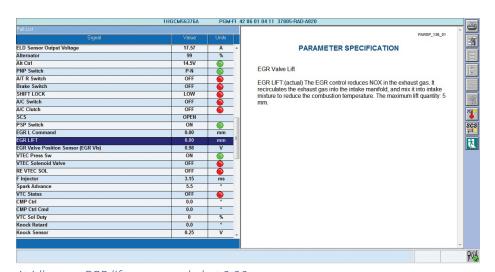
At idle rpm, EGR lift was recorded at 0.00 mm.

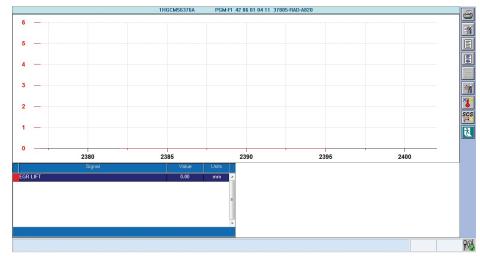
Compared to the earlier EGR connection test, this graph also indicates a seated EGR valve. HDS will also allow a running EGR test within the Inspection Menu.

At idle rpm, EGR lift was recorded at 0.00 mm.

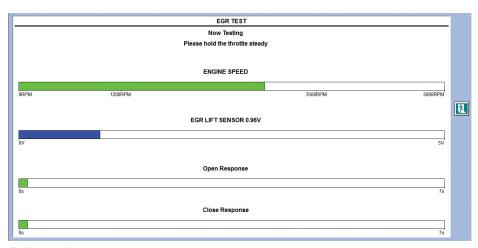
EGR running test

The test passed, no faults were recorded and no misfires were recognized.

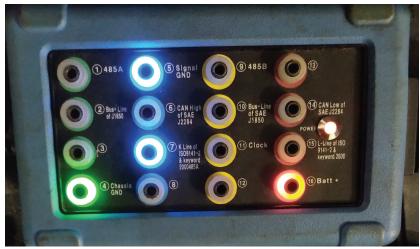
K line connection

A lesson learned was to follow and search the correct information when understanding the type of communication system this Honda has. For diagnosis, the Honda uses the "K" line for diagnosis and this was noticed with a breakout box. PIN 7 during diagnosis, would flash.

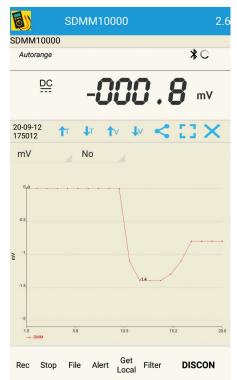
A 20 second running test offers the interior lamp ON at 1.4 amps.

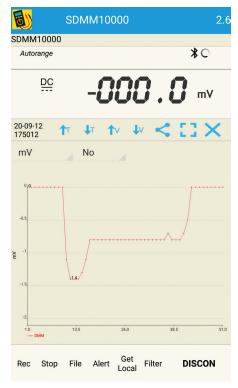
51 second finished test

At the end of this 51 second test, the Honda is in sleep mode.

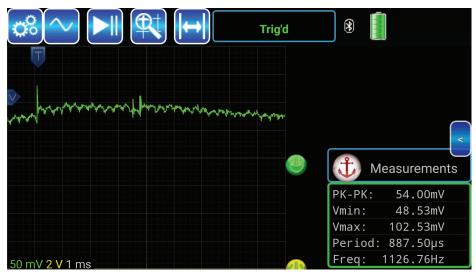
OK AC ripple test

This particular test passed and provided confidence that the alternator would function correctly.

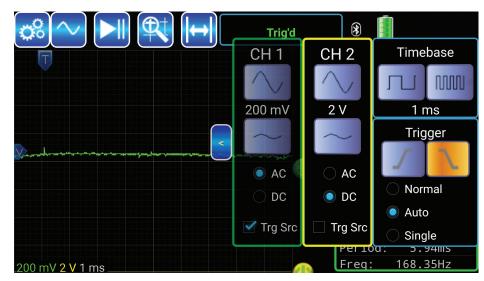
Scope 200 mV setting

The capture at 200 mV (above) and at one ms timebase offered another view if AC ripple spikes were evident.
