BMW High Mileage Service

By Augie Ferron

2004 BMW X3 2.5i with M54 and manual transmission.

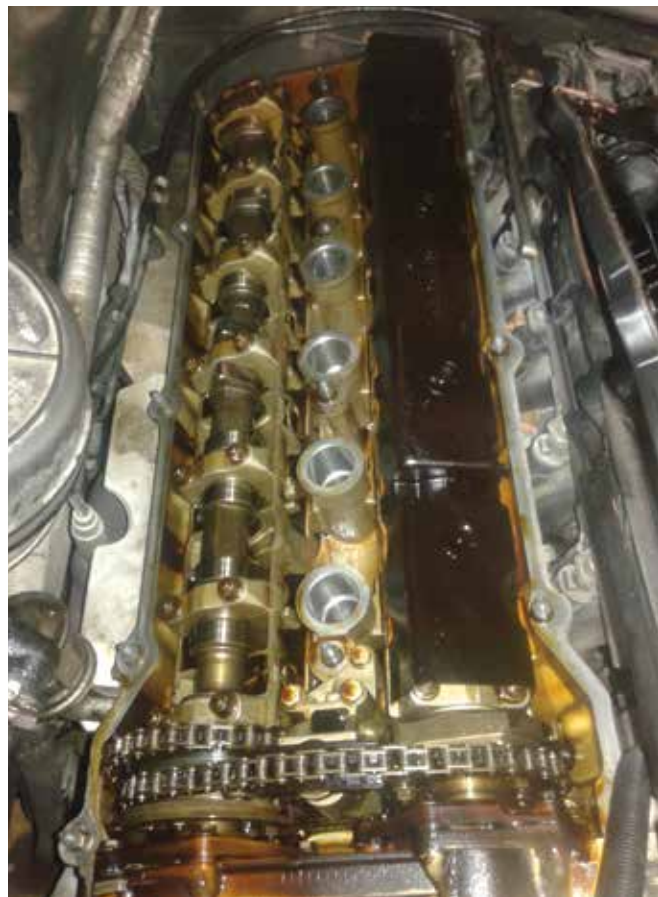
Gasket replacement

An external oil leak at the valve cover was noticed with this high mileage vehicle, so it was certainly prudent to remove the ignition coils (oil soaked on three) and replace the gasket. Cleaning the coil towers and replacing the spark plugs proved a success with a cautionary mention to the owner for a future replacement of the ignition coils.

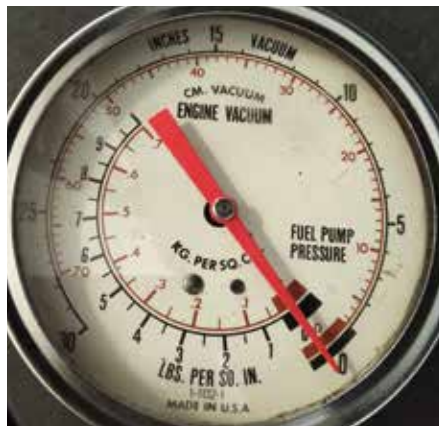
Dipstick vacuum test

Attaching a simple vacuum gauge to the dipstick opening offers a view of the ventilation system not having an internal leak. The reading should be near zero. It is simplistic but it works. High vacuum may indicate internal damage to the ventilation system.

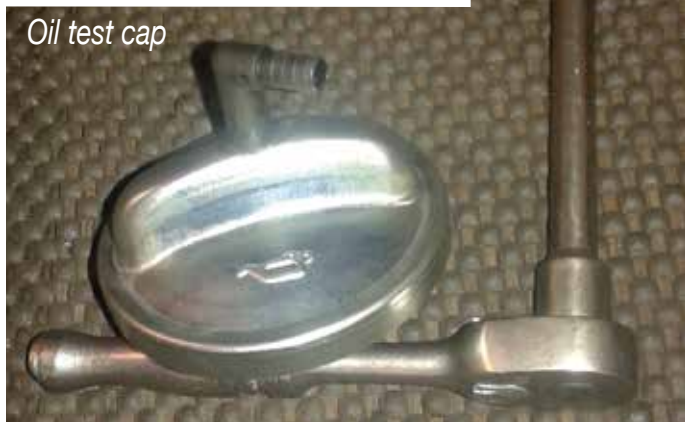
Oil test cap

An aftermarket oil cap was found to fit many BMW and VW/Audi models. The cap was modified by drilling a hole on the top and inserting a new/used elbow from a battery ventilation tube with some JB Weld.

A hose is connected from the test cap to one open end of the slack tube. The other end of the slack tube is open to the atmosphere. With vacuum applied (engine hot and at idle), the red liquid will rise

This indicates the amount of vacuum measured (inches of water).

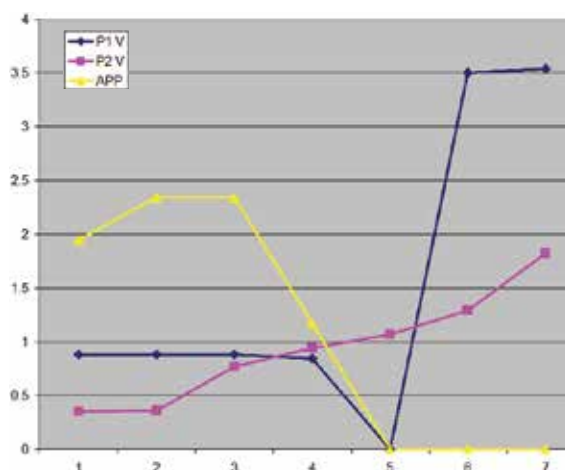
Throttle defect

P1 V	P2 V	APP
0.88	0.35	1.95
0.88	0.36	2.34
0.88	0.77	2.34
0.84	0.94	1.17
0.00	1.07	0.00
3.5	1.29	0.00
3.54	1.82	0.00

The graph offered the defect at the throttle pedal potentiometer as immediate proof and repeatable every time.

When the parts are placed side by side, it is obvious that this new part was updated along with the wiring position mounted higher than the original.

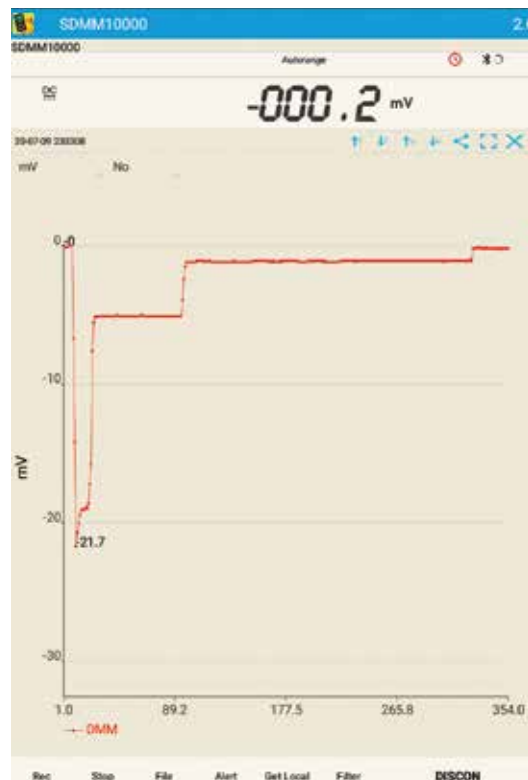
Parasite recording

tests that measured the parasite every second for 354 seconds. This test was applied multiple times with no key in the ignition, but it seemed to go to sleep faster if the door was opened and closed once and no one entered or "woke up" the ignition system.

This model tested perfect despite a radio replacement.
