## Toyota Secondary Air System Diagnosis and Repair

Vehicle under test  
and final repair:  
2007 Toyota  
Tundra 4.7L SR5

Customer  
complaint:  
MIL lamp on

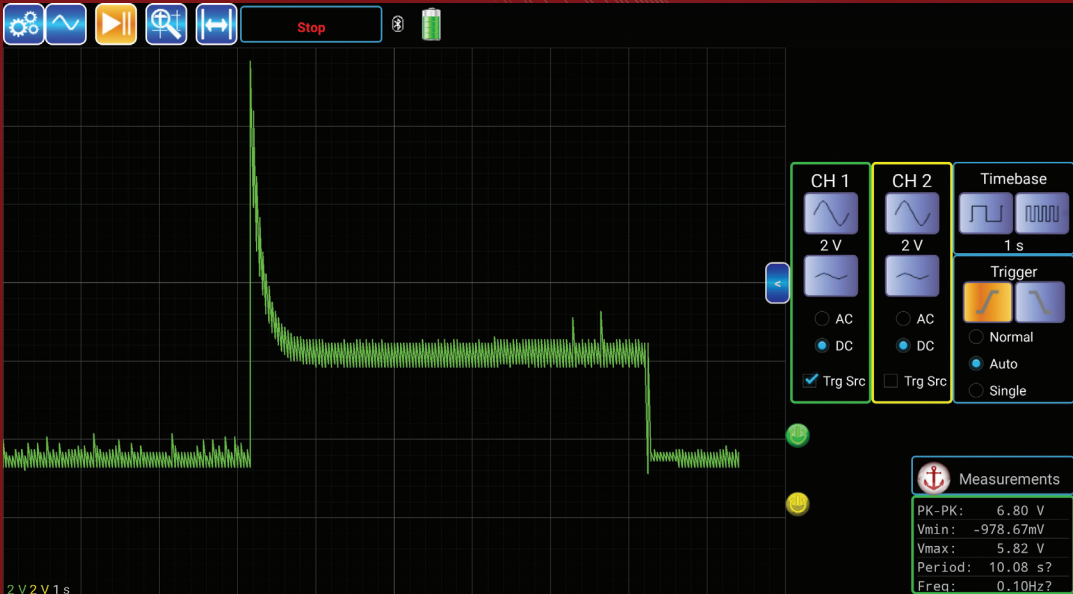
Pump ON for 5 seconds

In this case, new faults are recorded and, additionally, this test added the possibility that one air pump and/or relay is defective. To repeat the test, the ignition key should be cycled after the wait period has lapsed (30 seconds) and faults deleted.

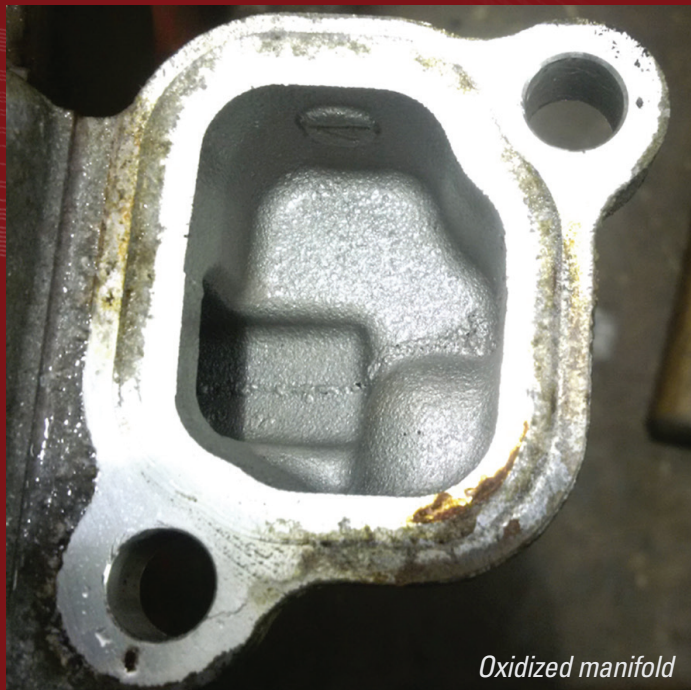
*Oxidized manifold*

At the front and rear of this engine model there are two aluminum crossover manifolds for coolant transfer at both cylinder heads. Under the rear transfer manifold is where the leak was found between the cooling transfer manifold, gasket and passenger cylinder head.

Two images are included and indicate what happens when routine service is not performed in at recommended intervals. The used/old coolant attacks the aluminum, seals and gaskets over time.

The repair is simple, with a new/flat/clean quality file used to "draw file" the manifold and test each cleaned surface with a flat gauge. Measure and test any draw-filed surfaces in multiple directions. The concept is to only remove enough material to clean and flatten the surface for mating. All surfaces should be cleaned, polished, and tightened with the correct factory torque specifications during assembly.

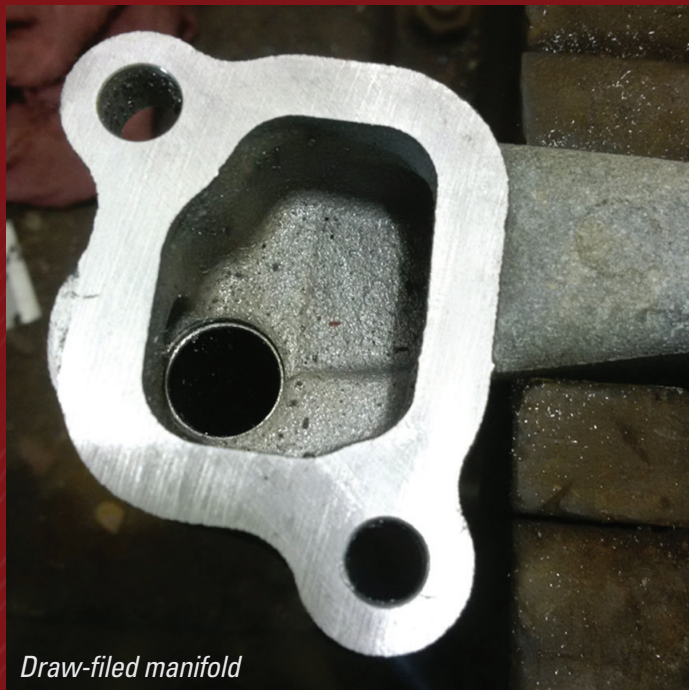
*Draw-filed manifold*

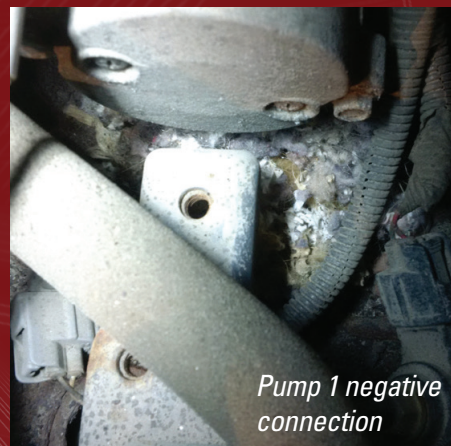
*Pump 1 negative connection*

In this specific test on this specific vehicle, the air pump at the RF fender was extremely noisy and the air pump under the intake manifold had an open circuit. What could NOT be tested is the ground tab for the air pump under the intake. The wiring for the RF fender air pump can be tested but it did spool up.

Clean any and all rodent debris if evident; clean out the water drain beside the starter motor and also the air pump negative connection to the right of the starter motor. Now is the time to ensure the ground connection is in perfect condition. Check the starter B+ connection and condition before continuing with the intake manifold installation.

Note the connection of the air pump harness and ground connection bolted to the engine block.

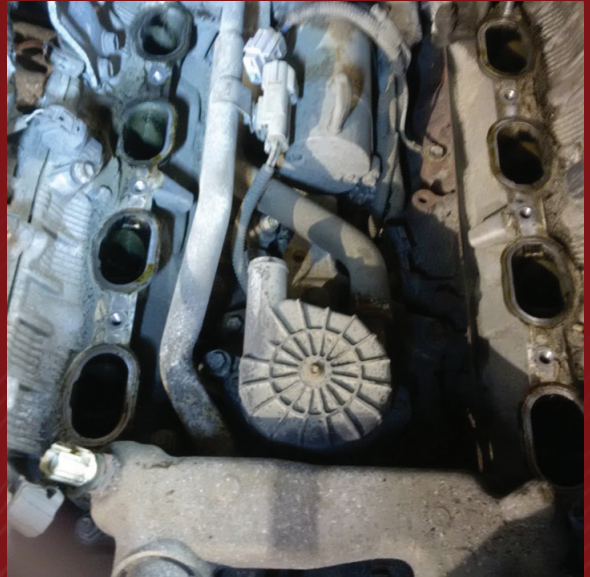
*Air pump location 1*

**The Repair:** This specific Toyota required both air pumps and both air switching valves to be replaced. Each pump has a different part number and they are not interchangeable. All gaskets and seals for the switching valves **MUST** be replaced. The intake manifold must be removed to access one pump (1), the inner RF fender liner requires removal to access the second pump (2).

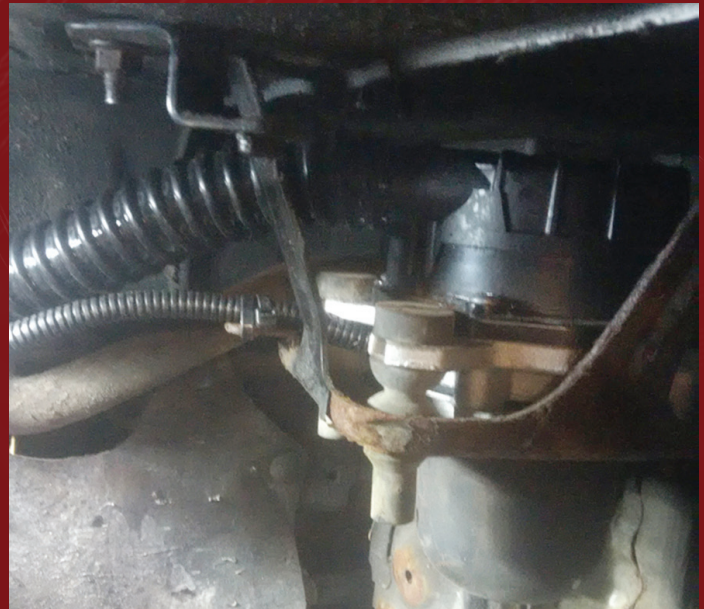
*Air pump location 2*

If the TSB was followed, an updated inlet tube was also connected to lessen the amount of dirt and water ingested at the RF fender location. Inspect that area for impacted dirt and wash that area with water. Make sure the inner fender liner is not damaged or any other body part is missing.
