# TOYOTAtech

## Diagnosing Toyota Tacoma Speed Sensors

February 2021

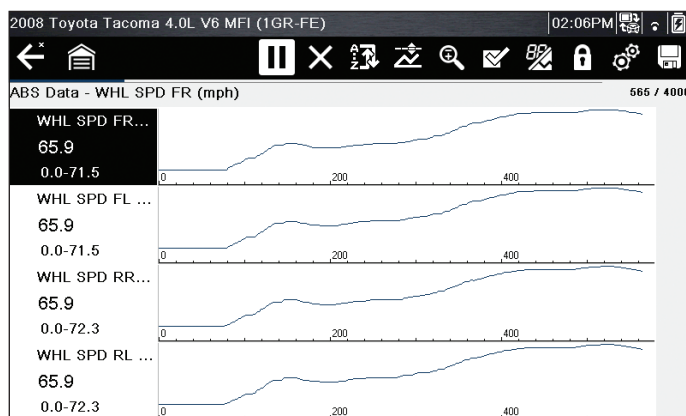
Speed sensor data graphs

The visual inspection was followed by a road test while graphing the wheel speed sensor data on a scan tool. Graphing the signals makes it very easy to spot a speed sensor that is different from the other wheels or has a signal that is dropping out. Much to my surprise, all the speed sensor signals were identical, with no dropouts or speed variations.

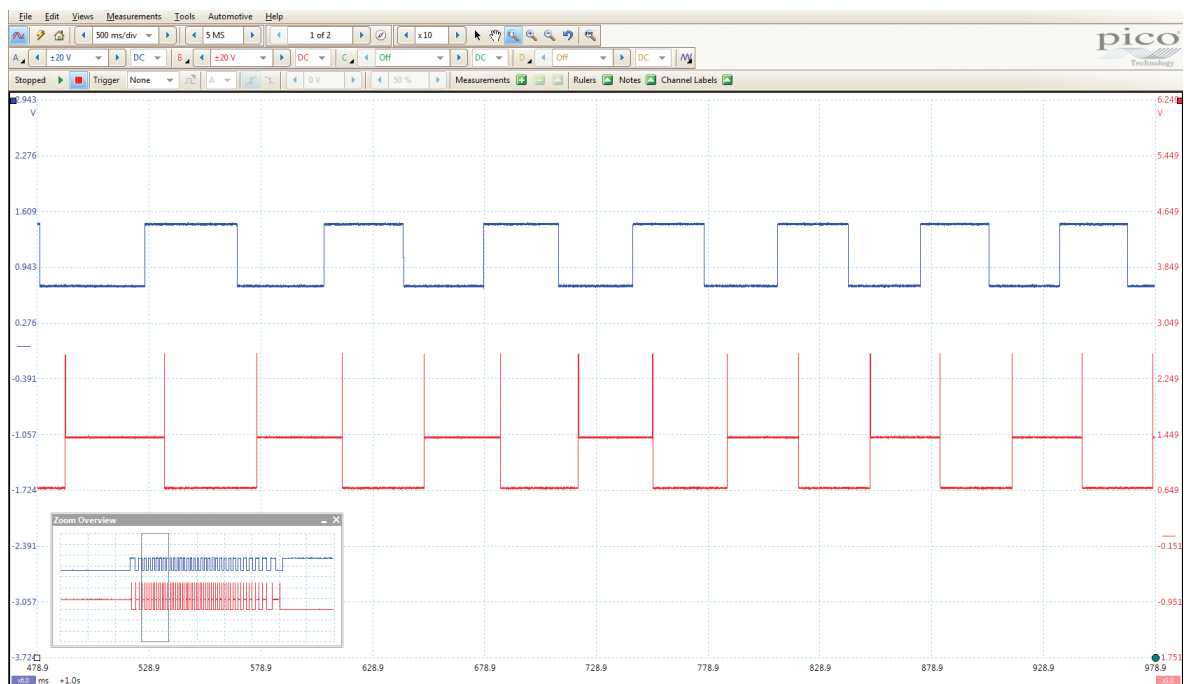
Picoscope results

This truck doesn't have a limited-slip differential so by spinning one of the wheels in a forward direction the opposite wheel would spin backward. The scope capture clearly showed both voltage signals the MR sensors can produce.

In the capture, Channel A (in blue) shows the signal produced when the wheel was rotated in a forward direction, and Channel B (in red) showed the signal when the wheel was spinning backward. The only problem was that the wheels were actually spinning in the opposite direction!

I now had all the data I needed, and all of my questions answered. The ABS faults were setting because the rear wheel bearings were installed on the incorrect sides of the vehicle. This caused the wheel speed sensor signals to show the rear wheels were rotating in reverse when they were moving forward.

I installed the new wheel bearings, this time on the correct sides of the truck. I cleared codes and then

took another drive on the freeway to verify I had corrected the customer concern. This time the ABS light stayed off when the truck reached 62 mph.

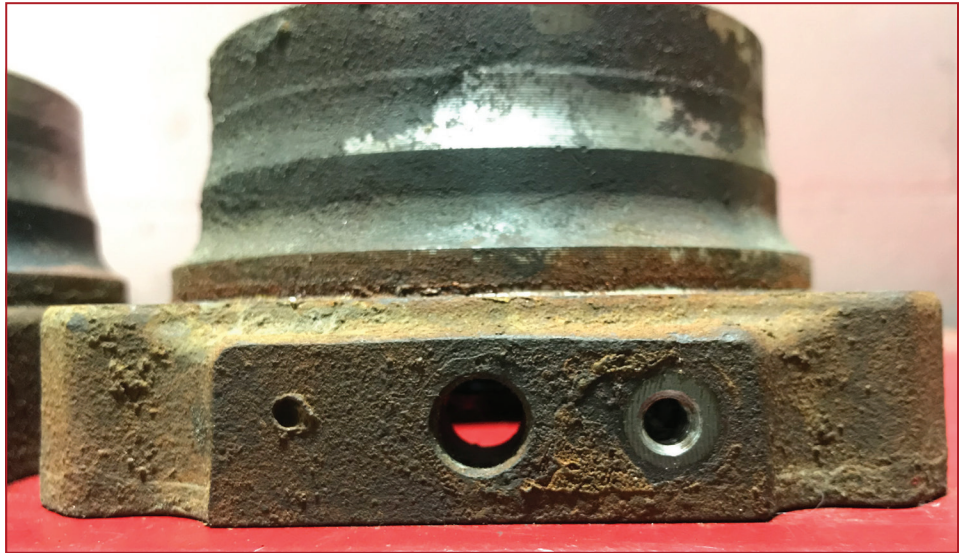
*Old bearings*

When I was inspecting the old bearings, I did uncover another interesting bit of this story. One of the bearings had a small hole drilled in the side across from the speed sensor mounting hole. The previous technician had begun drilling a new mounting hole for the speed sensor before deciding he could just switch the sensors side to side. He was unaware of the issues he created by switching the speed sensors though.
