TechNews

The Case of the Reluctant Titan

The file contained notes and documents for a 2006 Nissan Titan with a 5.6 L V8 engine and 180 K miles on the odometer. This Titan had an issue of intermittently not being able to accelerate.

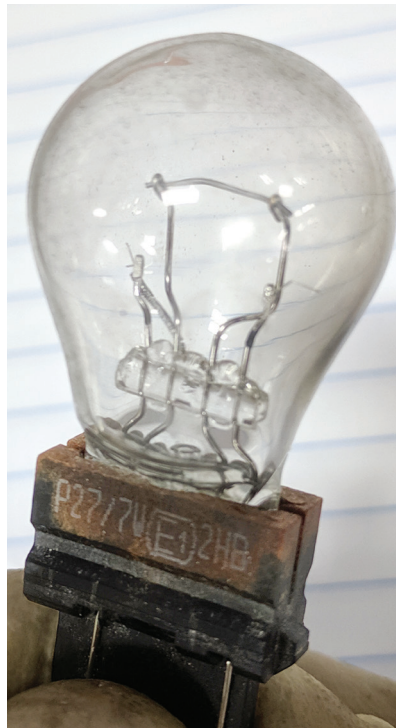
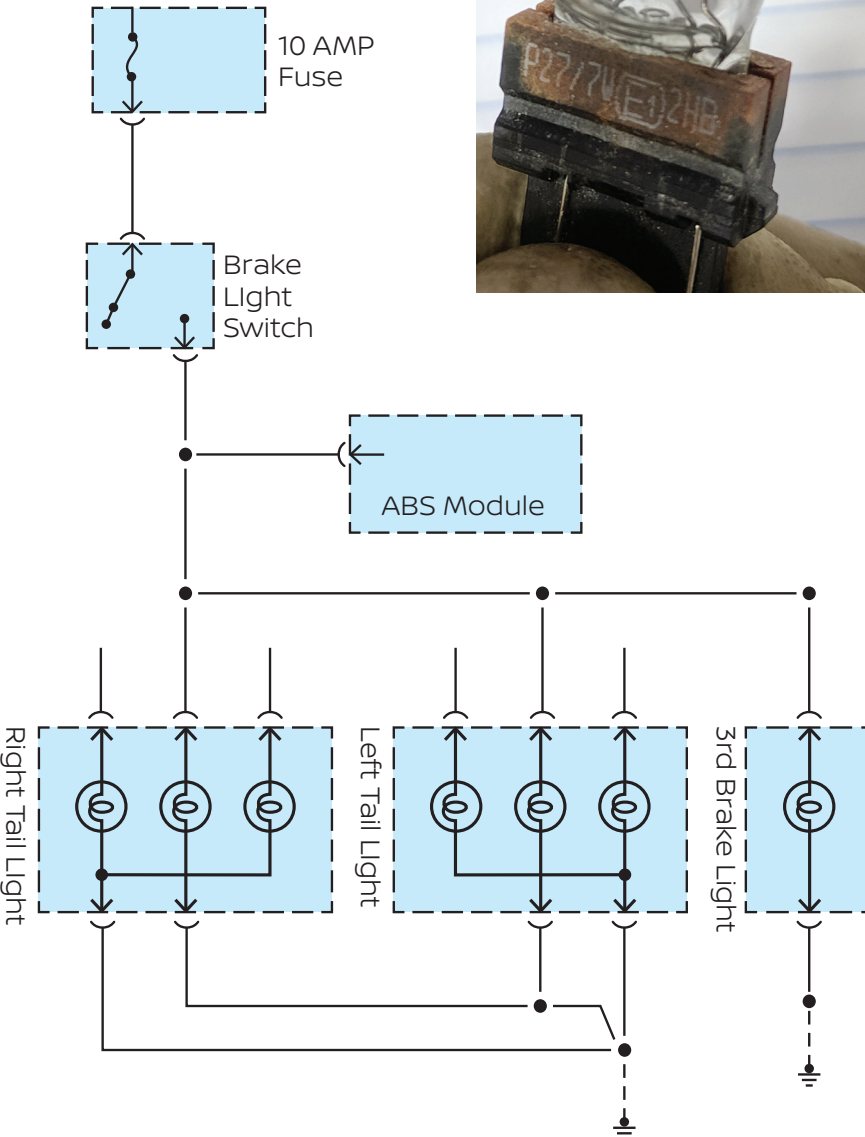
Then he had another tech in the shop help him check all the lights on the vehicle. The headlights and taillights were fine, but there was a brake light out. Harry removed the bulb to replace it but, being the good detective that he was, he noticed something that stopped him in his tracks.

One of the bulb filaments was broken. He pulled out his magnifying glass to inspect this new piece of evidence. What he found was astonishing. The broken filament was touching the other filament.

stored because the system was working just as it was designed to. The broken bulb filament was acting as a brake switch input and misleading the engine control module into restricting the throttle blade.

Harry replaced the bulb and checked the brake switch data PID again. Now the brake switch showed OFF whether the headlamps were on or not. One more road test confirmed that the truck was indeed fixed.
