# Understanding Mitsubishi LIN Circuits

A clear wiring schematic  
is your best friend when  
tracking down LIN faults

**IMPORT  
SERVICE**

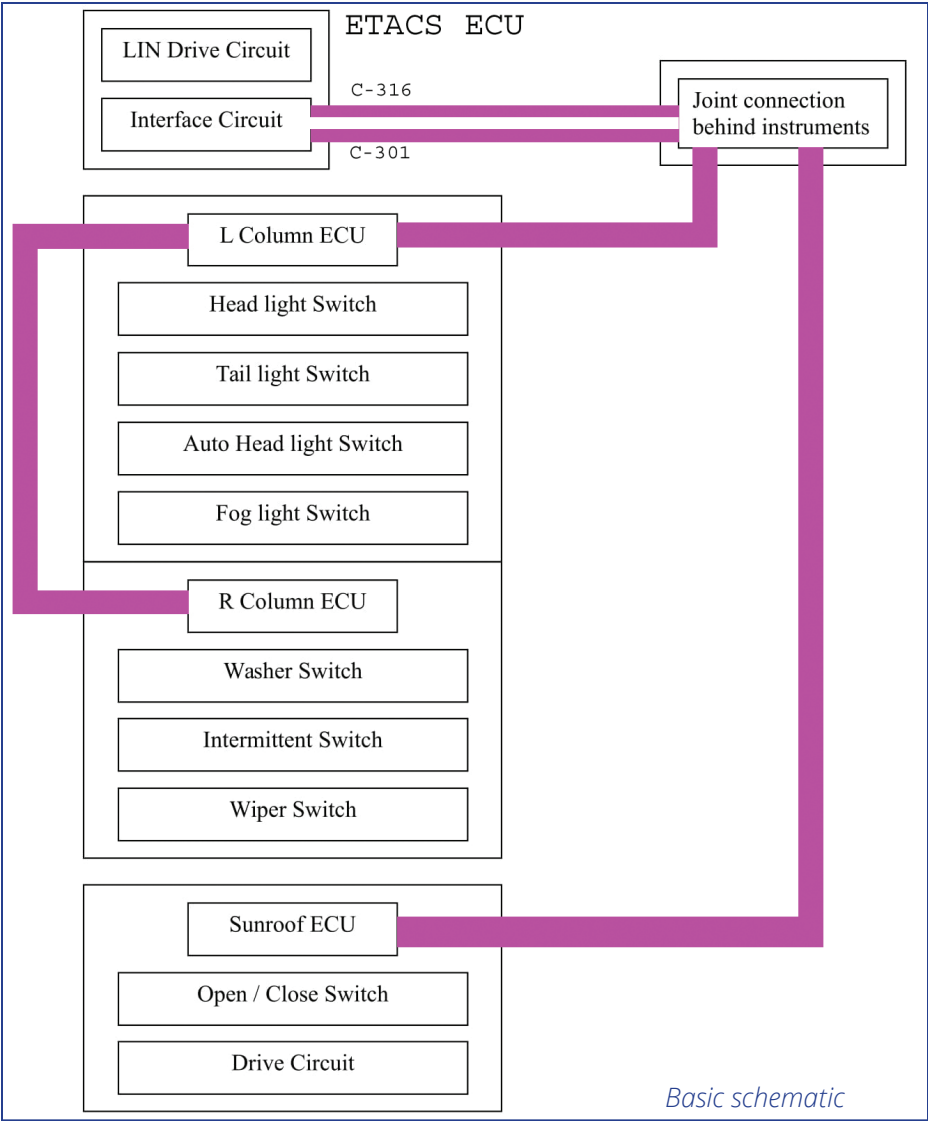
To the right is a simplified diagram made with MS Word and Photoshop. Follow details in this article by searching and printing all the required schematics. Use a highlighter to indicate the controls for this model.

The LIN connection (wiring) is violet for this Lancer and the ETACS is the master control unit.

Both the left stalk and right stalk ECUs are internally connected to LIN.

Both left and right stalks share internal B+ and B- connections. One LIN connection is provided to the left stalk.

The sunroof ECU LIN wiring is connected to a joint connection behind the instrument cluster with the left and right ECU stalks

at the steering wheel. The sunroof ECU connection continues from the joint connection to the ETACS module connection C-316.

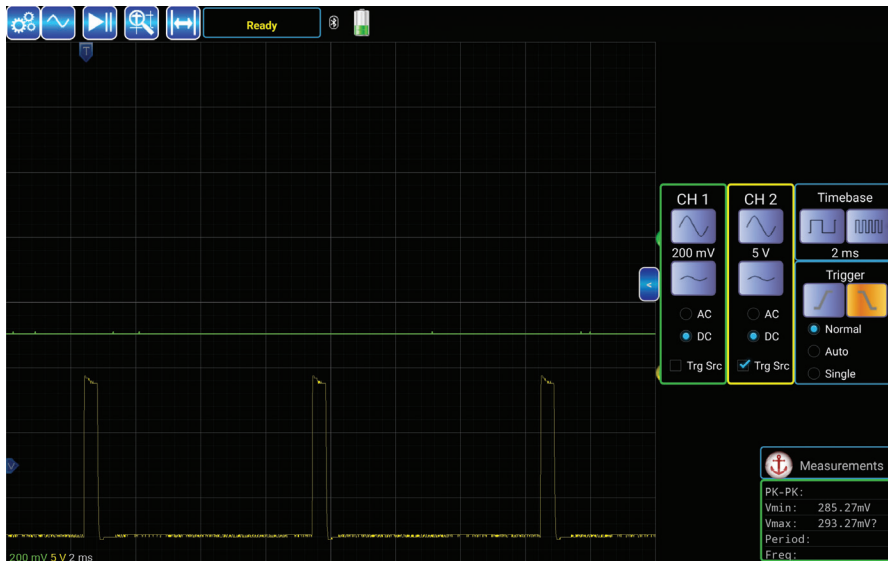
Stalk communications

The image indicates the cut violet wire and the connection that can be used with the oscilloscope. A jumper wire can also be a quick solution to open or close the LIN connection to move between tests. The "sewing needle" also becomes useful for probing these smaller diameter harnesses.

We attached the oscilloscope at the stalk LIN bus and looked at the image. Normal LIN "chatter" is quick with many messages and this was not the case. As an experiment to see how the stalks send messages, at the cut wire, we looked at those messages while operating each stalk. We attached the second channel to view LIN messages. The yellow image was zoomed in with a repeating "three points" (very brief and two in view) every time any switch position was moved or manipulated. This should mean

**NOTE:** The correct repair is NOT solder; use "crimp and shrink" or a crimp barrel with high quality shrink tube.

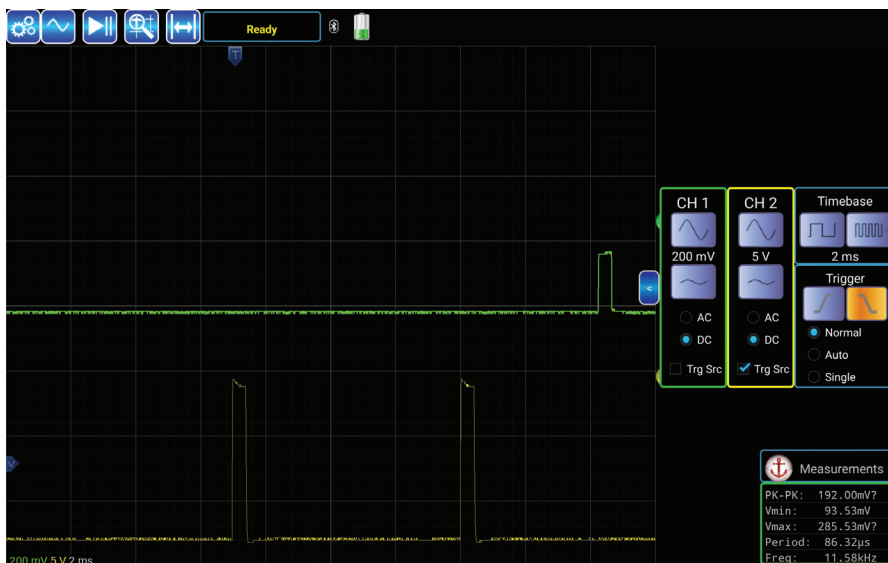
LIN defect messages

the microcontroller was trying to send a message. The green pattern is of the cut wire and was not expected. The message appeared not consistent with LIN message structure. All the messages were saved and noted.

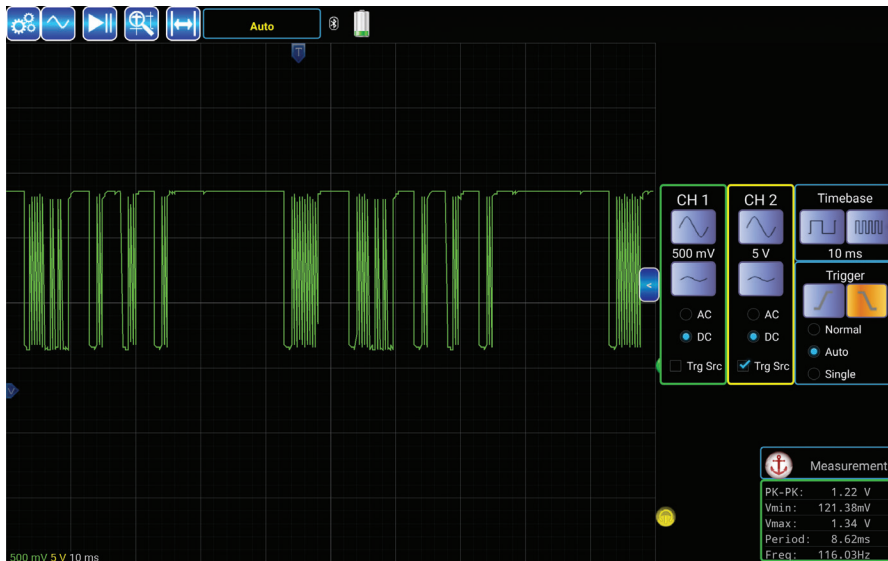
Final repair

The final repair and the image is what should be expected and if paying attention, moving each stalk will show a slightly different pattern within the LIN message.

In this situation, disconnecting the sunroof control harness at the ETACS module C-316 resulted in the perfect LIN message structure (you could reconnect the cut wire to test).

This shop and customer opted for a used sunroof controller and it worked perfectly. The LIN messages were stable and all controls at the steering column worked as intended. The final test was to reattach the original sunroof controller and notice the change.

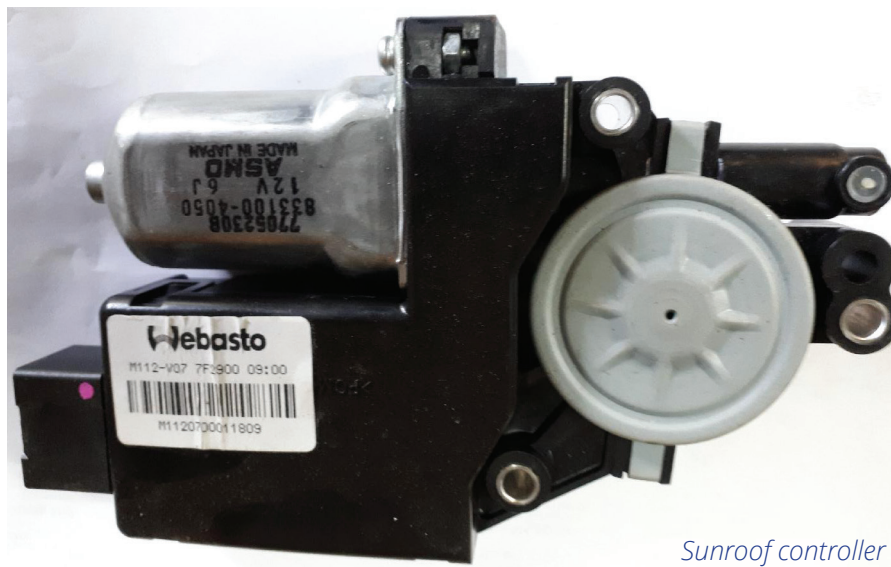
Sunroof controller

The modules and operation at both stalks were all back to normal. Recording the LIN waveform and reconnecting the harness connection C-316 shut down the stalk communication and resulted with an unfavorable LIN message structure.

With the schematic, the sunroof control also has a microcontroller

and the final proof is to disconnect that specific module and measure the violet harness between those points, the result being the harness is intact and not shorted to positive or negative.
