May 2021

TechNews

The
Infamous
U1000
Code
A Study in
Nissan Network
Diagnostics

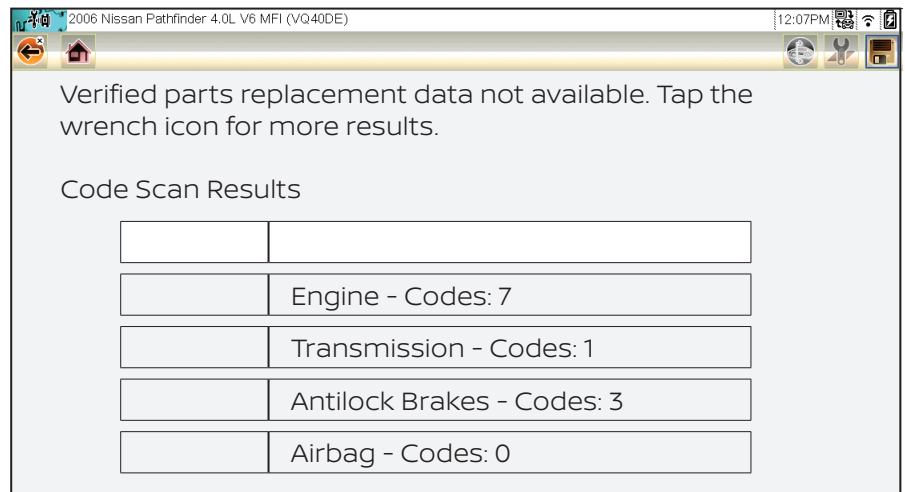
Figure 3: 2006 Nissan Pathfinder module scan results

The “scan all modules” function on our Pathfinder scans four modules, three of which have codes.

Our vehicle is not 4wd, so we don’t have a transfer case module. Next, because this is a stripped model, we do not have a driver’s seat control unit or a Display Control Unit. But we should have all of the following: ECM, TCM (AT), Meter, BCM, Air bag, SAS (Steering Angle Sensor), ABS, and IPDM. Instead, we have only ECM, TCM, ABS, and Air bag.

Our next step is to see which codes we have. Unfortunately, Nissan often only provides us with the generic U1000 code. We also note (without surprise) that we have a P1612 NATS code

which is to be expected without communication with the BCM. An additional code registered is the P1212 TCS (Traction Control System) communications line. This code, along with others registered in the ECM memory, are what are called “sympathy codes,” and are very common distracters when troubleshooting network problems.

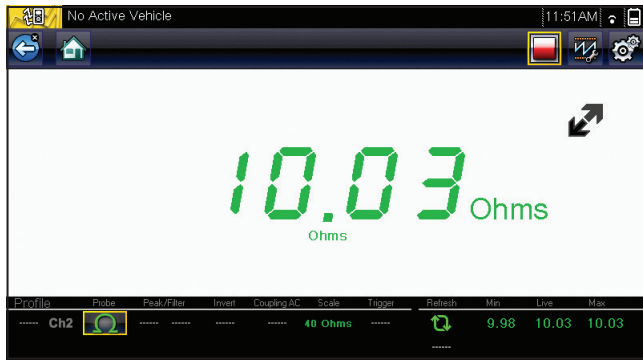
Figure 6: OBD CAN bus resistance

doesn't always help, in this case we realize we have found an issue indeed. The number should be 60 ohms, since the mandatory two 120 ohm resistors are wired in parallel in the network wiring. While individual additional modules put a very slight parallel load on the circuit, their resistance is typically so high that the 60 ohms remains virtually unaffected. However, our reading is not 60 ohms, but 10 ohms.

We are definitely onto something here. It might be a shorted wiring problem, but that is somewhat unlikely since there is some communication going on with the bus. A short would almost certainly bring the whole bus to a screeching halt. A scope check was probably not necessary, but curiosity is often a helpful trait in the auto technician

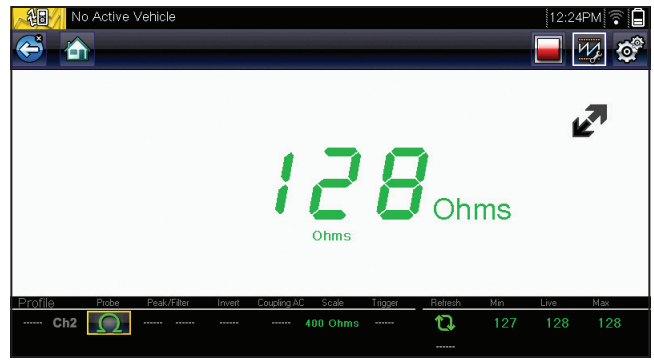
Figure 8: CAN bus resistance ECM unplugged

corresponding disappointment when no change was noted. But, as things sometime go, it wasn't until the ECM was unplugged that the resistance returned to the anticipated 120 ohms (actually 128).

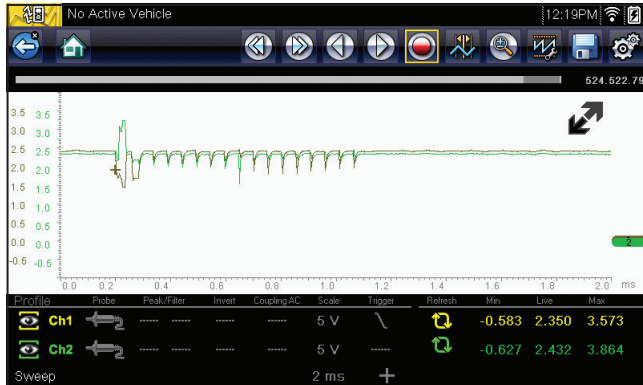
Figure 7: CAN bus defective waveform

This pattern is about as far from a good OBD CAN as one can get, but ironically there are still four modules capable of communicating.

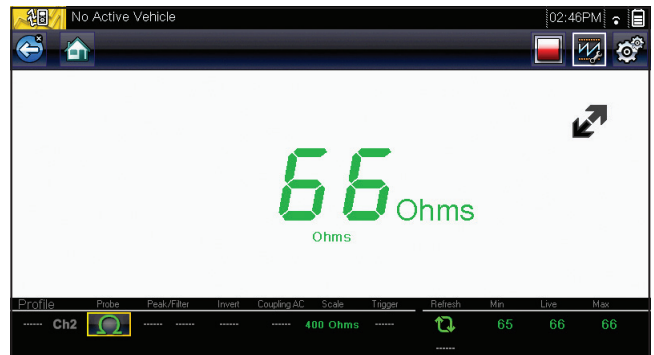
Figure 9: Used ECM resistance

A used ECM was sourced and plugged in. Resistance was rechecked.

Extra trouble was encountered in overcoming the anti-theft system due to the use of a used ECM but, once that was overcome, the vehicle started and ran normally with all modules back online.

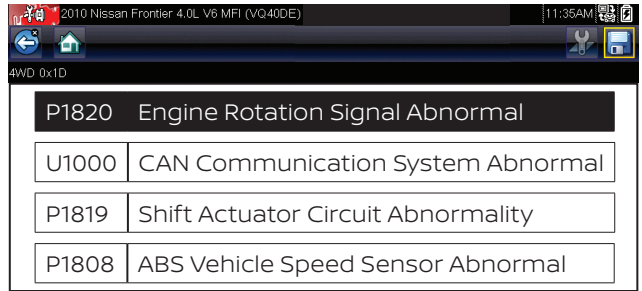
Figure 11: 2010 Nissan Frontier 4x4 module scan

Scanning it independently, we found that it communicated just fine, in spite of being missing from the all-module scan (see Figure 11).

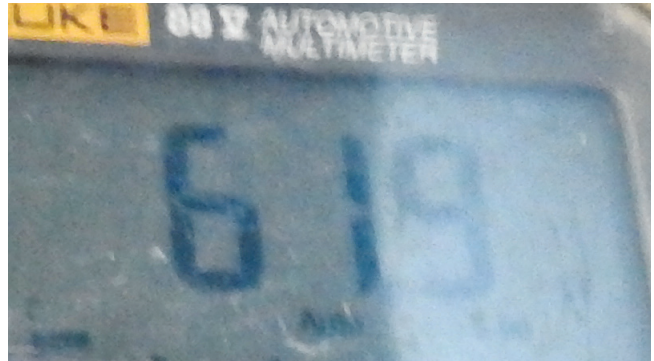
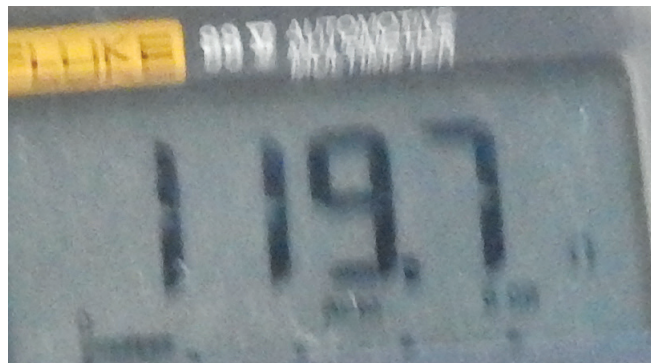
Figure 12: DVOM readings of network with ECM plugged (top) and unplugged (bottom)

Resistance was dead on at 61.9 ohms. To confirm the ECM has a terminating resistor, we went ahead and disconnected it and remeasured resistance as

illustrated in the photo (see Figure 12).

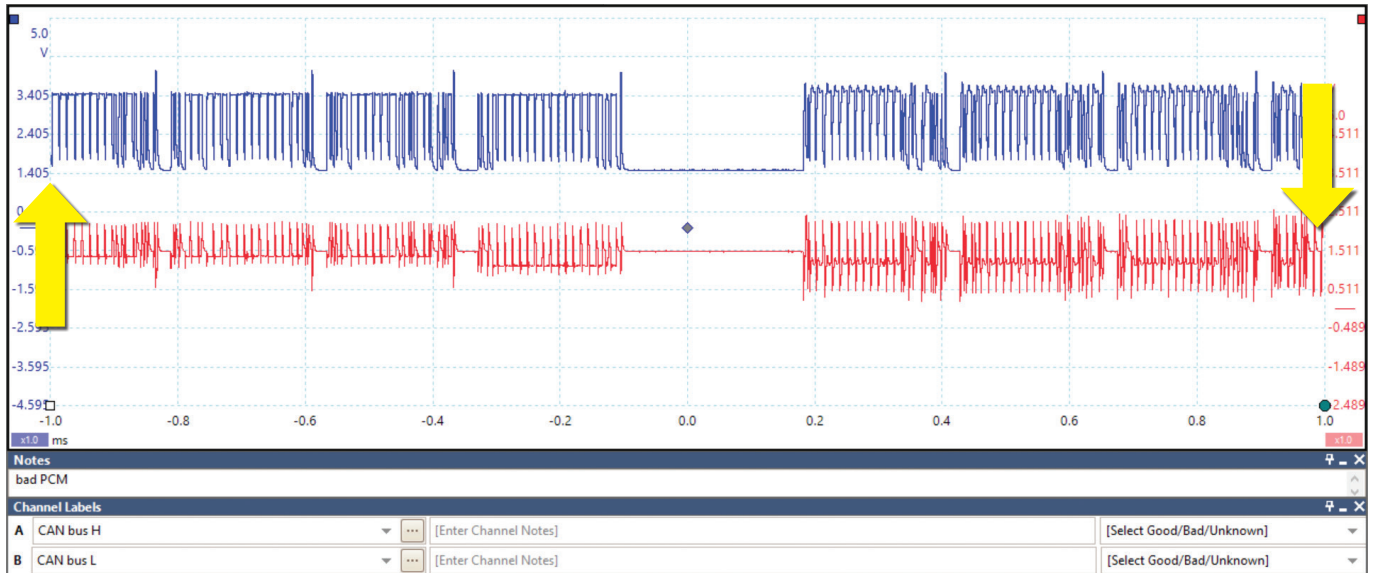
Figure 13: Alternate Pico scope capture bad CAN bus waveform ECM connected

this time we were rewarded with a problem signal. Note particularly the fact that the rest voltage is NOT at 2.5 volts and not even very close to it.

Also, CAN high and CAN low should be identical to each other. They were most assuredly not (see Figure 13, page8).

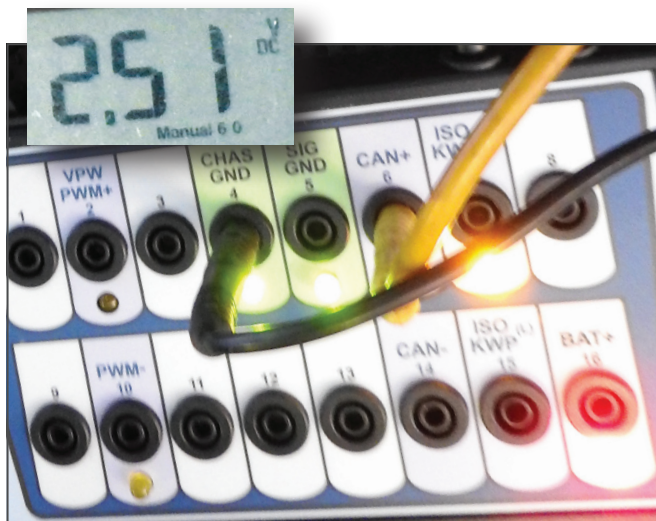
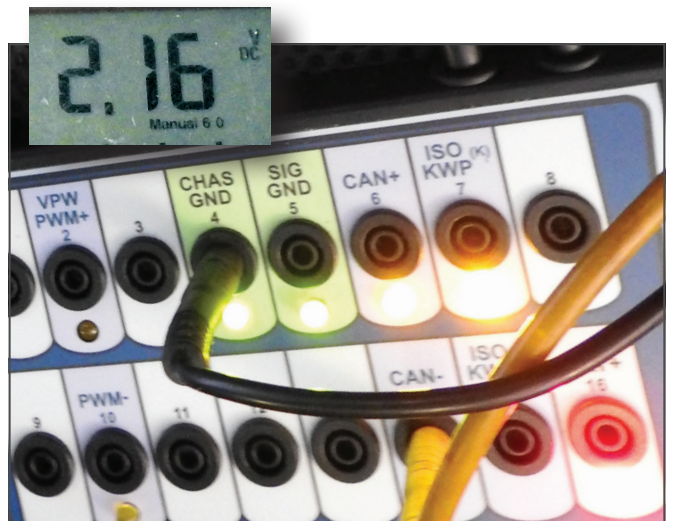
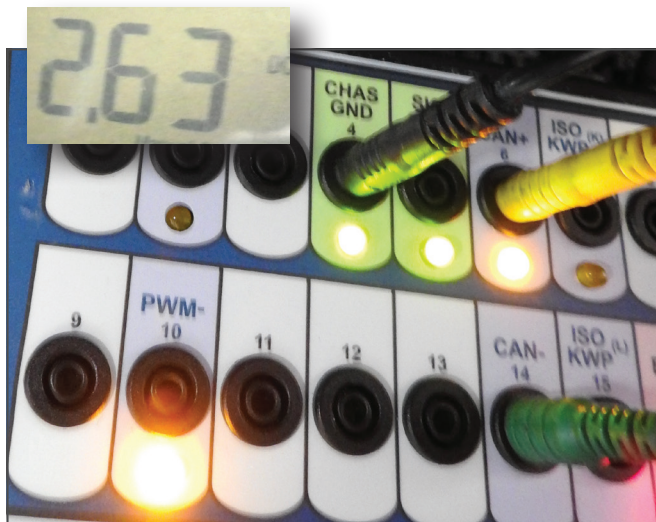
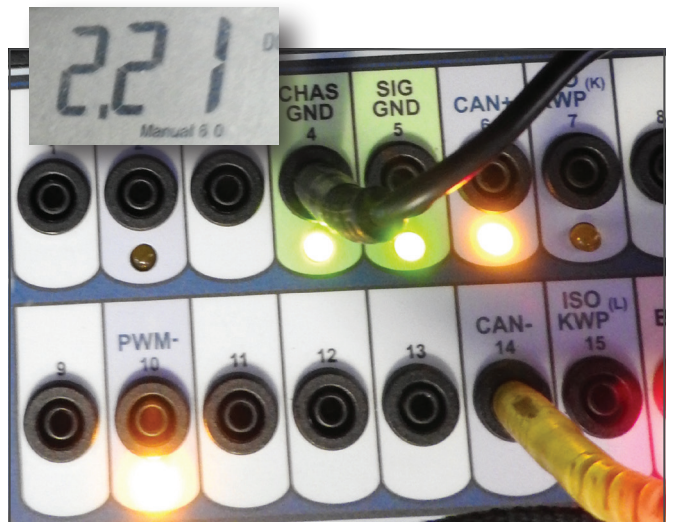
Figure 14: Voltmeter readings of CAN bus with ECM connected and disconnected

For those of you not equipped with a scope, we have provided voltmeter readings to show the difference between CAN high and CAN low with the ECM connected and then disconnected (see Figure 14, next page). When deciding whether or not to replace a component valued at over \$1,000, it is nice to have the scope readings as opposed to only those from the voltmeter, which gives us an average. Even the high-speed Min/Max feature of the Fluke 88 Series 5 meter is no match for the very fast CAN network. Notice the time base on the data capture; there is only 1 ms on the entire screen.

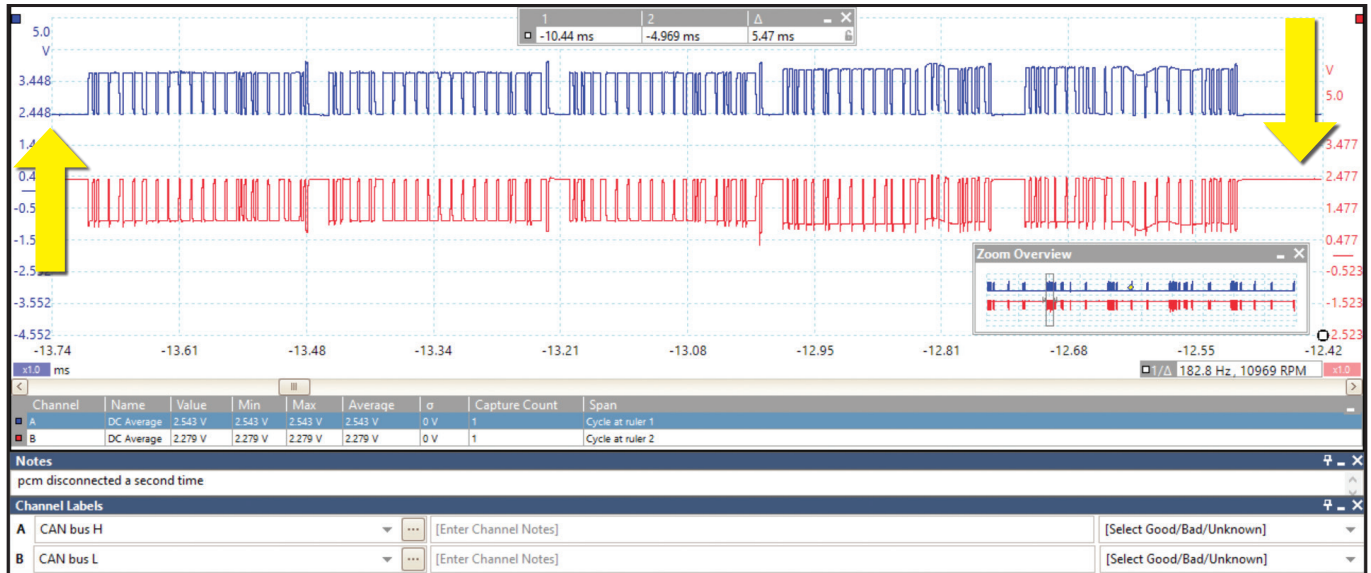
Figure 15: CAN bus waveform with ECM disconnected

Figure 15 (page 9) shows the waveform with the ECM disconnected. Note how the voltage levels at rest are very close to the 2.5 volt OBD CAN standard. You can also see the slight Nissan non-conformity with the 3.5 and 1.5 volt standard.

This time, in order to avoid the misery experienced with the used ECM on the last vehicle, a new ECM was sourced from Nissan. A VIN write and programming were performed using NERS software and a subscription to the Nissan website (a subject for a different article). A rescan was performed afterwards and some concern resulted from the results (see Figure 17, previous page).

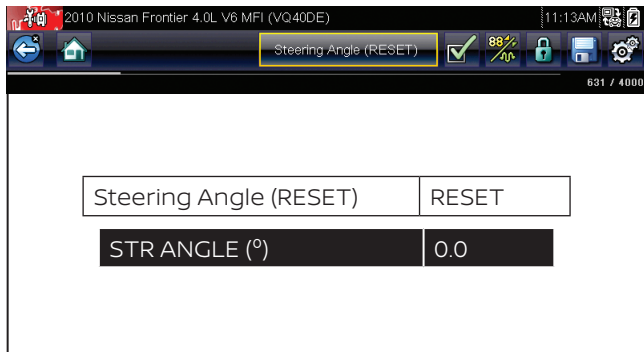
Figure 18: Steering angle sensor reset procedure

Was the SAS faulty? Why does the TCM show a U1000? It was feared that we have missed something, even though the vehicle started and ran just fine. A resetting attempt of the sensor was made (see Figure 18, previous page).

After the reset, a final scan confirmed all codes were resolved (see Figure 19, previous page).
