TOYOTAtech

Toyota Camry Crank No-Start 2GR-FE or not 2GR-FE

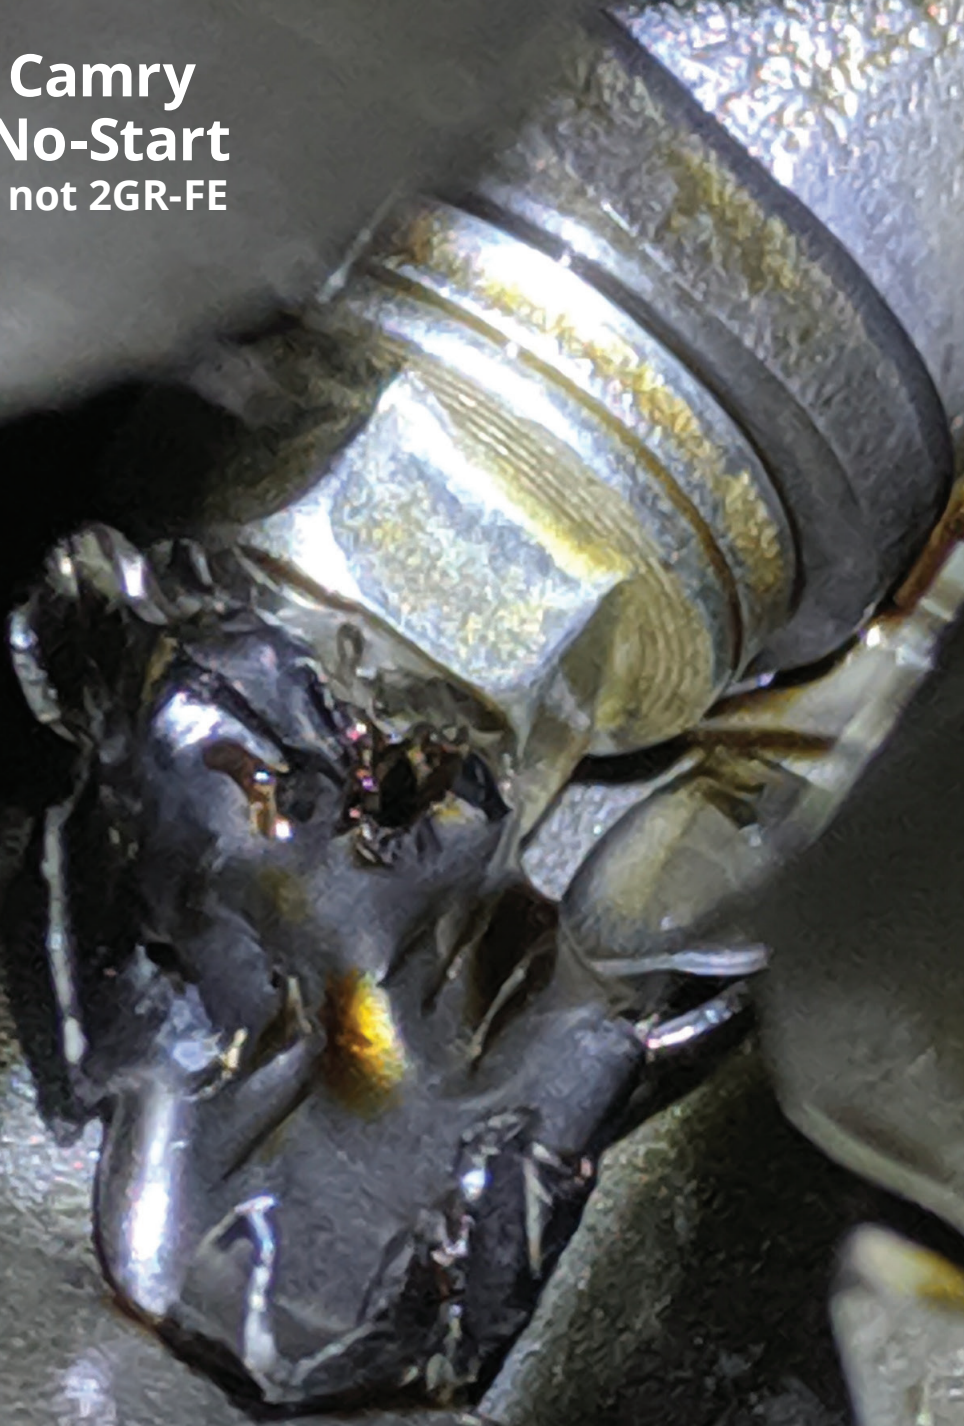
*Twisted metal found
below the cams*

Once the valve cover was removed, I found a piece of twisted metal below the cams.

At first, I could not tell what this piece of metal was, or where it had come from. It wasn't until I inspected the inside of the valve cover that I realized what the piece was. The piece of metal was in fact the baffle from the valve cover. There was only a small, jagged piece of the baffle left on one of the rivets.

This baffle is directly below the oil filler cap on the front valve cover. The baffle is designed to deflect oil that is slung by the camshafts, but it also has the unintended consequence of making the process of filling the engine with oil slow and frustrating. Seeing the broken baffle jogged my memory and I suddenly remembered a service bulletin from Toyota about cylinder head cover baffles. The bulletin states that engine damage can occur if the baffle is damaged

during the oil fill process, which is clearly what happened to this 2GR-FE engine.

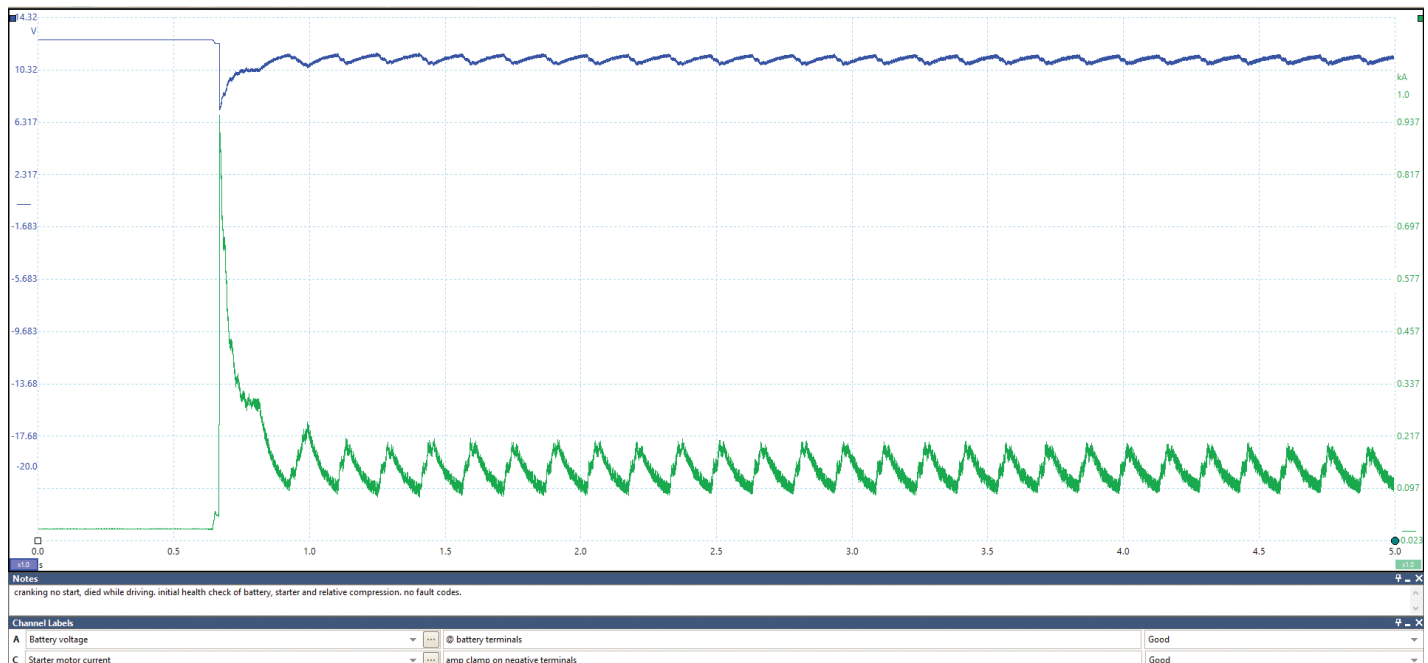
The resulting waveform showed a strong battery (blue trace) and it also dispelled any fears I had about the compression of the engine. The cranking amperage of the starter motor showed consistent peaks and amplitudes (green trace). This indicated even compression across the six-cylinder engine. Satisfied

PicoScope waveform shows strong battery (blue) and starter motor consistent peaks and amplitudes (green).

with the engine's compression, I chalked up the odd cranking sound to the cylinders being slightly washed from all the attempted starts.

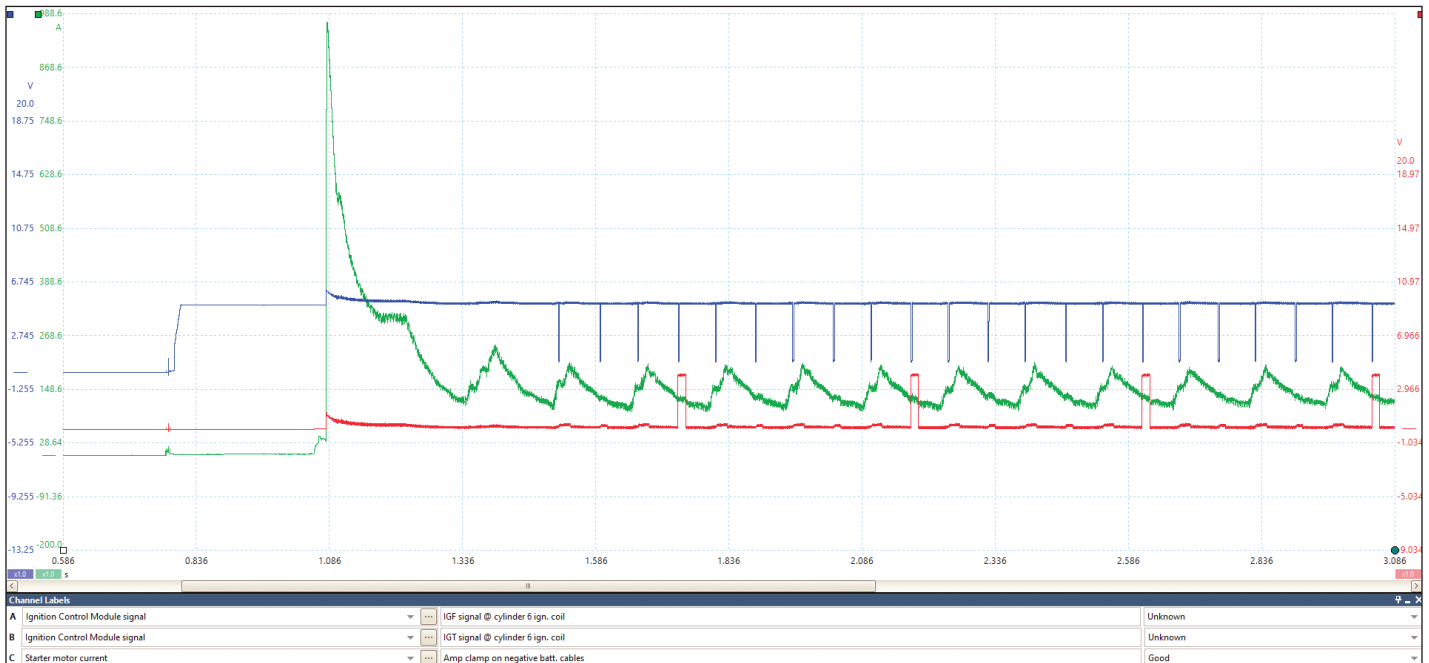
The results were quite startling. There were only three starter motor current peaks, which represent compression strokes, in between each ignition event for

cylinder six. Furthermore the ignition event was not close to a compression peak, as one would expect. Ignition timing should be very close or right at TDC while cranking. There were two possibilities on this vehicle: either the ECM was firing the ignition coils at the wrong time, or there were three missing compression peaks.

An additional scope capture with the ignition feedback signal (IGF – blue trace) proved the latter to be true. The IGF pattern confirmed six ignition events. This engine had three dead cylinders.

Cranking current, IGT, and IGF waveforms

I used a mechanical compression gauge to confirm that cylinders 2, 4 and 6 had no compression. My first relative compression test indicated a healthy engine, when in fact there were three cylinders not contributing. Due to the cylinder layout and firing order of this V6 engine the three dead cylinders fell in between the three good cylinders and were effectively hidden from view on the relative compression test waveform. This explained the no start condition and the odd cranking sound too.

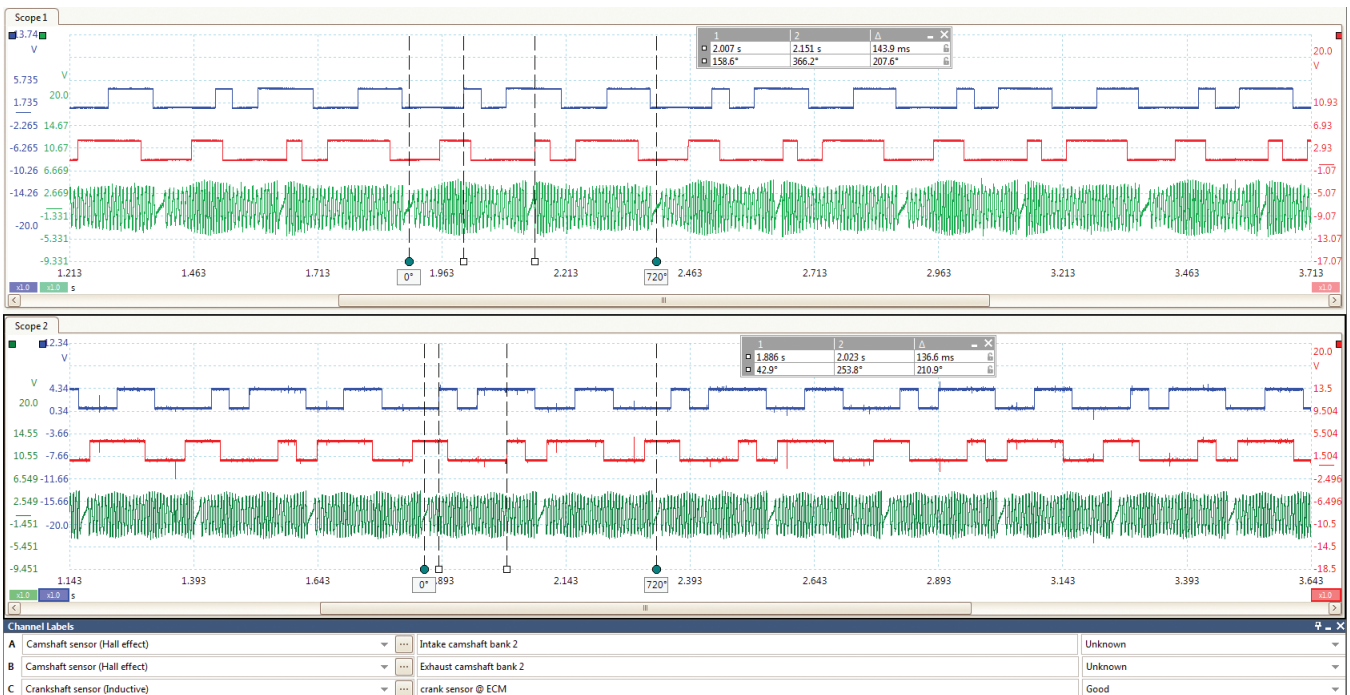
The most likely explanation for the three cylinders on Bank 2 having no compression was incorrect camshaft timing. A known-good waveform is very useful for determining the correct relationship between the camshaft sensor and crankshaft sensor signals.

By utilizing PicoScope's multi scope views, reference waveforms, and rotation rulers, I was able to compare my no start Camry waveform with the donor Sienna capture on the same screen. After comparing both cam/crank waveforms, it was clear that the Bank 2 camshafts were way out of alignment on the Camry.

Comparing a known-good 2GR-FE cam timing waveform

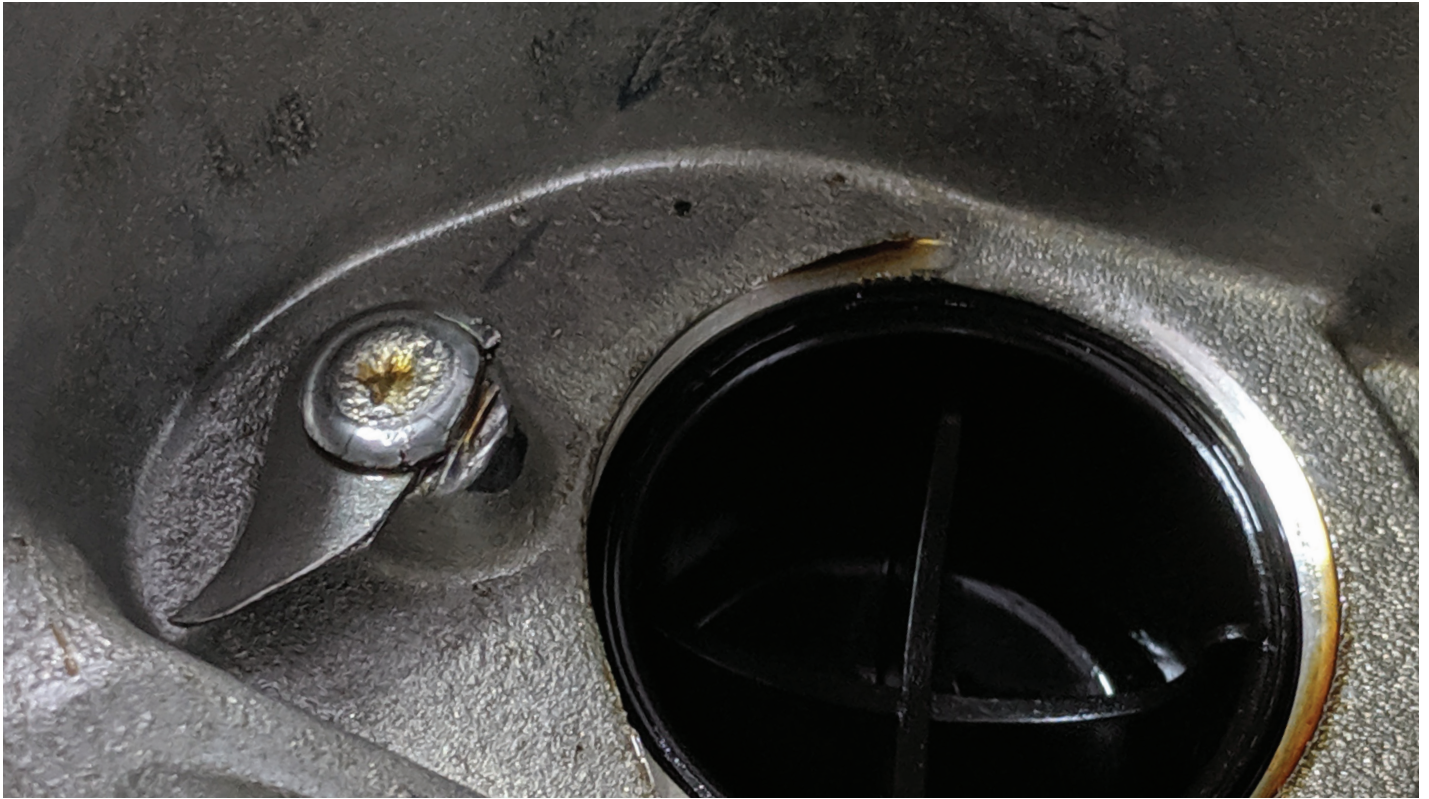
Only a small jagged piece of baffle was left on one of the rivets.

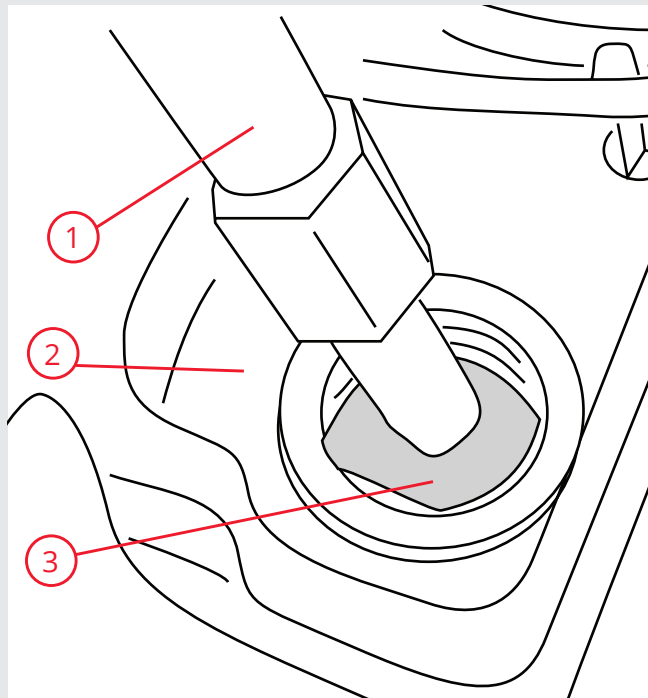
Figure 1. Example of Correct Oil Filling Procedure

Use care when inserting oil fill devices into the head cover. Forcefully inserting oil fill devices or funnels into the oil fill hole may result in baffle damage during the oil fill process. If the baffle **DOES** become damaged, repair it to prevent any additional engine damage from occurring.
