# TechNews

## Troubleshooting the Infiniti IQ X56

Shown here: Infiniti QX56

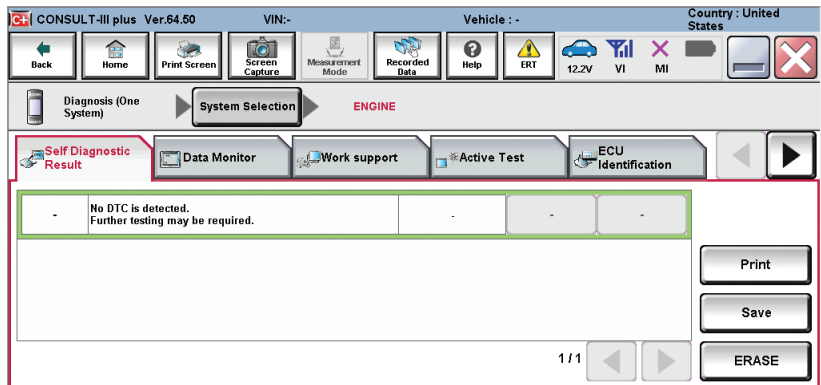
QX56 Codes

System	Parameter	Value
ENGINE	INT/V SOL(B1)	0 %
ENGINE	INT/V SOL(B2)	0 %
ENGINE	ENG SPEED	225 rpm
ENGINE	VVEL POSITION SEN-B1	1.1424 V
ENGINE	VVEL POSITION SEN-B2	0.7152 V
ENGINE	VVEL TIM-B1	14.5145 deg
ENGINE	VVEL TIM-B2	3.2835 deg

controller. There was an rpm signal present and the fuel pressure reading was in range. Coolant temperature and intake air temperature were correct. The camshaft timing PIDs were concerning though. The bank 1 cam timing showed 14.5 degrees, while bank 2 was only at 3 degrees. This bank to bank disparity is a strong indication of a camshaft timing issue.

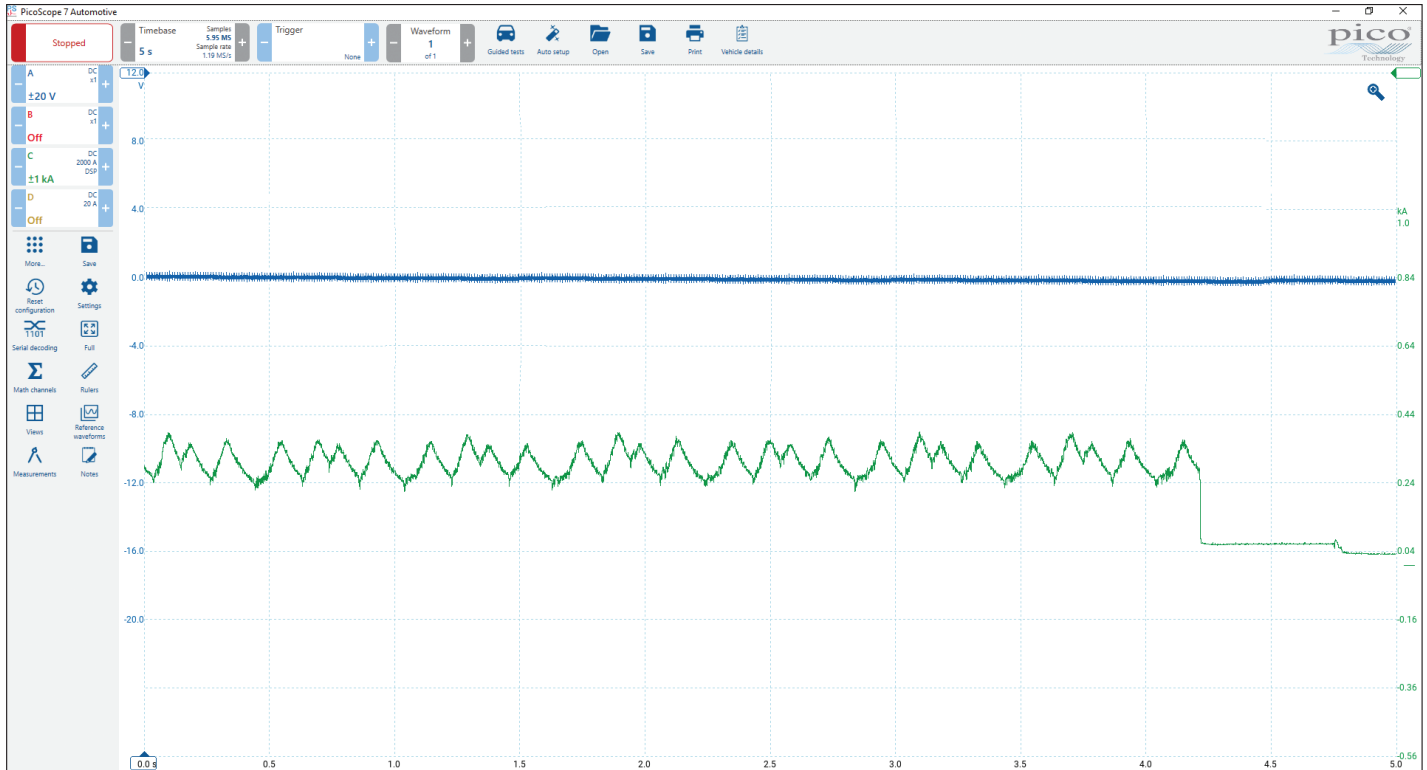
Relative Compression Test

Due to the no start condition, a relative compression test was an easy and logical next step. With a high amperage current probe clamped around the negative battery cable and a second lab scope channel attached to the cylinder 1 ignition coil as a reference, the engine was cranked over again. The resulting waveform shed some light on the health of the engine, but it also raised a new question about the ignition system.

The starter motor current (channel C in green) matched the cranking cadence of the engine, showing multiple cylinders with low compression.

The ignition sync (channel A in blue) showed no activity at all, indicating there was no spark control signal to the ignition coil. The test results were beginning to fall into place, but the lack of spark was a bit of an anomaly that still needed to be addressed.

gathered so far, it was possible to determine which cylinders were low on compression even without the ignition sync. The scan tool data pointed toward jumped camshaft timing and potentially bent valves. This would mean that cylinders 1, 3, 5 and 7 would have low compression.

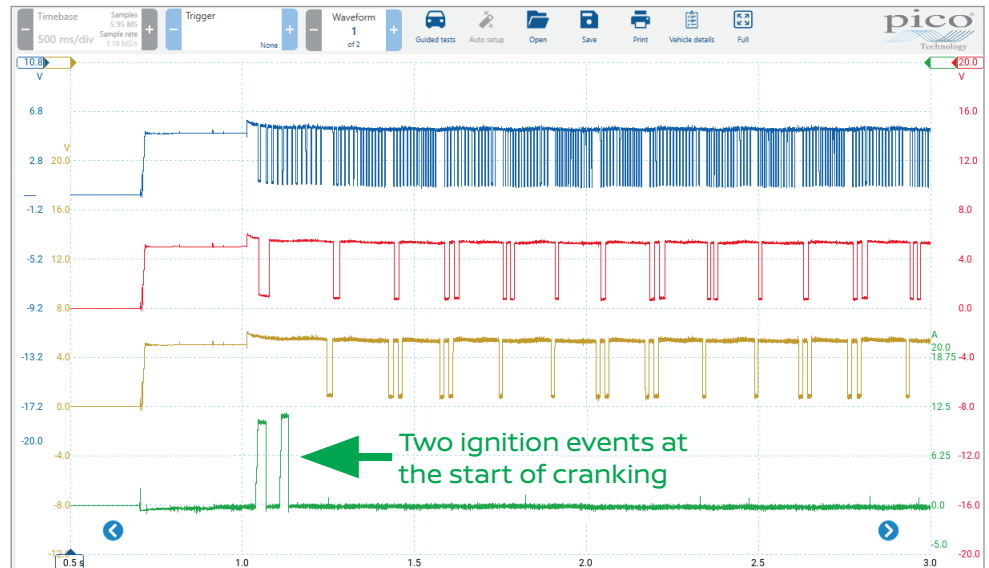
Cam & Crank Sensors

To confirm if the camshaft timing had indeed jumped, a lab scope was connected to the crankshaft sensor and both camshaft sensors. An amp clamp was also connected to the fuse for the ignition coils. The resulting waveform answered the no spark issue, as well as the camshaft timing.

There were two ignition events at the start of the engine cranking over. Subsequent tests showed the same results. There were one or two ignition events each time the engine was cranked over. The lab scope capture seemed to show that the engine control

module was disabling spark, most likely due to the camshaft timing issue. After consulting with a trusted Nissan/Infiniti expert, these suspicions were confirmed. There is an engine management strategy that will disable spark when camshaft timing is outside of certain parameters.

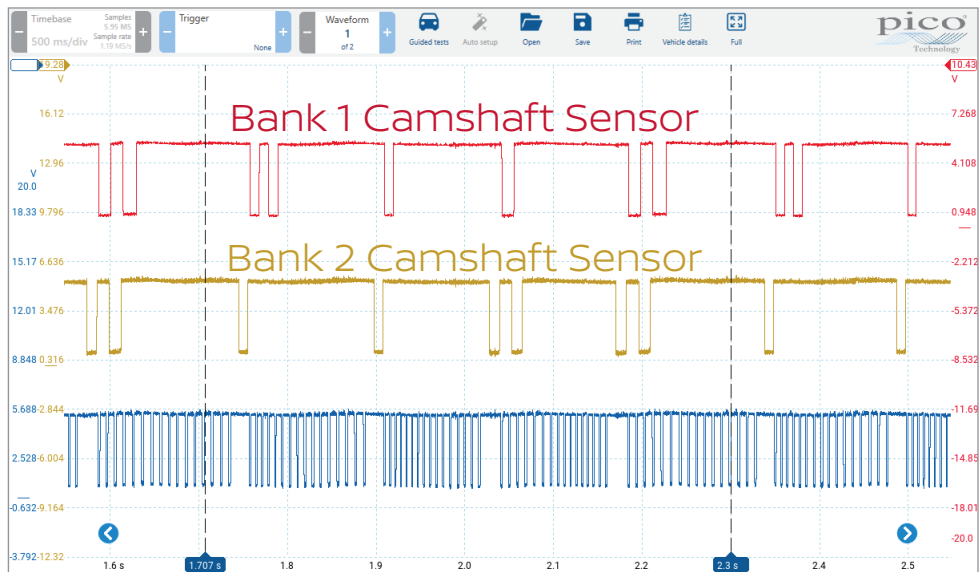
Crank & Cam Correlation

With the no spark question now answered, the focus was shifted back to the camshaft timing. Using the crankshaft-to-camshaft correlation diagram found in service information, it was clear that the bank 1 camshaft had jumped time. The cam sensor patterns showed the bank 1 cam was significantly advanced.

In the end, the engine on this QX56 was condemned. An oil sample revealed large amounts of metal and bearing material, and the engine had over 160 K miles on the odometer. All these factors added up to an engine that was not a good candidate for new timing chains and a cylinder head repair.
