Curing the BMW N54 30FF Fault Code

Understanding the BMW twin turbocharged N54 engine operation and diagnosing and repairing failure points

BMW N54 engines have been setting a 30FF fault code ever since the vehicles hit the dealerships in 2006. "DME: Turbocharger, charge-air pressure too low." This fault code can lead you down many different paths. On this specific 2009 BMW 535xi we start with the basics.

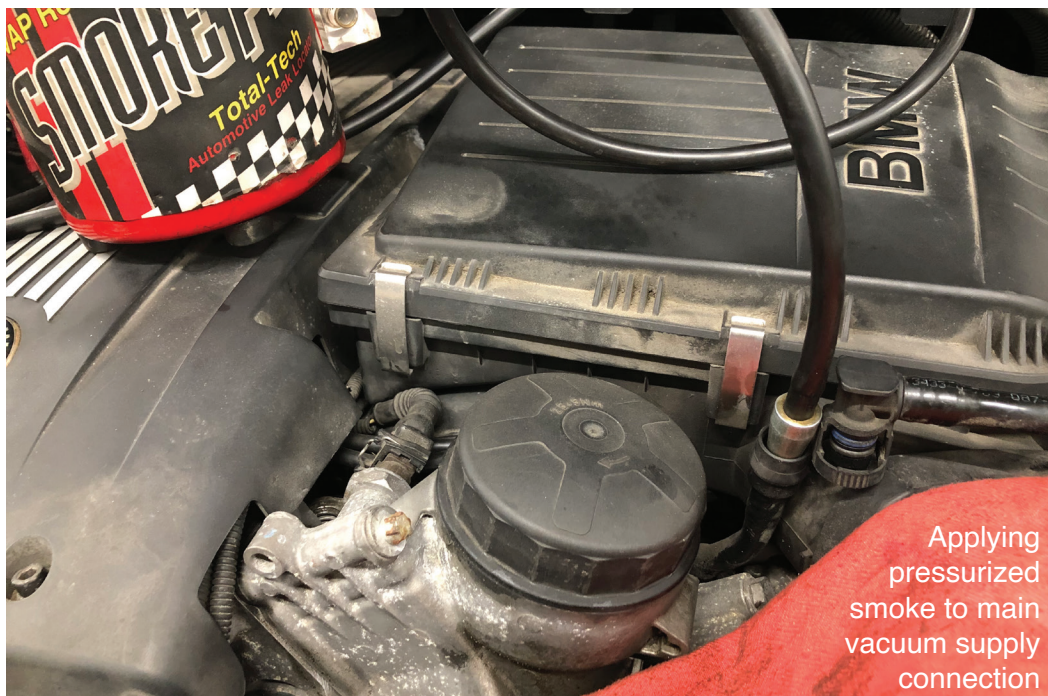
Applying pressurized smoke to main vacuum supply connection

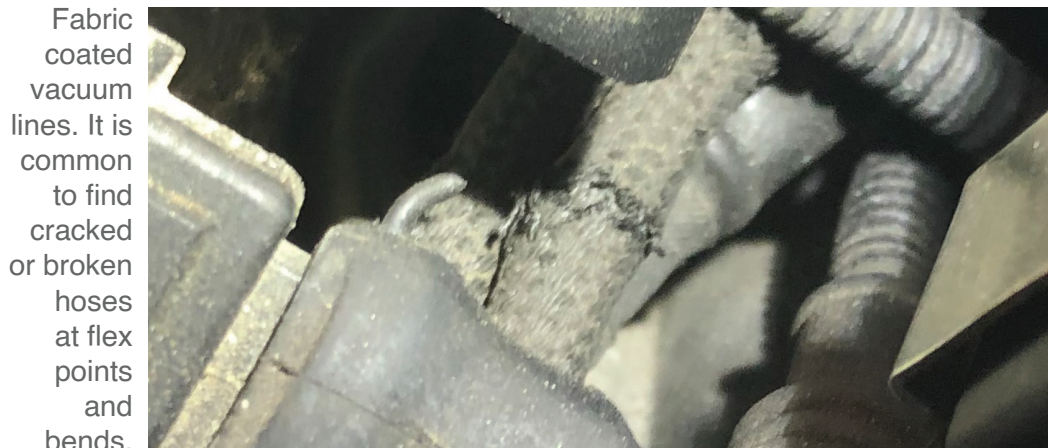
It is very common to find a broken line. These vacuum hoses are rubber with a fabric covering. You will notice the fabric deteriorates and flakes away. If you find deteriorated fabric, the rubber hose underneath has also been compromised. In most situations, it would be best

Fabric coated vacuum lines. It is common to find cracked or broken hoses at flex points and bends.

to replace all these vacuum lines once the defective hose has been isolated. We were not so lucky on our 535xi. (No leaks were found, no kinked or pinched hoses.)

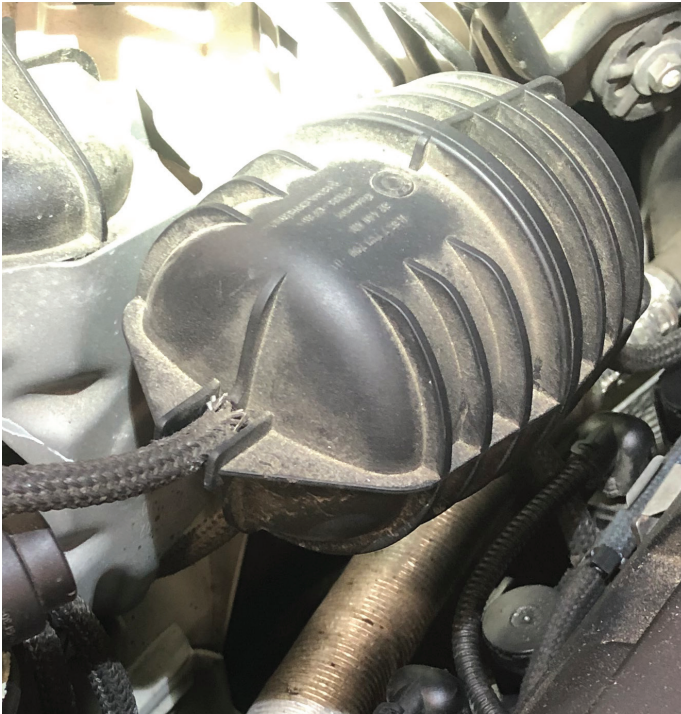
These plastic tanks hold vacuum for a constant supply when needed. Many line connections and bends equals possible failure/leaks.

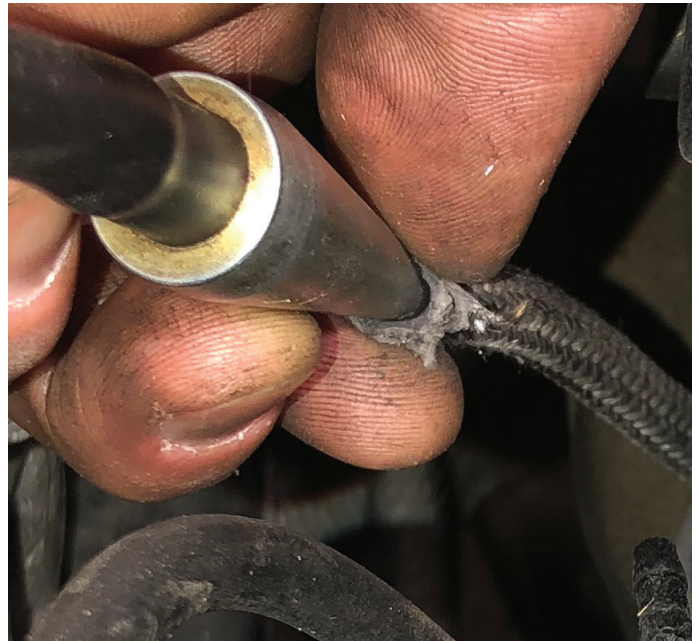
Applying pressurized smoke past the electric solenoid to the wastegate actuator

pressurizing the system, activate the solenoid. You should hear and feel the solenoid activate, but also see it with the smoke. We performed this test and found both control solenoids activating correctly. By activating with the BMW tester, we know the wiring is good and the DME is supplying and grounding the solenoids as it should.

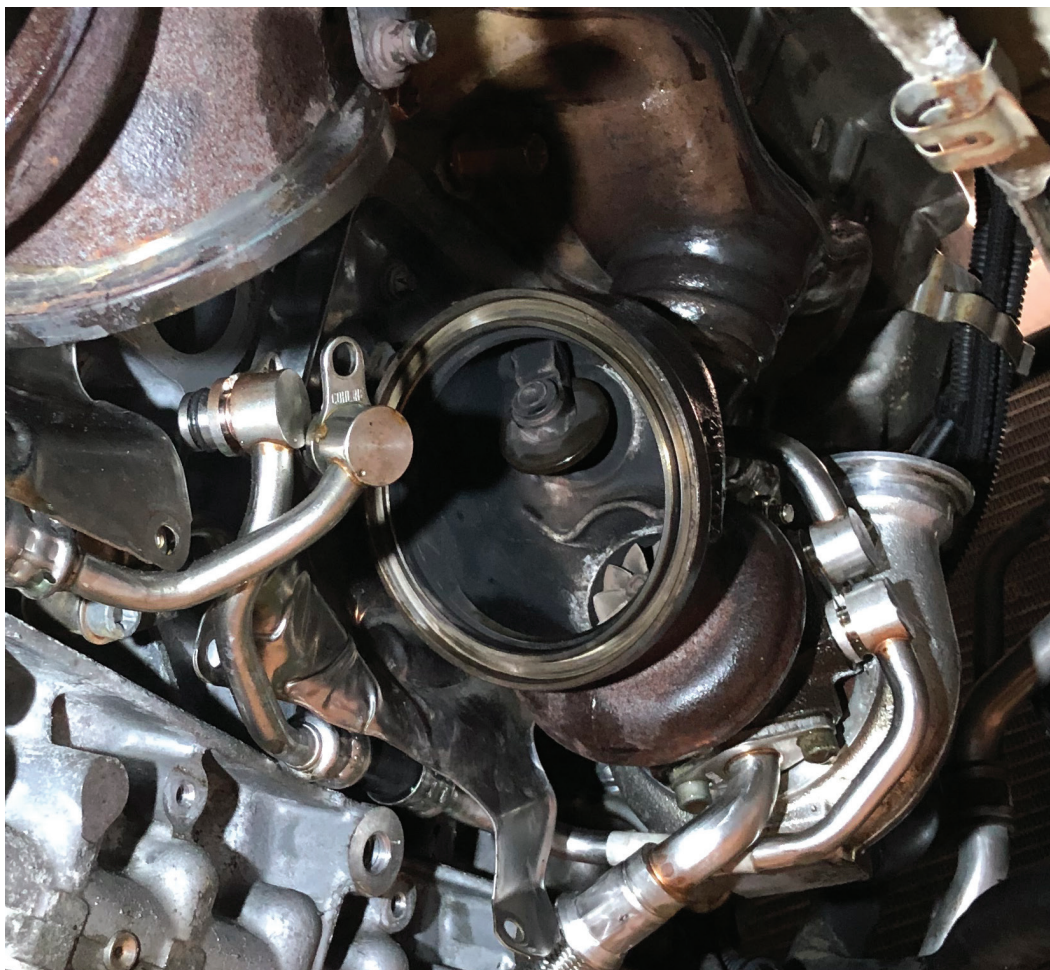
Both turbos installed with catalytic converters removed, provided access to the wastegate valve.

With the catalytic converters out of the way, we discovered a very obvious issue. The wastegate valves on both turbos were incredibly loose. When actuating the wastegate diaphragm with our trusty hand vacuum pump, the valve barely touched the exhaust port on Bank 2. And Bank 1 wasn't much better. The turbines spun free on both turbos and showed no signs of wear.

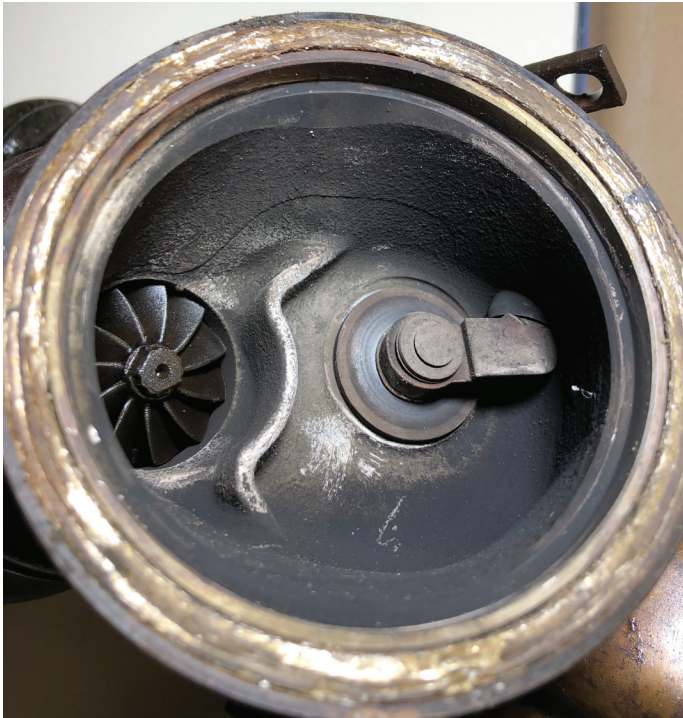
View inside turbo assembly with wastegate valve and turbine exposed.

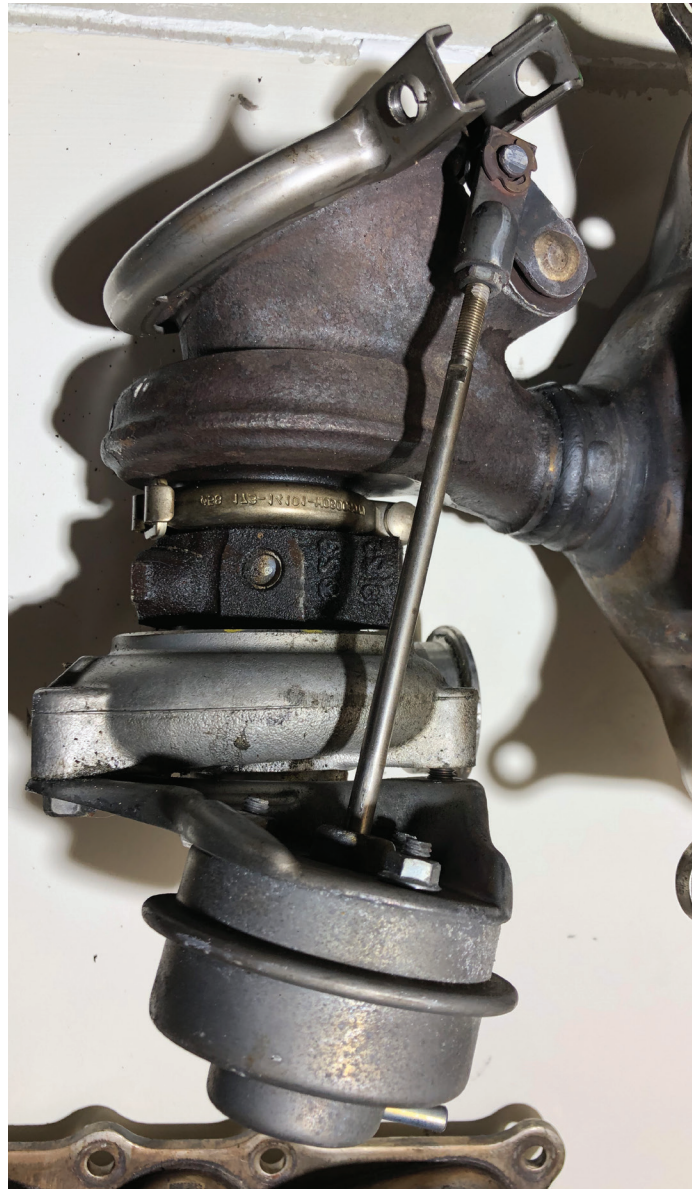
Complete wastegate actuator bolted to turbo.

After double checking the integrity of our turbo assemblies, turbine bearings, and overall condition, we decided to simply replace the wastegate actuators and adjust correctly. Parts are readily available and affordable. The diaphragms had aged and worn out with heat cycles of the engine. All the coolant lines were in rough condition and were replaced as well. The oil feed lines appeared to be in good condition, but we felt it would be best to replace those while we had everything apart.
