September 2021

the bimmer pub[®]

Diagnosing BMW BSD & LIN Networks A Tale of Two Vehicles

By Jordan Hill

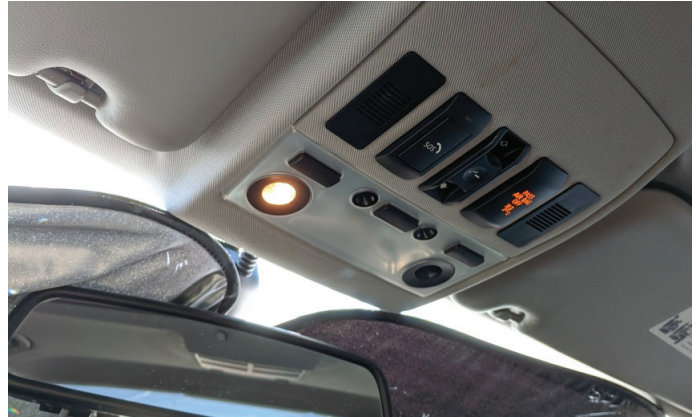
535i map light

Grabbing the key from the key rack, I headed out into the parking lot. I opened the trunk and connected the battery. The first thing I noticed after sitting down in the driver's seat was that the map light was switched on.

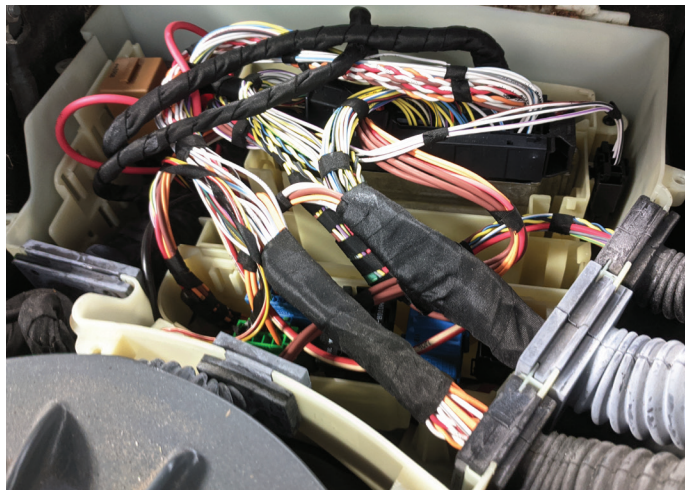
I began testing by accessing the DME inside the E-box near the passenger side firewall. With a lab scope connected to the violet BSD wire at the DME connector I monitored the signal voltage. There was a reading of 0 volts on the wire with almost no discernible activity. When

the driver's door was opened there was a momentary spike and when the ignition was turned on there was some 'noise' in the circuit.

The next step was to disconnect each component on the data bus looking for a change in the signal. First we checked the intelligent battery sensor on the negative battery terminal in the trunk. This was followed by checking the single wire alternator connector, electric coolant pump, and the oil condition sensor. With all the components unplugged there was still no activity on the BSD wire.

All of this added up to a failed DME. The DME is the master module for the BSD network and should supply 12 volts on the BSD wire to the other components. My service writer priced up a new DME, alternator, and intelligent battery sensor just to be safe. The owner approved the repairs with the understanding that I could not verify correct operation of the electric coolant pump or the oil condition sensor until the repairs were completed.

The parts were ordered and a few days later, when they all they were delivered, I installed them on the vehicle. The new DME was programmed with ISTA-P along with several other modules which needed an updated programming level.

With fear and trembling I turned the ignition on. Much to my relief, Channel A of PicoScope showed 12 volts, indicating that the Bit Serial Network was alive and well. The engine started and ran, and the volt meter on the battery terminals now read 13.6 volts. After two road tests with multiple key cycles in between there were no faults in the DME, and all the readiness monitors had run and passed.

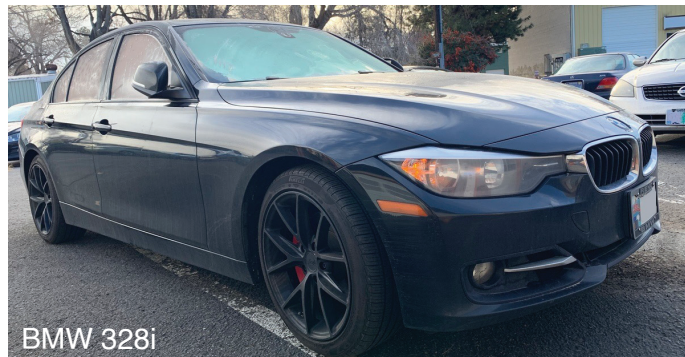
BMW 328i

The cooling fan turned on shortly after starting the BMW's engine and pulling into the shop, so I was not concerned with the fan operation as a cause of the overheating. A visual inspection of the cooling system revealed coolant stains around the expansion tank. The coolant level was low in the expansion tank as well. I filled the tank to the correct level and pressure tested the system. The pressure gauge held steady at 16 psi for 10 minutes, so I did not suspect a leak in the system. The low coolant level and staining were consistent with an engine that overheated and boiled out of the expansion tank cap.

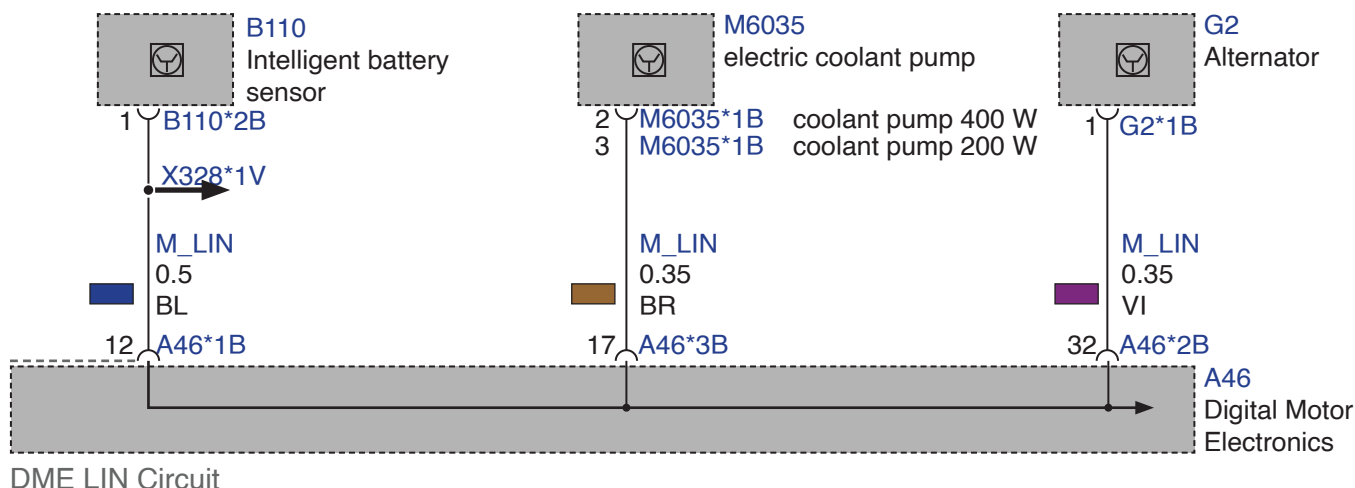
LIN BUS PicoScope

I connected PicoScope to the power, ground, and communication wires to the coolant pump. The power and ground circuits both tested good. On the communication wire I found that there was activity when the coolant pump connector was disconnected, but once the connector was plugged back in all activity stopped. This is where I made my second mistake. I assumed that this meant the coolant pump was faulty and when it was plugged in it was bringing down the communication line.

When I looked at the original scope capture of the LIN bus wire a second time, I saw that the square wave pattern only went from 0–7 volts. This lower voltage seemed to indicate resistance in the LIN wire to the coolant pump, and checks of the LIN signal at both the alternator and intelligent battery sensor showed 0–12 volt square waves.

With this new understanding, I visually inspected the wiring harness from the coolant pump up to the DME. Along the front of the engine there was a section of the wire loom that was damaged and when I opened up the loom I found an exposed section of wire that had corrosion built up on it. After replacing this section of wire the LIN bus signal at the coolant pump was correct and the fault code cleared.
