TechNews

Diagnosing Nissan No Starts

By Jordan Hill

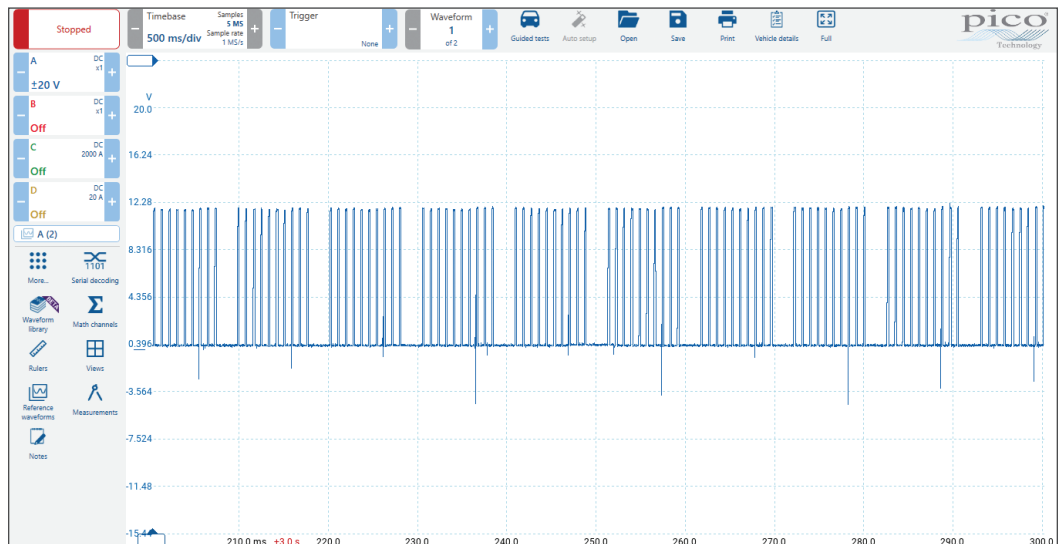
Normal Crank Sensor Signal

Even though the engine was starting correctly, a lab scope was connected to the crankshaft position sensor signal wire and a good signal pattern was recorded.

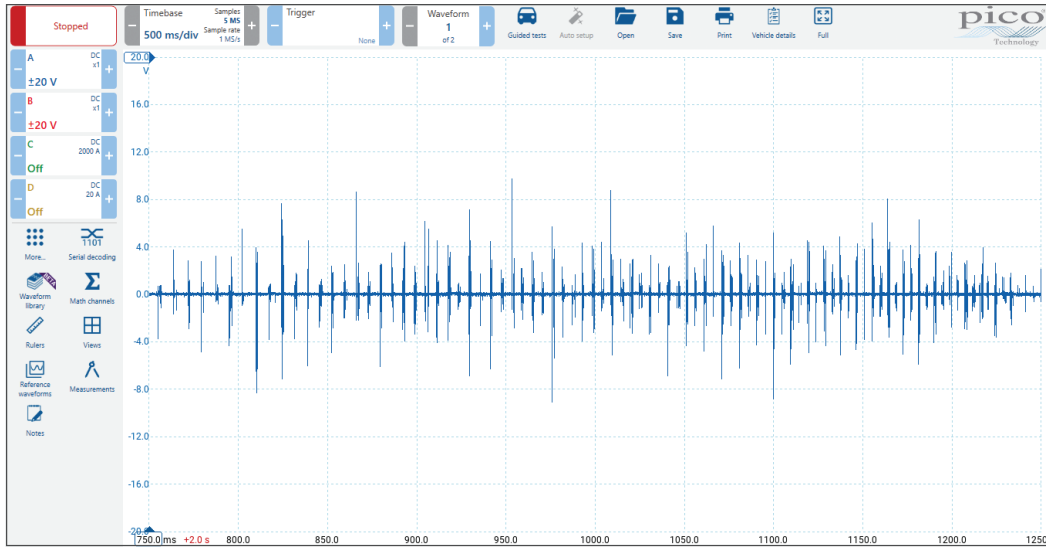
Failed Crank Sensor Signal

scope lead still connected, the crank sensor signal was captured while the engine was cranking and not starting. There was no discernible signal from the crank sensor, confirming an intermittently failing sensor.

A new OEM crankshaft position sensor was installed and the fault cleared. The Frontier, now starting correctly every time, was returned to the owner. This was a straightforward diagnosis and repair, but that is no reason to alter the testing procedure or skip over steps. On the contrary, straightforward failures are a chance to try out new testing methods or refine portions of the diagnostic process.

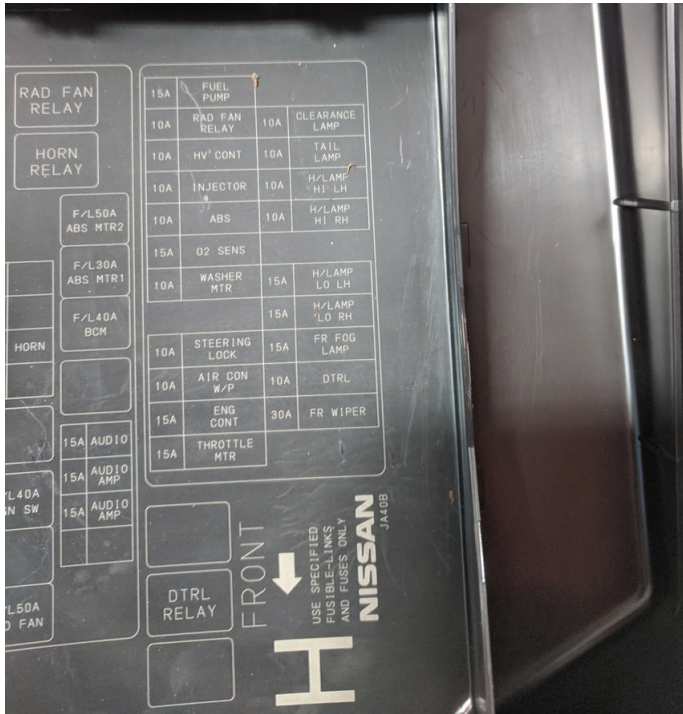
Under-Hood Fuse Cover

A vehicle scan revealed there was no communication with the engine control module and there were Loss of Communication faults for the ECM logged in several other modules. A great first check in a situation like this is to verify the condition of all the fuses. This is a quick basic test, but it paid dividends on this sedan because the 15 amp Engine Controls fuse in the under-hood fuse box was blown.

The fuse was replaced and the vehicle now started up. This success was short lived though, because the engine only ran for a few seconds and then shut off.

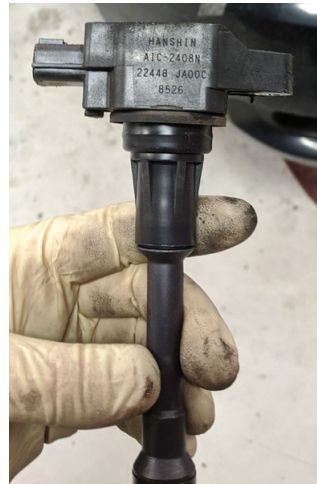
Shorted Ignition Coil

The same Engine Controls fuse was blown again. Following the fuse distribution wiring diagrams showed that the 15 amp Engine Controls fuse provided voltage to the engine control module and the ignition coils along with a few other components. By disconnecting the ignition coils one at a time and sacrificing several more fuses, it was determined that the cylinder 1 ignition coil was completely shorted and blowing the Engine Controls fuse. With the cylinder 1 ignition coil unplugged, the engine would continue running without blowing the fuse.

It was strongly recommended that all four ignition coils should be replaced to prevent this situation from happening again, but Kyle was on a tight budget and opted to only replace the one ignition coil that was shorted. The one new OEM Nissan ignition coil was installed along with another new

Engine Controls fuse in the under-hood fuse box. All the communication faults were cleared and the Altima was taken on an extended road test to confirm the vehicle was repaired and was ready to be delivered back to its owner.

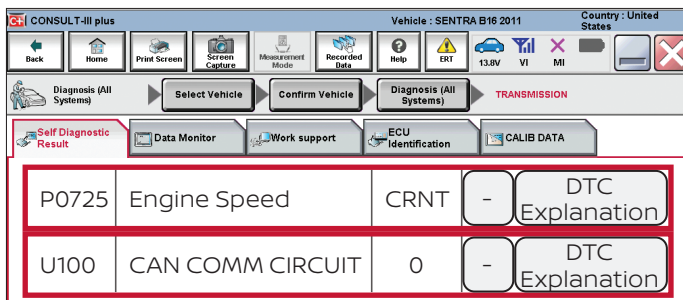
Sentra Transmission Faults

With the embarrassing 'senior moment' details out in the open and the vehicle now in the service bay, it was time for testing to begin. The battery was tested first and it was in need of a recharge. With the charger attached to the battery, the rest of the basic checks were carried out. Everything else under the hood looked great. This B16 was very clean and clearly owned by someone who did very little driving, as the odometer had not even broken 30,000 miles. The fault scan showed a couple interesting faults in the transmission control module. There was an engine speed fault and a CAN communication error.

The ignition had been left in the ON position for several days, and it had been jump started, so checking the fuses was the next logical step. The under-hood and passenger compartment fuses all tested good though, so focus was shifted to the fault codes that were in the transmission module. The codes were hard faults that remained in the module after trying to clear them several times. Researching through service information revealed that Nissan had released Service Bulletin NTB11-043 which addressed both the engine speed fault and CAN communication fault that this Sentra had.

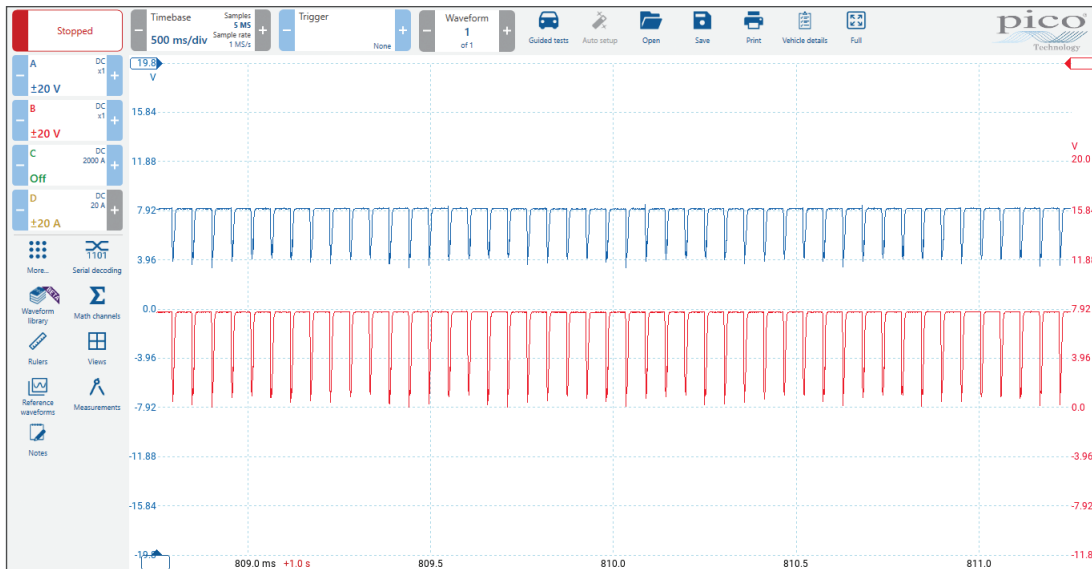
Altima CAN Line Voltages

Next, a lab scope was hooked up to the breakout box to test the CAN line voltages. The CAN High and CAN Low voltages were incorrect and it was clear that no data was being transmitted.

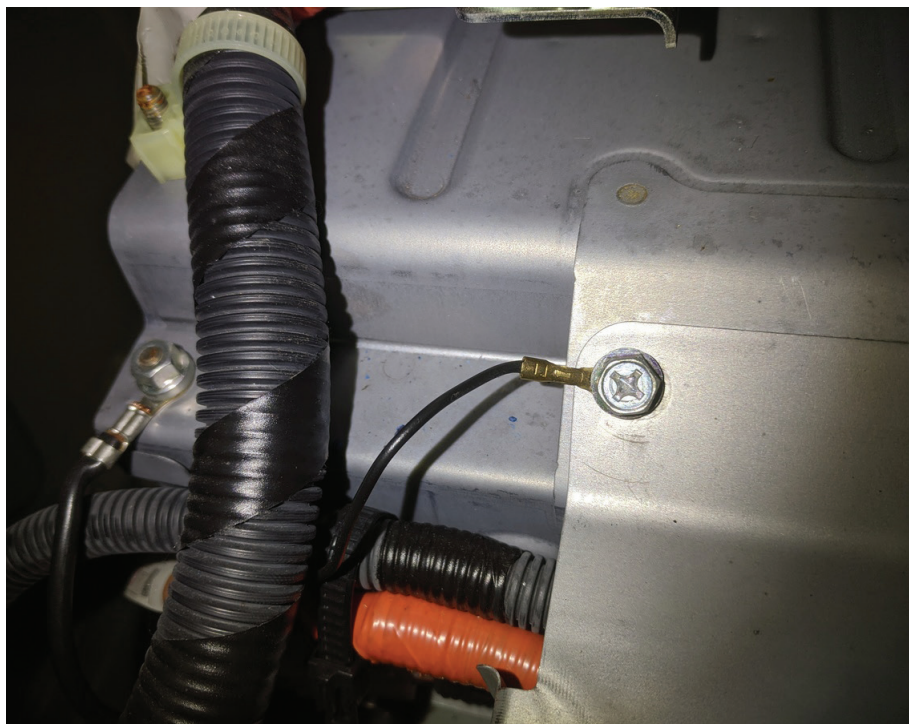
Hybrid ECU Ground Wire

Wiring diagrams verified the ground wire was for the Hybrid ECU. The missing ground for the Hybrid ECU had

taken down all communications on the CAN network. The faults were cleared and the vehicle was taken on two test drives. During the second test drive the Check Engine, Brake, VDC and Red ! Warning lights came on. All the modules were scanned for faults again and now there were several codes indicating a failing high voltage battery pack.

Further inspection revealed the High Voltage battery covers were improperly installed and there was a damaged ground wire on the battery

been disturbed and how the ground wire was damaged. The used car lot had tried to repair or had possibly replaced the High Voltage battery and created the stalling and no start conditions. Unfortunately, the vehicle's new owner got more than a mode of transportation when he bought this Altima; he got someone else's problems that were not correctly repaired. No starts won't be going away any time soon, so it is necessary to have a solid diagnostic plan ready to conquer these challenges. |

housing. The ground wire was repaired and reattached to the High Voltage battery housing. Incredibly the vehicle would now Ready On and the engine started. All modules were now present on the scan results and the CAN line voltages were correct.
