Parking brake (EPB), Not possible to get brake caliper in service position

No: TJ 27500.6.0
Func Group: 5127
Func Description: Brake caliper
Partner: 3 US 7510 Volvo Cars North America
Issue Date: July 08, 2016

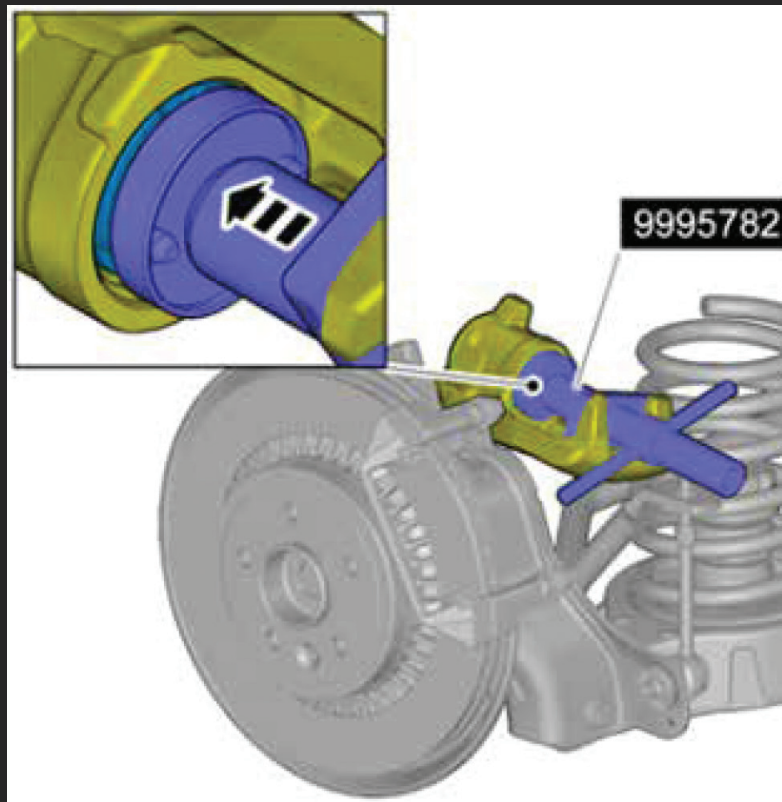
It may happen that the brake piston does not retract at all or does not retract completely, which makes it impossible to remove the rear brake pads from the caliper due to one of the following reasons:

- An electrical failure or a communication error between VIDA and PBM and caliper actuator.
- A seized piston, probably due to excess wear on the brake pads causing the piston to have an unsuitable angle to fit the caliper housing, which causes a wedging/racking condition.

- Blow clean the caliper/ actuator with high pressure air.
- Remove the actuator from caliper housing by loosening the two screws.
- Check the caliper to see if the activation shaft has been rewound, if necessary manually screw back the activation shaft clockwise by using a suitable torx screw drive (refer to the TJ for video).
- Reinstall the actuator to the caliper.
- Push the piston into caliper housing all the way once the activation shaft is fully returned.

If needed, use special tool 9995782 (refer to image on right).
