TOYOTAtech

15-Minute Toyota Diagnostics

By Jordan Hill

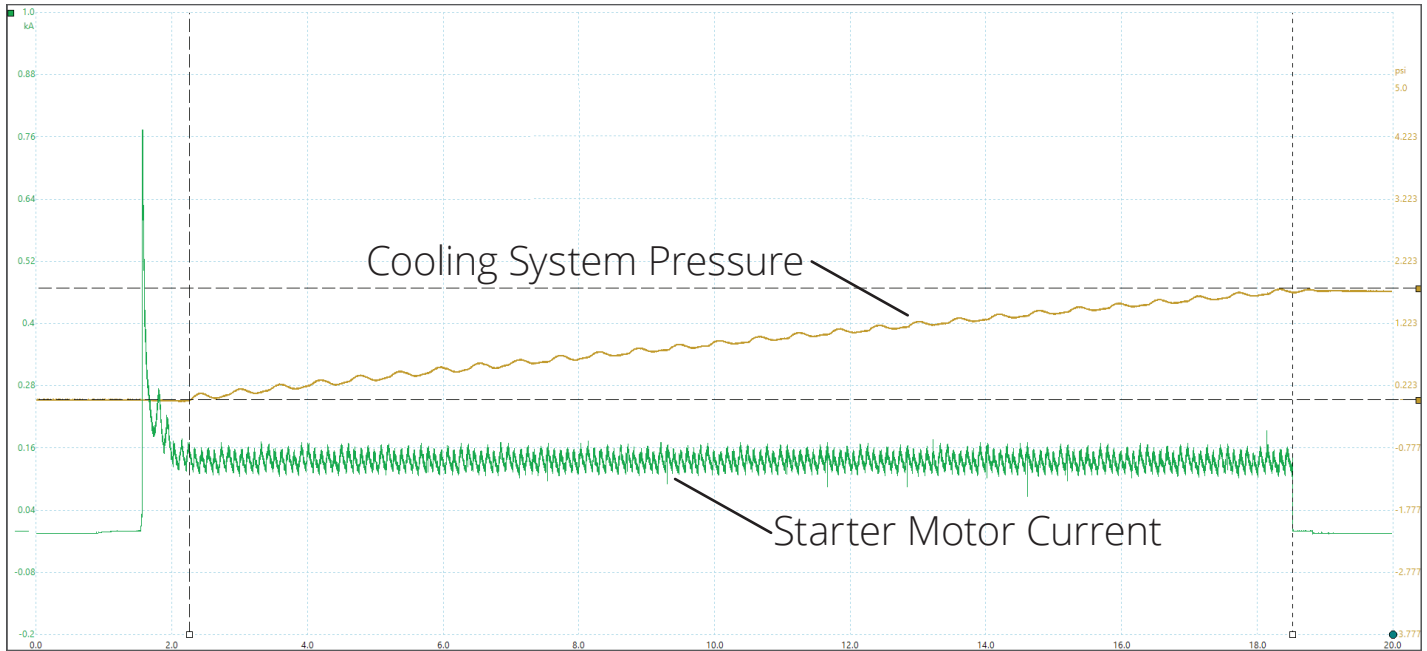
Cooling System Pressure Waveform

This captured waveform shows the starter motor current and the cooling system pressure. The pressure transducer measured a definite rise in pressure at the radiator cap in just a few seconds of cranking the engine over. There was also a repetitive pulse in the pressure trace. By using the cylinder 1 ignition voltage as a reference point, and a waveform overlay tool the cause of the excessive pressure in the system was quickly identified. Every time cylinder 1 was on the power stroke the transducer read a pressure pulse.

This quick and effective test confirmed a cylinder head sealing issue and pinpointed the leak to cylinder 1. This test also identified the hard starting issue, cylinder 1 misfire fault and the reason for the low coolant level.

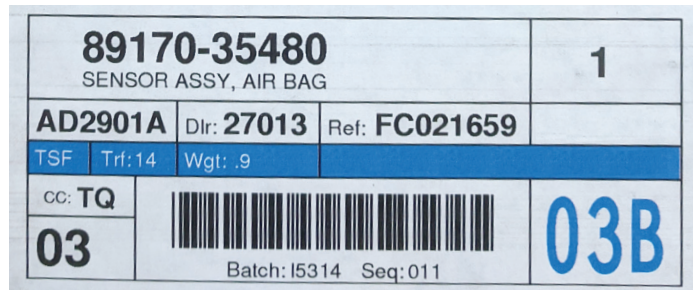
Airbag Module Part Number

At this point, it was clear that something wasn't right. There's no communication with the acceleration sensor, and there were fault codes for components that the vehicle wasn't equipped with. These conditions would most likely be caused by an incorrect Airbag Sensor Assembly.

A phone call to the local dealer confirmed that the wrong Airbag Sensor had been installed on this vehicle. The correct part was ordered from Toyota and once in the vehicle the calibrations were performed

successfully, and all the codes were cleared. A fault scan, a visual inspection and some deductive reasoning were all that was needed to get this SUV back on the road quickly and without any unnecessary testing or repairs.

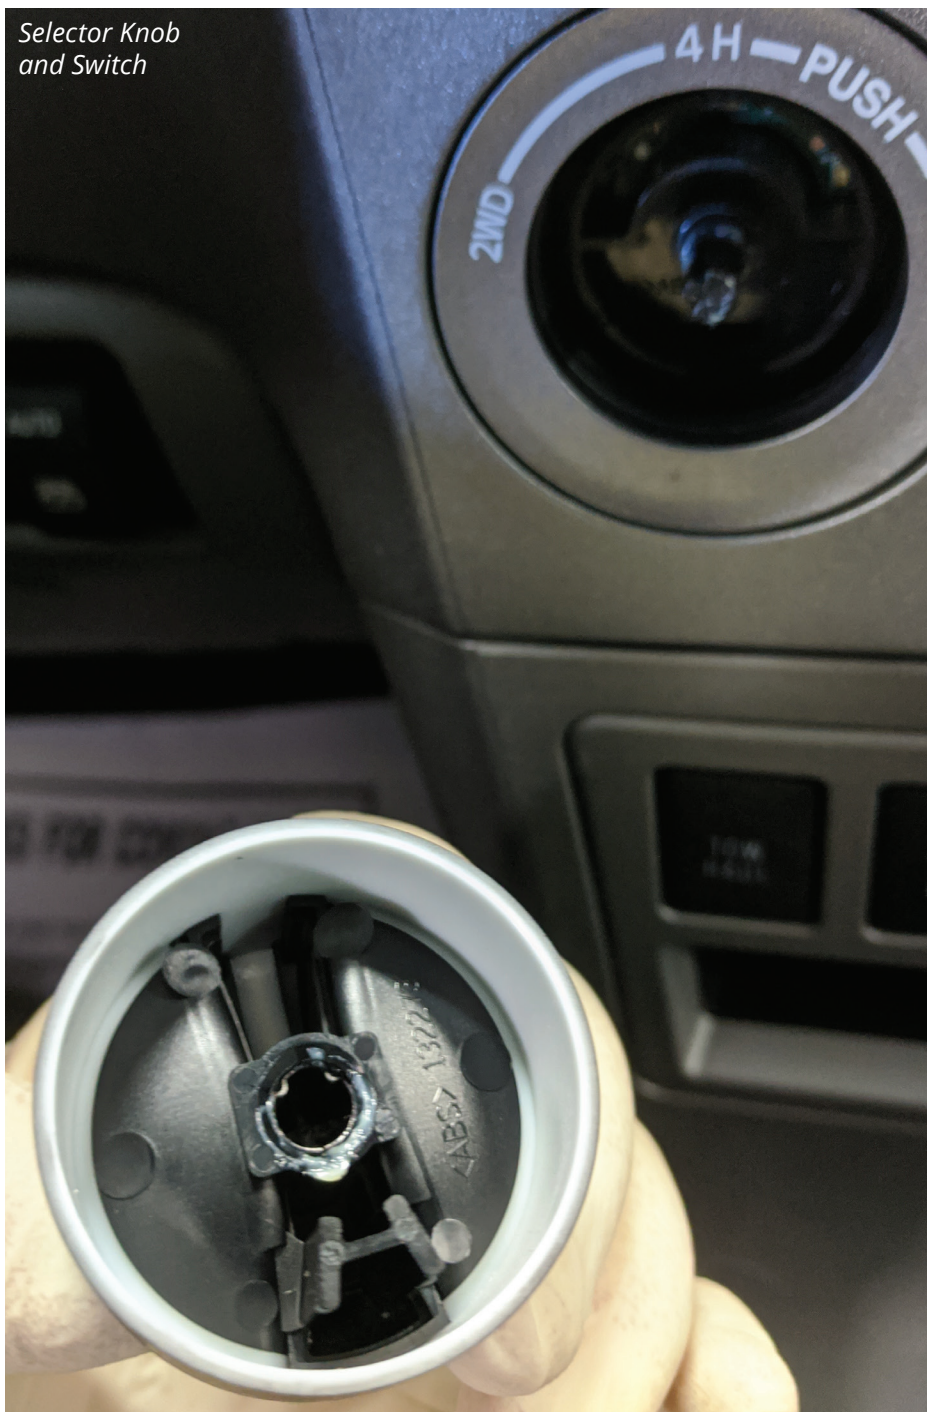
*Selector Knob
and Switch*

With this new information in hand, the technician took a closer look at the 4WD selector knob and discovered it was installed incorrectly. The knob was clocked out of position in such a way that it could turn, but it was not actually moving the switch to the correct positions. He reinstalled the selector knob in the correct position, and normal operation of the 4WD system was restored.

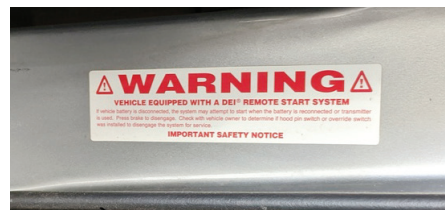
Remote Start System sticker found in the driver's door jamb.

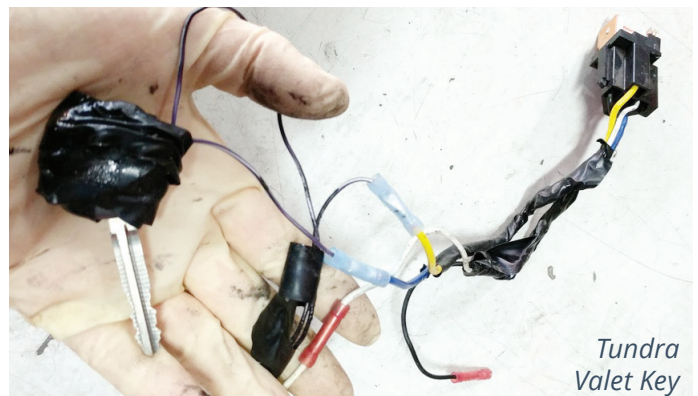
Immobilizer Wiring

With the steering column covers removed, the problem was easily identified. The remote starter wiring was spliced into the immobilizer wires at the ignition switch. When the steering column was moved all the way out, the wires were being pulled tight causing an open connection.

With the remote start system removed, and the damaged wires repaired, the truck started every time, no matter what position the steering column was in.
