TOYOTAtech

The Sad Saga of the 2007 Lexus ES350 and a P0051 AF Sensor Heater Circuit Code

By Edwin French

December 2021

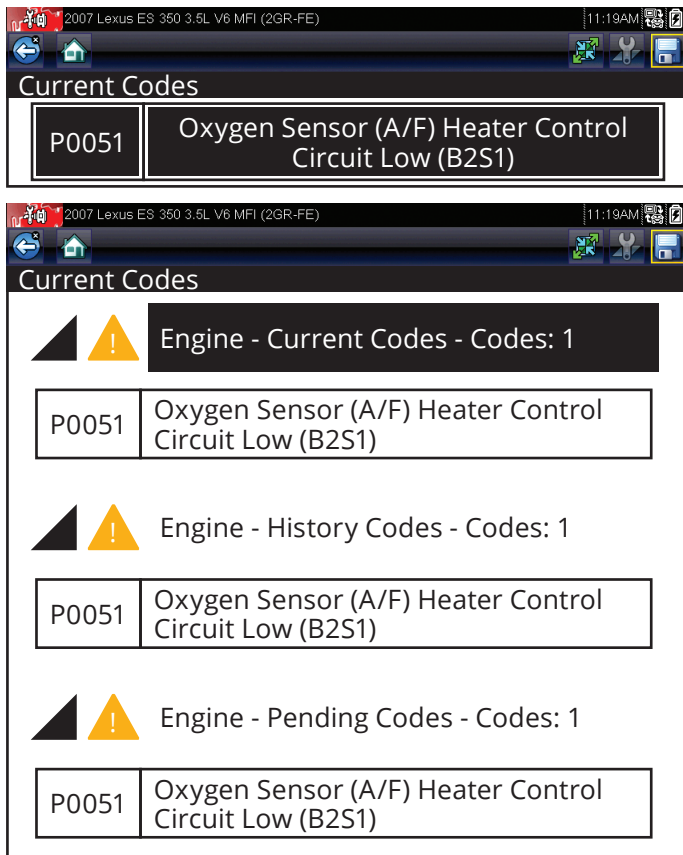
Some months ago, I was called to a shop to assist in the diagnosis of a 2007 Lexus ES350 (Figure 1) with a code P0051, "A/F Sensor Heater Control Circuit Low (B2S1)" (Figure 2). We'll call this shop "Shop B." Another shop, let's call them "Shop A," had installed a used motor but had been unable to diagnose the P0051 that appeared after the engine installation. Shop A then sent the vehicle to Shop B for troubleshooting. Shop B also had difficulty, so they called me.

Figure 2: All modules scan shows A/F sensor heater control circuit code as current, history and pending.

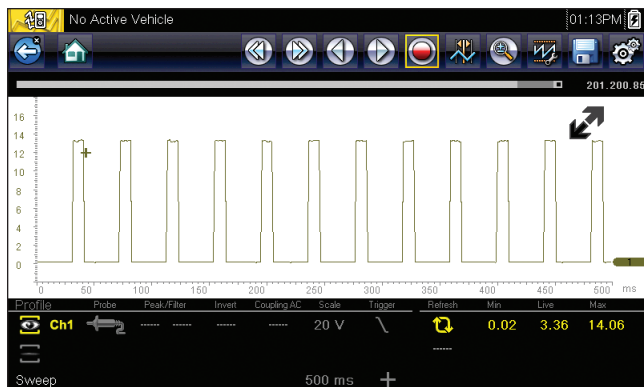
Figure 9: A normal pattern on the A/F sensor heater wire as the ECM controls the temperature by cycling the heater on and off

When the ECM is driving the A/F sensor heater, you'll normally see a square wave on the heater wire from the sensor to the ECM. The B1 sensor waveform pictured is normal (Figure 9), which you'd expect since there isn't a B1 code. B2 on the other hand is just a straight 13.7V line. The ECM wasn't grounding the A/F sensor heater at all on our problem bank.

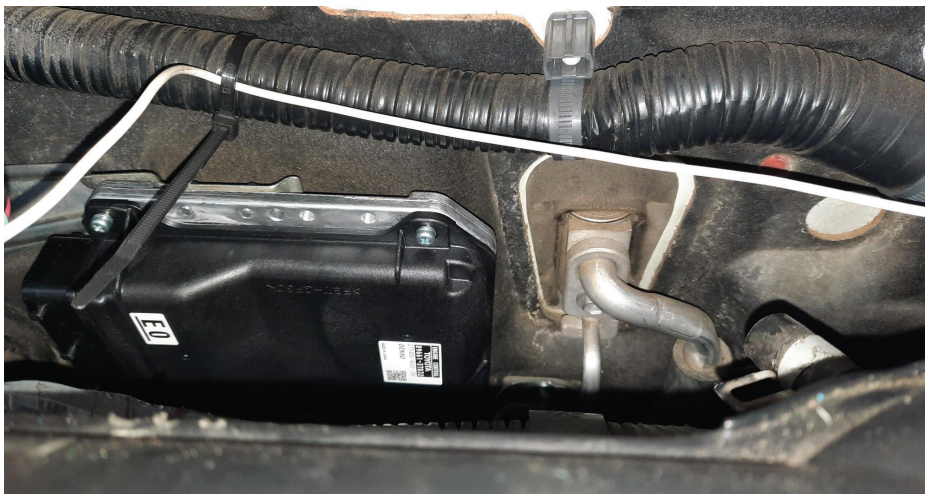
I arrive at Shop D and install the new ECM on the firewall location. As I'm doing so, I notice some replacement wiring that looks familiar. (Figure 10) Before completing the job, I asked the Shop D service writer if the Shop C has requested anything beyond the ECM preparation (which turned out to be nothing more complicated than a VIN write; no anti-theft preparation or tool use necessary with a new OE part.) They said no, so I went ahead with my work.

Figure 10: Replacement OE ECM

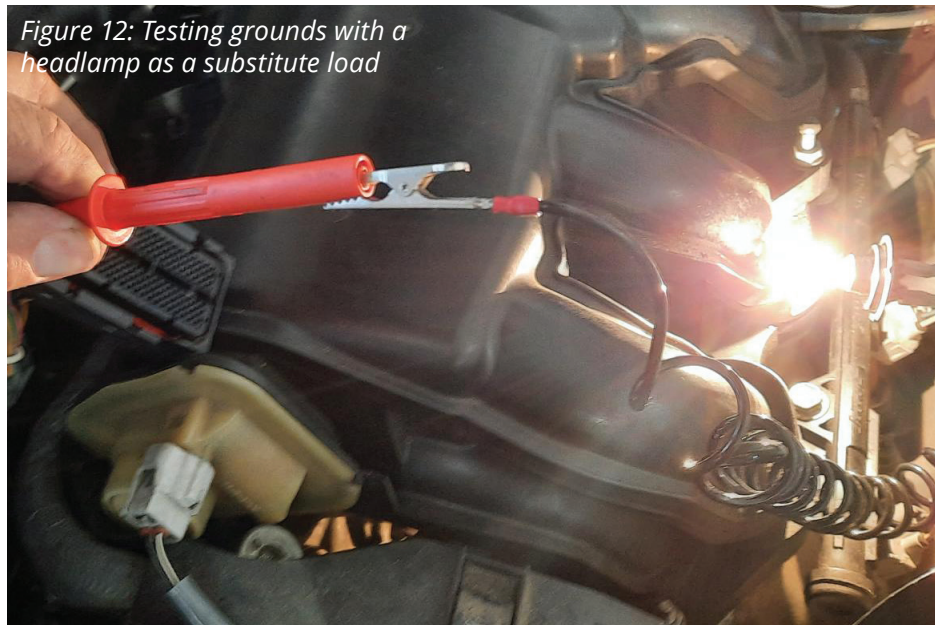
Figure 12: Testing grounds with a headlamp as a substitute load

I work my way down the chart by hooking my test lamp to battery positive and then touching my probe to each of the ground pins at the ECM connector (Figure 12).

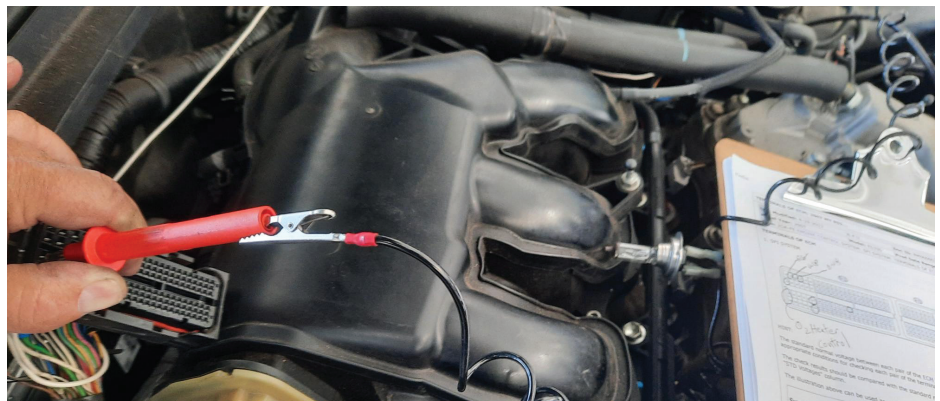
Figure 13: The headlamp doesn't illuminate when checking Pin 46.

This is tedious work, confirming the pins and checking for the lighting of the test lamp, and I'm not spurred on much by my skepticism that this is a waste of time. However, when I get to Pin 46 my test lamp does not light up (Figure 13).

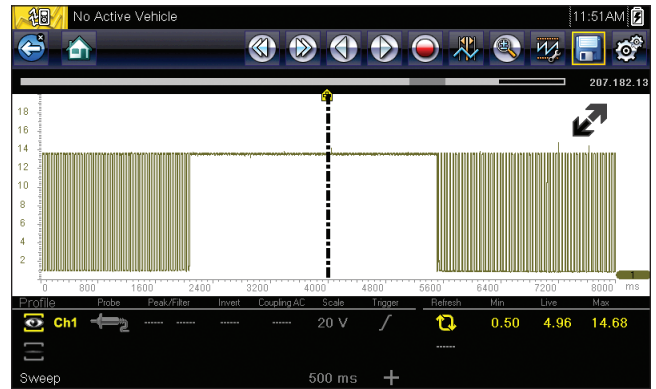
Figure 16: Heater control worked normally with the temporary ground. When removed, it stopped working. When reconnected, it started working again. Proof positive I had found the problem.

When I applied the ground, I at first just started the engine and got a surge of excitement after the second key cycle with no MIL illuminated. But lest I go off track, I hooked up my scope to the control wire on Pin 109 again and fired it up. You can imagine how excited I was when I saw the square wave. Plus, removing the temporary ground caused the duty-cycle to disappear, then reappear when I reconnected the ground (Figure 16).

I had found the problem! Lexus uses a single wire to do nothing else but provide the ground for the B1 A/F sensor heater. It would have been very handy if this had been identified in the diagram provided in the P0051 code description (Figure 17). Regardless, here's the lesson I promised at the start of the article: Before replacing an ECM, find the "Terminals of the ECM" chart on TIS, and check every single ground before getting a new ECM. ■

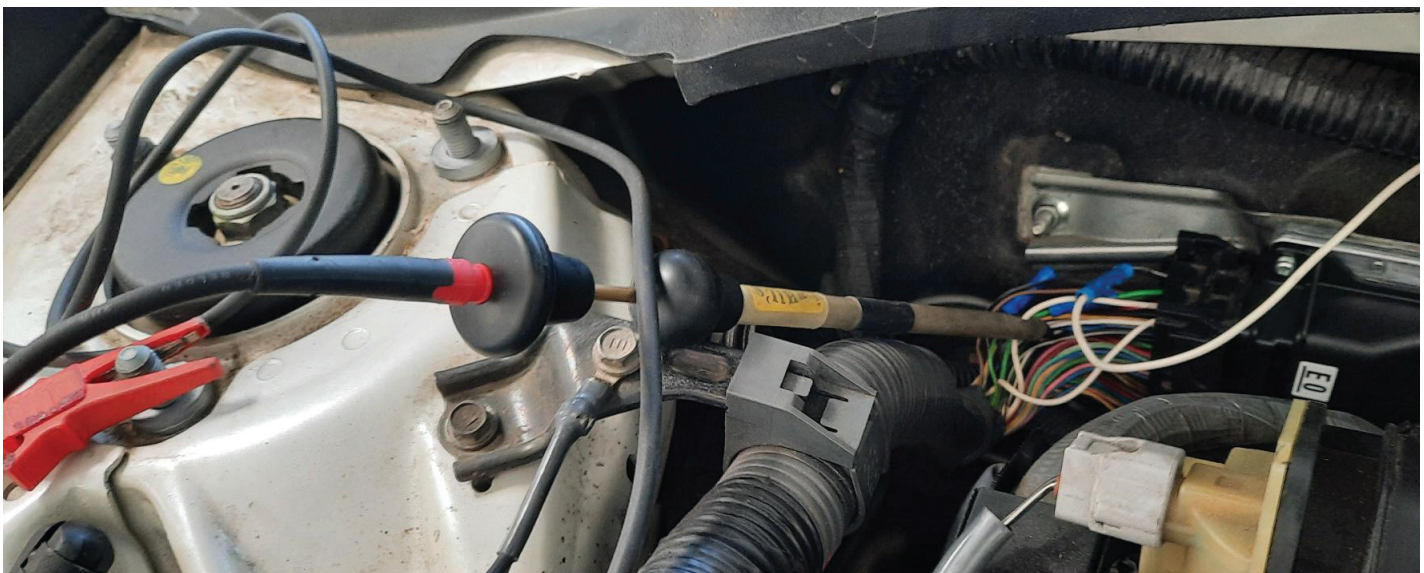
Figure 15: Applying temporary ground with my Phil's Probe. I don't like to flow current through the Phil's Probe as too much will burn off the needles, but I'm going to risk that the pulse width modulation of the sensor will not burn the needles (and it didn't.)

do with my problem? I decide to apply a temporary ground and find out (Figure 15).

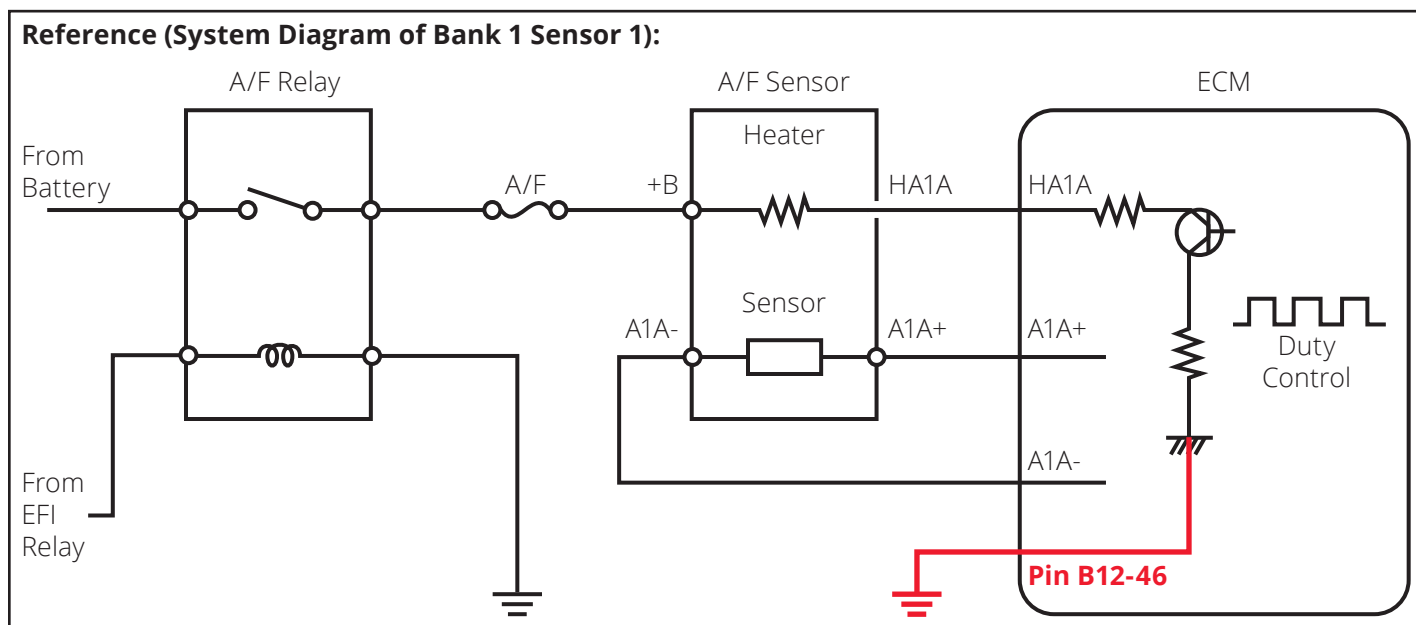
Figure 17: A diagram showing where B2 A/F sensor transistor grounded would have saved me a lot of time
