**SUBARU
BOXER
HYBRID**

Subaru
Cross-Shrek-trek

By Jordan Hill

Multiple faults for several different systems on Subaru Crosstrek requires prioritizing and working through one at a time.

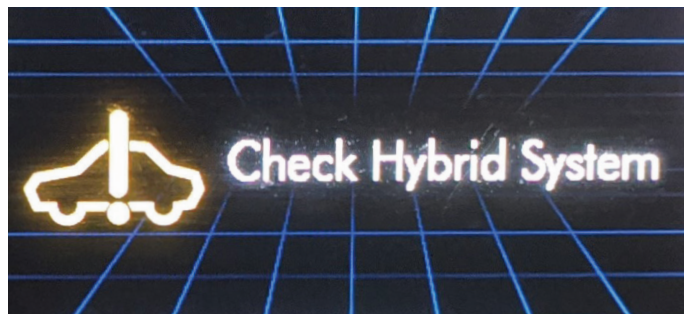
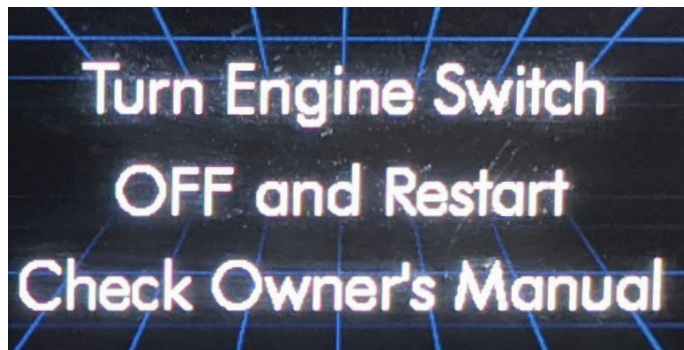
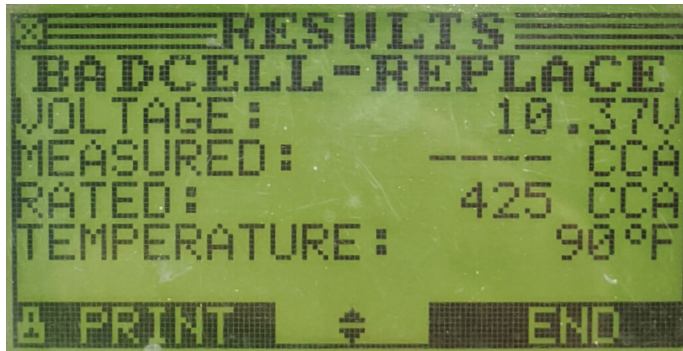
Restart Battery Failed Test

The P1C22 fault stated that the auxiliary battery voltage was low, so the logical place to start was testing both of the under-hood batteries. The auxiliary 12V battery tested OK, but the restart 12V battery on the right side of the engine compartment failed testing with a bad cell.

Despite the code description stating "12V auxiliary Battery Low Voltage," this fault actually referred to the restart battery. This was most likely due to a discrepancy with the aftermarket scan tool being used. After calling a few of our local distributors, it

was clear that this battery was going to have to come from Subaru. The dealership was called and we were stunned to find out the price of this little battery — over \$700! Once the sticker shock wore off, the battery was ordered and installed.

There were several important installation notes for this battery listed in the replacement procedure. The battery sensor located on the negative terminal needs to be disconnected briefly to reset the learned memory. Furthermore, after the battery is installed, the ignition needs to be turned on for at least ten seconds before starting the engine and the brake pedal needs to be released. This allows for two things to occur: the initial testing of the electronic throttle valve and position learning of the brake pedal stroke sensor.

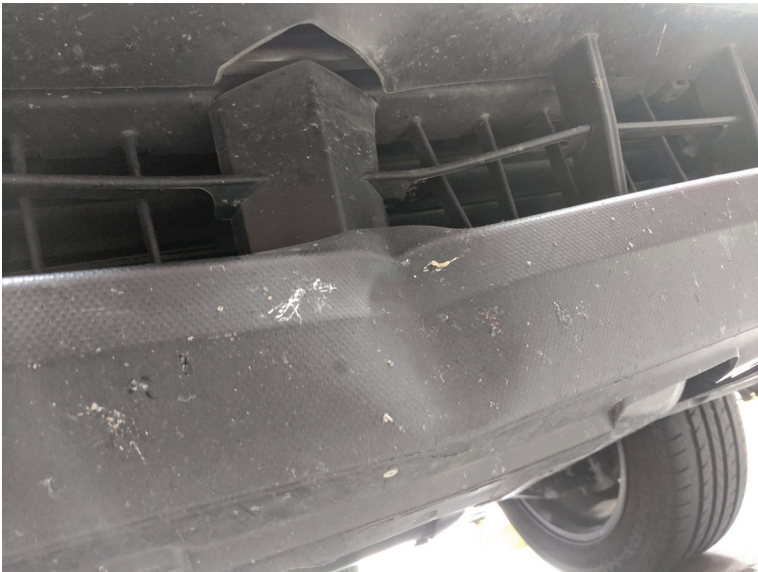
Front End Damage

After looking at the communication fault codes in the hybrid control module, it was clear that they were all related to the LIN bus that the grille shutter was on. A visual inspection of the active grille shutter revealed damage to the bumper and grille shutter. The owner of the vehicle confirmed that road debris had hit the front of her vehicle while driving on the freeway. The front bumper had been pushed back into the grille. This is one disadvantage of the active grille shutter; it is easily damaged by any type of front end collision.

The damage to the active grille had affected the LIN bus signals, causing all the communication faults along with the fault in the engine control module. The new grille shutter was ordered and installed. After clearing the fault codes, the Picoscope was connected and the LIN bus decoder (built into the software) was used to verify that the network was communicating correctly now. Serial decoding using a lab scope is a powerful tool that can quickly determine if all the data packets on a data bus are correct. With the new grille shutter connected, all the data packets on this Crosstrek's LIN bus decoded correctly, so layer two was now diagnosed and repaired.
