Technical Knowledge for Volkswagen[®], Audi[®]
and Porsche[®] Service Professionals

2013 PORSCHE CAYENNE ALARM FAULT

A Porsche Cayenne owner offers an interesting story about the 2013 model that seemingly has a mind of its own when it rains or is washed.

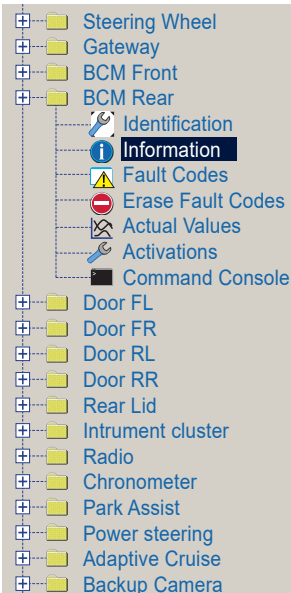
Information BCM Rear

The VIN and Hardware with software version are indicated with the image named "Information BCM Rear."

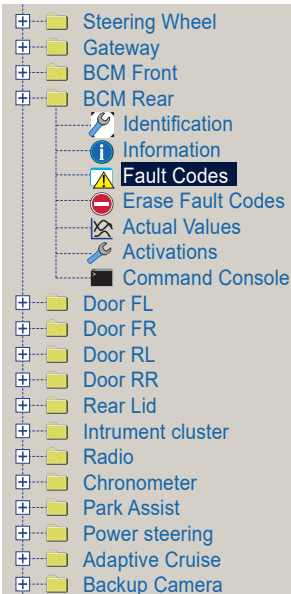
Final Fault Recording

Remember, just before the initial scan, the alarm did not operate and we tested that theory again after the BCM Rear fault was deleted. That BCM Rear fault immediately reappeared.

The information provided by Durametric should help identify the BCM Rear if required. One last test identifies a repeating LIN Alarm fault. (See "Final Fault Recording," next page.)

3281471/32123F
	Warning Indicator Off
	Test Completed This Monitoring Cycle
	Test Failed Since Last Clear
	Test Not Completed Since Last Clear
	Pending DTC
	Test Failed This Operation Cycle
	Fault Active

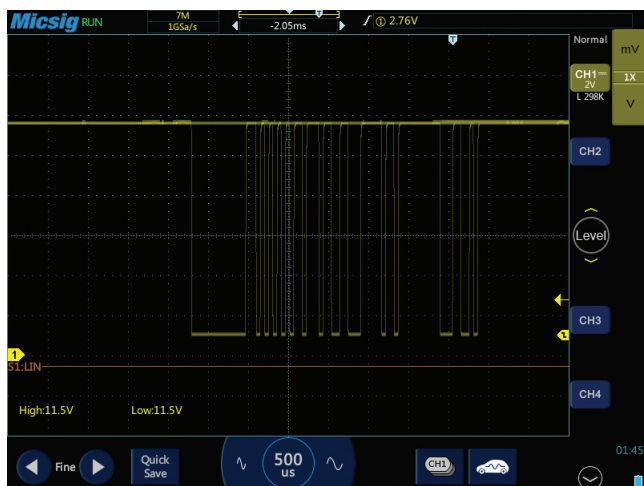
LIN Message

The last test is to trigger the alarm and test for faults before reassembly. The image and wiring connections of the LIN alarm will match a properly published schematic. The bottom black wire is the LIN connection and can be easily back-probed. The image "LIN Message" will indicate a clean and stable message structure.

messages with the original module appeared corrupted and highly extended.

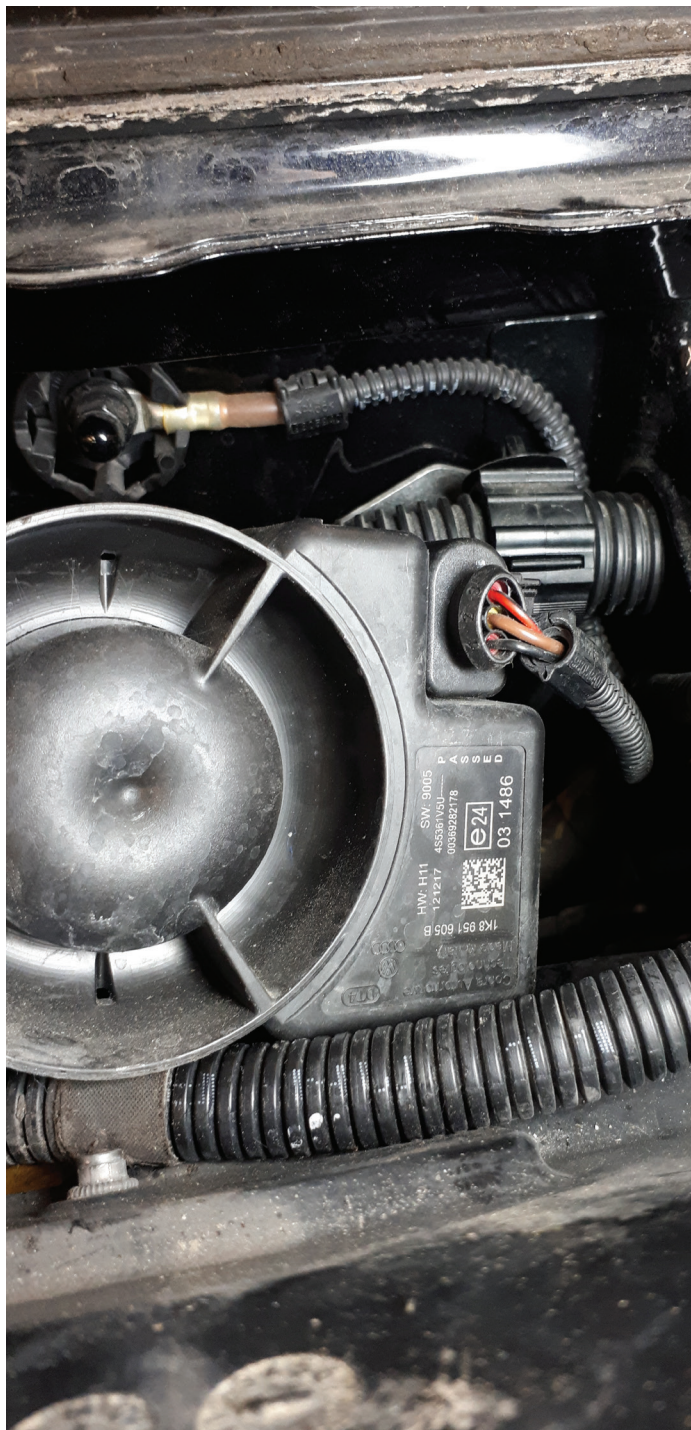
Original LIN Alarm: With the correct tools and some patience, the original LIN module was removed and the replacement installed. Follow the instructions within the document but at least test the LIN messages with an oscilloscope.

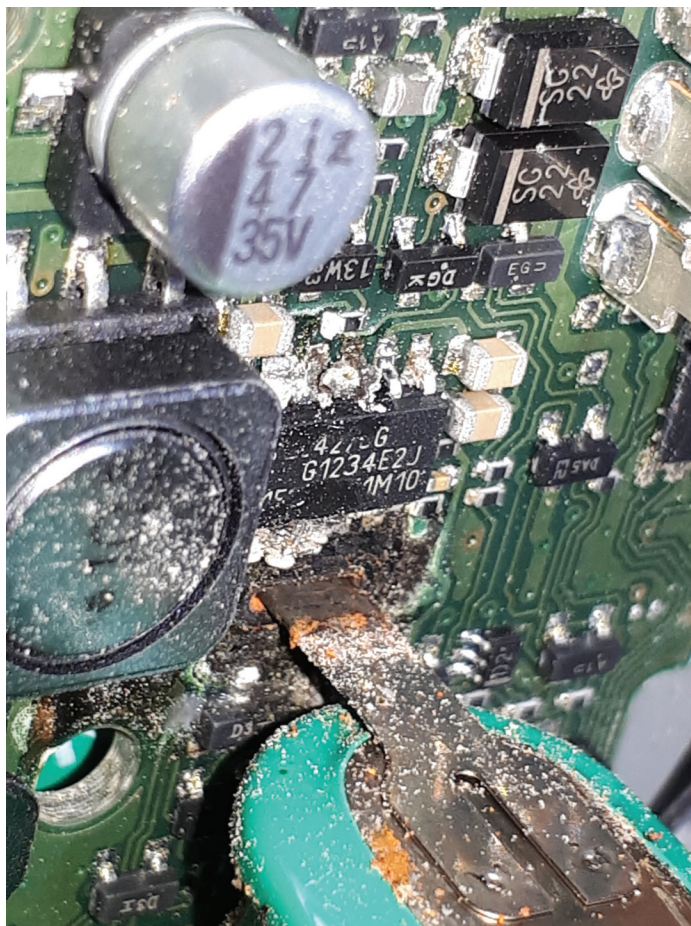
Burned circuit 1

A close inspection of the LIN alarm does not indicate a water leak, while the piezo speaker is sealed with no oxidization. It seems humidity is the cause of alarm

activity. The powdered substance appears to not originate from the battery but from the burning IC's circuit board and melted solder.

Call it the "micro big bang theory." The battery leg may have arced.

A battery solder point melted, but a close inspection indicates that one of the ICs also failed and melted. That major failure melted/arced one of the battery solder points. The combination destroyed the IC board and surrounding circuitry and traces. Refer it to a cascading failure.

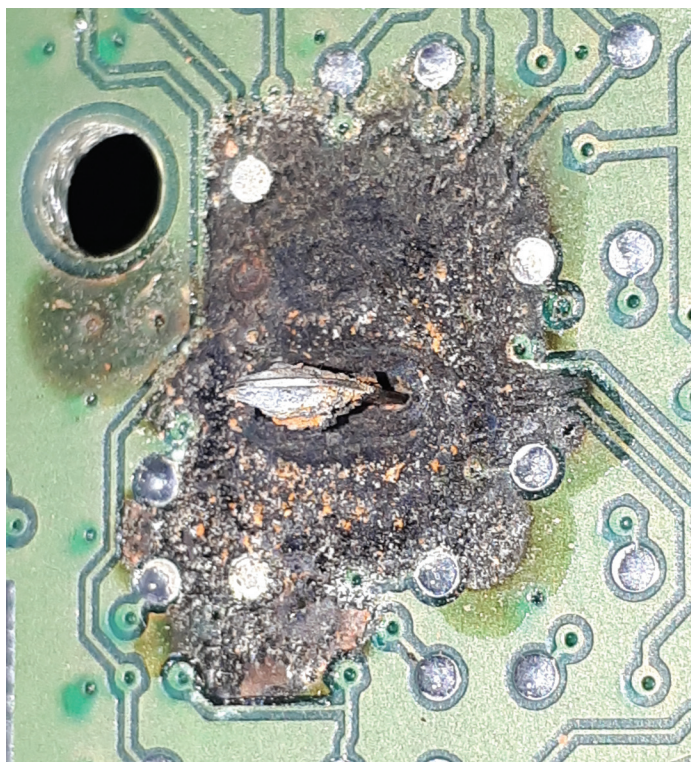
Burned circuit 2

The battery was de-soldered and wiped of all debris, indicating no leakage.

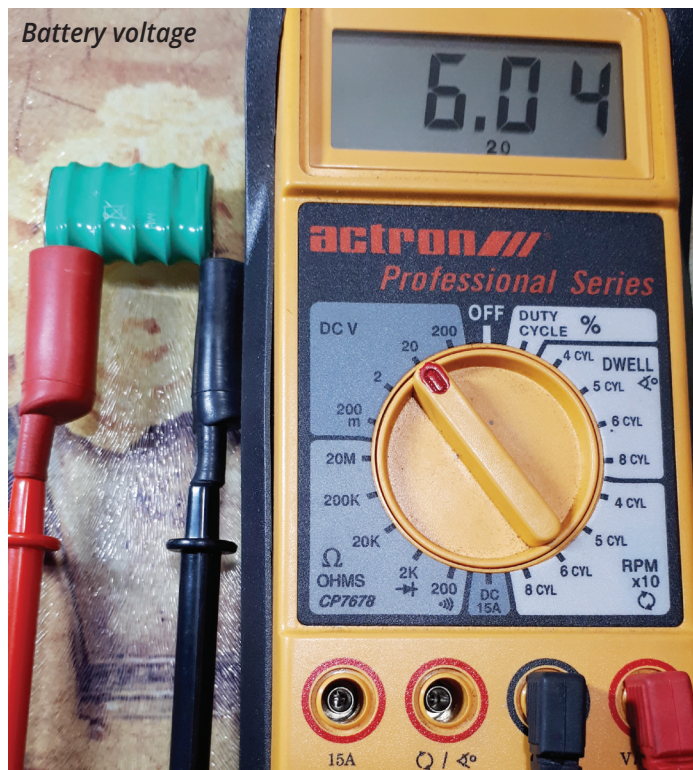
Battery voltage

The NiMH battery was tested as normal and actually accepted a charge. The battery drove up some 5 volt hobby motors, was recharged, and held a charge. This rechargeable battery will be put to future use to drive up some 5 volt devices. ■
