## Mercedes-Benz Service Bulletins

A few service bulletins that might affect your customer's vehicle

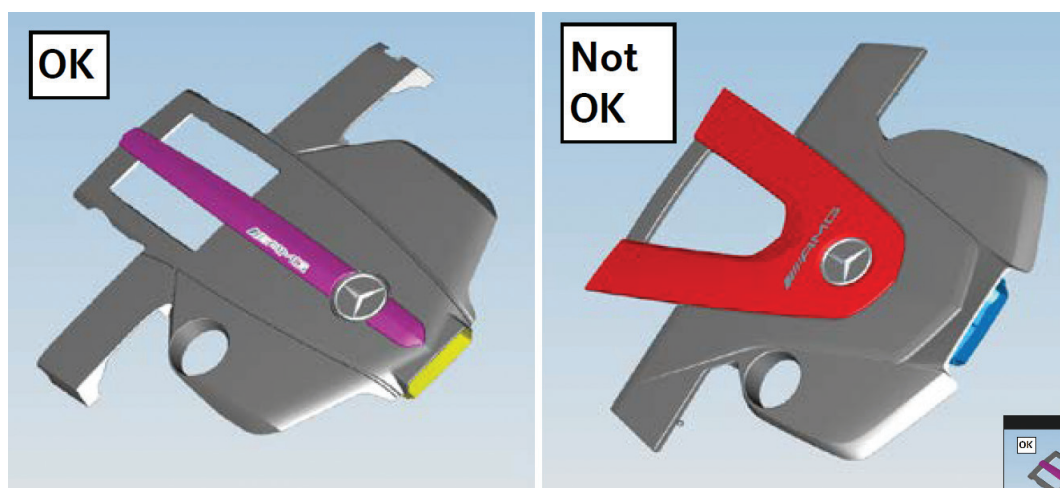
1. Certain 2017 AMG GLE models (166, 292 chassis) with Code 494 (US Version): Check that the correct engine cover (A276 010 87 12) is installed. Any vehicle with the incorrect cover should visit an Authorized

Mercedes-Benz dealer for a free replacement cover (SC 2017120008, work instruction code 1709P58C30).
