# TOUAREG TECH ASSIST SOMEONE TO LEAN ON

One such tech line call involved a 2014 Touareg R-Line equipped with the 3 liter turbo diesel powerplant. The owner of the MPV reported an issue with the console display. He stated that the information console would cut in and out randomly with the screen going dark and then turning back on. This had been going on for a couple of weeks and had been getting significantly worse.

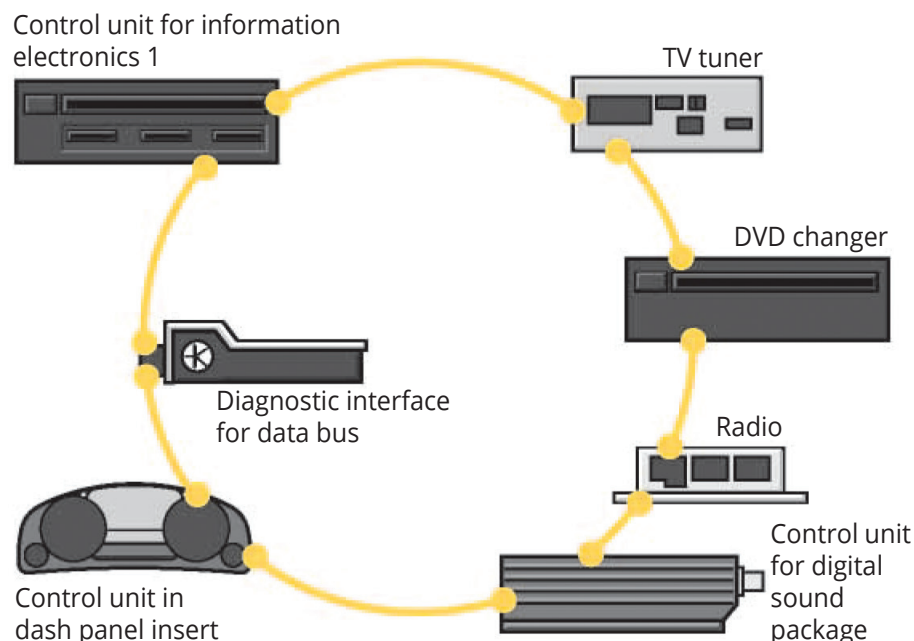
### MOST bus in Touareg 2011

Robert's findings lined up with the service information. All of the modules that were unavailable on the Gateway List were part of the MOST communication bus. Media-Oriented Systems Transport, or MOST, is a high speed fiber optic network used primarily, as the name implies, for multimedia systems.

On this 2014 Volkswagen, the MOST network consisted of the Radio, Instrument Cluster, Information Electronics Control Module, and the Data Bus On-Board Diagnostic Interface (also referred to as the CAN Gateway). The network is set up in a ring or loop where each module is connected to the next and ends back at the master module.

*Example MOST Bus Layout (optional modules shown, courtesy Volkswagen)*

The main clues for condemning the 5F module were the MOST bus layout and the Gateway Installation List results. The order in the Optical Diagnostic Test screen of VCDS reflects the order in which the fiber optic bus loop is in. The bus starts with the CAN Gateway as the MOST master, followed by the Information Electronics, Instrument Panel, and finally the radio. Based on the loop order, the 5F module is causing the issues because it is next in line after the CAN Gateway.

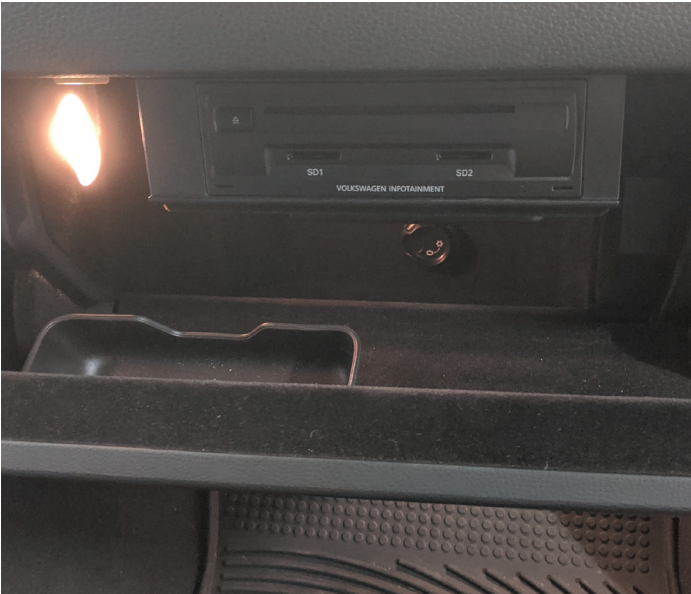
5F Module Location

Located in the glove compartment, the 5F module has many responsibilities. The controller manages the GPS, telephone, and Bluetooth functions, as well as the screen and video processes. It also has a DVD/CD-ROM drive, SD-card readers, and an internal hard disk.

The Installation List results show that the CAN Gateway is online, but the next module on the MOST bus, the 5F module, is not communicating, and therefore the other modules downstream cannot be reached. The 5F module is also the module in control of video and imaging processes, so when the module acts up it causes the display screen to go black for a few moments.

All the power and grounds were good to the module and all the connectors were securely in place. The 5F module was going to need to be replaced.

Next up, it was time to test the powers and grounds to the 5F module, which meant removing it from the glove compartment to access the connectors on the back of the controller. In order to remove the module, Radio Removal tool T10057 is required. There are two release slots in the front of the unit where you insert the removal tools.
