TechNews

Running Out of Time

Diagnosing an Infiniti Q50 Timing Problem

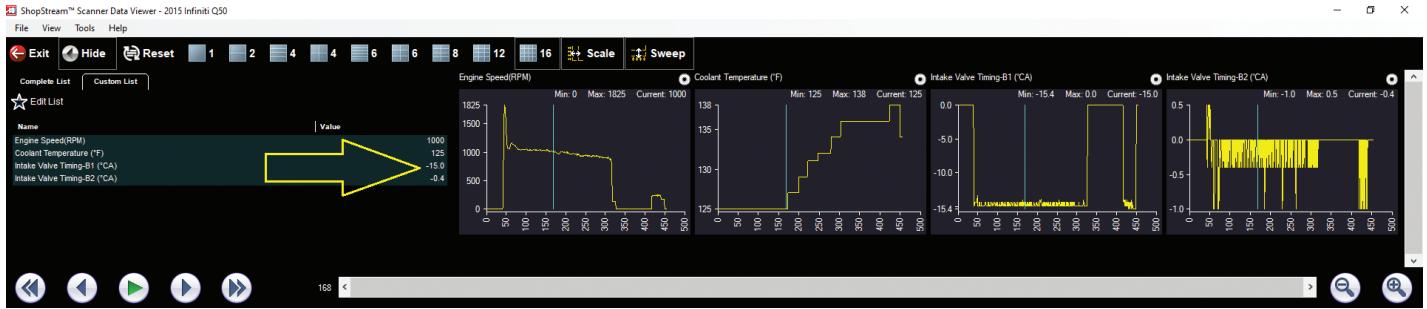
Camshaft timing scan data

At this point however, there was still a diagnosis to be performed on the P0011 DTC. Now that the oil level was correct and the horrible engine noise was gone, a road test was performed while capturing relevant data PIDs. After reviewing and saving the DTC and freeze frame data the code was cleared KOEO. It was discovered that within a very short period of time after startup the code would reset and all camshaft control would cease. However, the camshafts were controlled for a moment by being advanced, and then returned to a rest position of zero degree offset. At this point the Bank 1 camshaft would actually drop to -15 degrees, while the Bank 2 camshaft stayed right around 0 degrees.

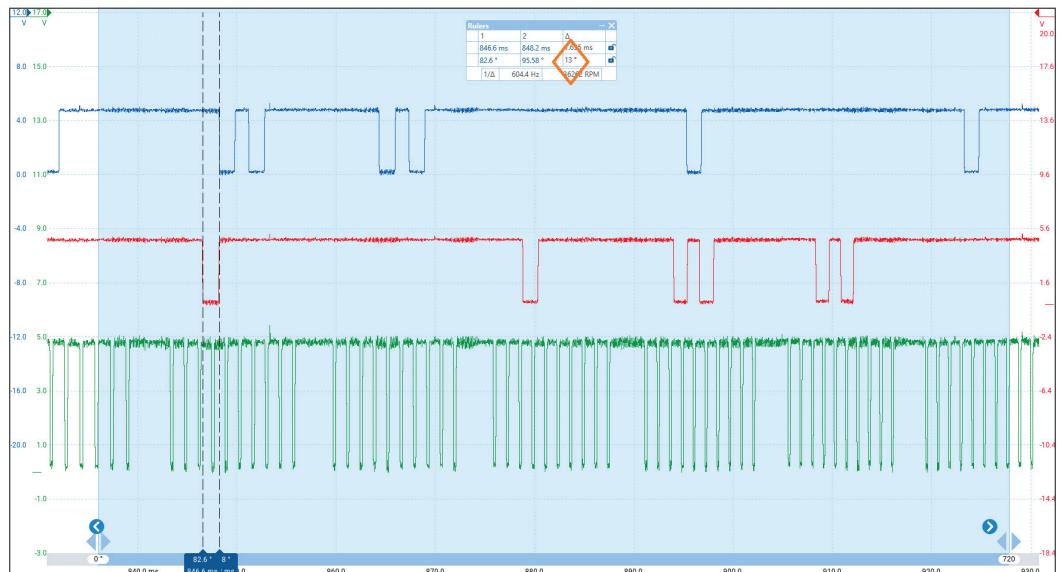
Cam crank waveform zoom

Using Picoscope's zoom and ruler functions and comparing to the known good example, it was clear that the Bank 1 camshaft was off by about 13 degrees. This confirmed what the scan tool data was showing and why the fault code was setting. Using the cam and crank signals for comparison in this way is a powerful method of 'seeing' inside an engine before tearing it down. When disassembling an engine it is best to know ahead of time what to be looking for; exploratory tear downs can lead to guessing and unnecessary repairs.

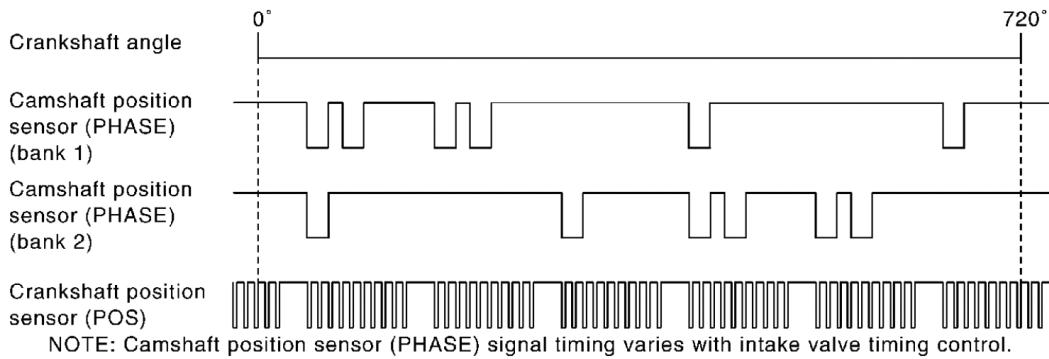
Cam crank waveform - Nissan service information

the diagram, the leading edges of the Bank 1 and Bank 2 camshaft signals should line up with each other vertically, although they are offset by one cycle. Where the Bank 1 signal starts with two double pulses followed by two single pulses, Bank 2 displays the opposite pattern.

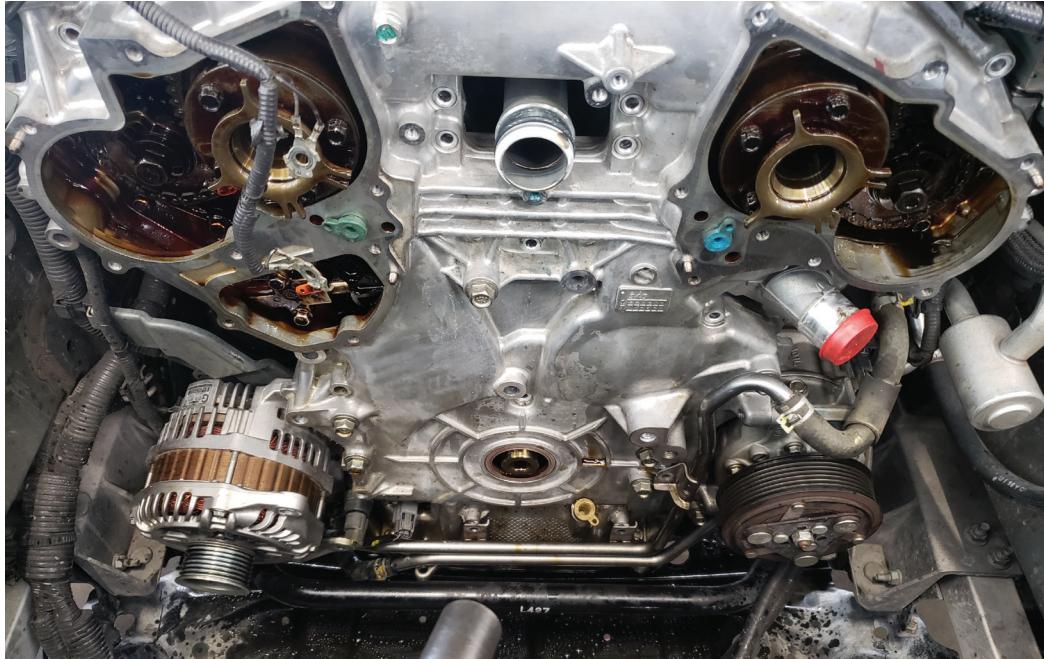
VQ37VHR engine tear down

to remove the front covers and check the timing chain alignment marks. The cooling fans and front accessories needed to be removed first followed by the timing control covers. The lower section of the oil pan also needed to be removed to access the two upper oil pan bolts that thread into the timing cover. All the remaining bolts that hold the timing cover in place were removed next and the cover was carefully pried free from the engine block. Great care must be taken when removing the timing cover to not damage the sealing surfaces.

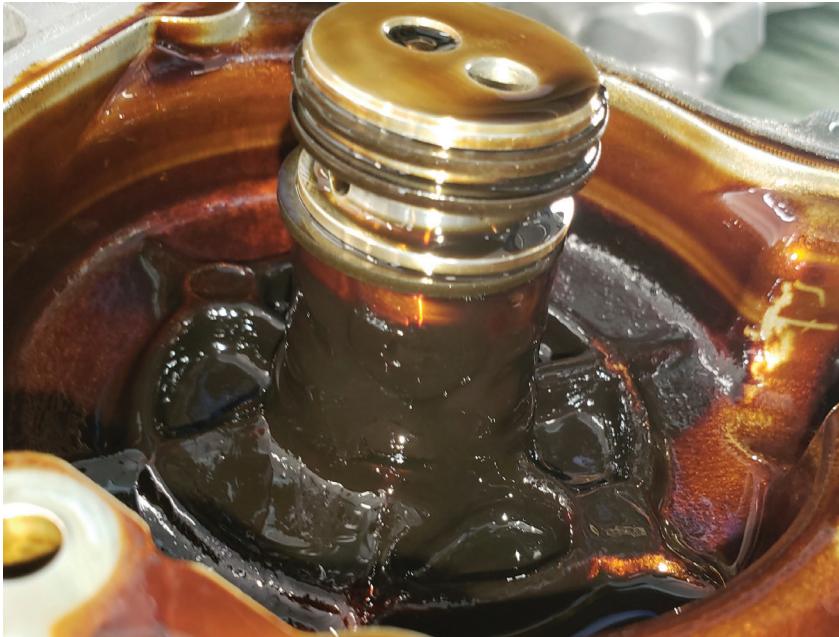
The engine position sensors had already been verified with the lab scope testing. Each of the control solenoid valves were bench tested and found to be working correctly. There was some sludge build up under the timing cover. While it did not appear to be excessive enough for the oil passages to be restricted, the components and passageways were cleaned. That left the signal target wheel as the most likely cause of the cam position fault.

Buildup on timing control cover

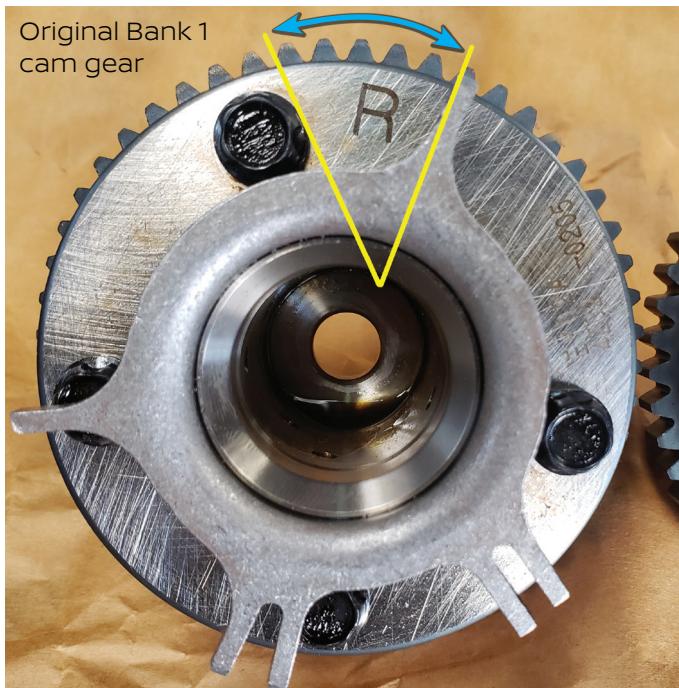
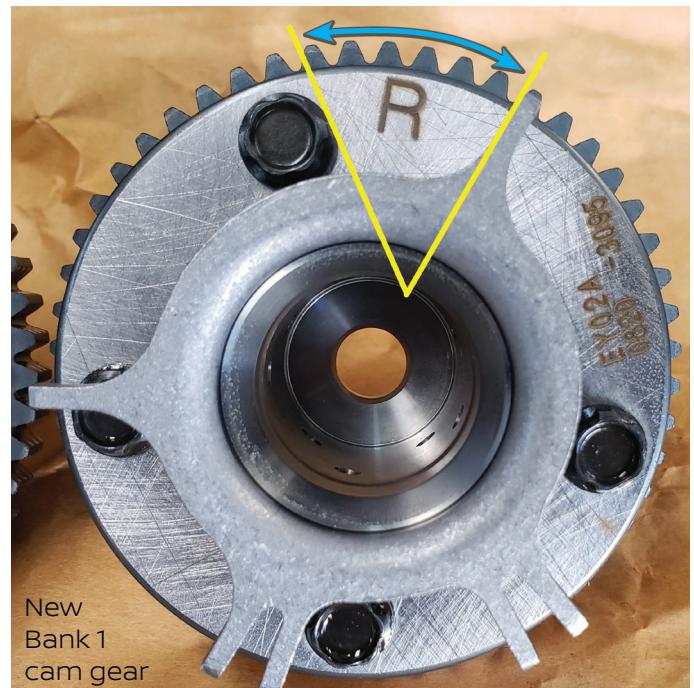
target wheel was definitely shifted on the old gear. With the sprockets side by side, it was clear that the target wheel had moved counterclockwise about one tooth. This could be further proven by counting the teeth of the cam sprocket and using some basic mathematics.

The cam sprocket has 52 teeth. Dividing the 360 degrees of a circle by 52 teeth equals 6.923 degrees of rotation per tooth of the cam sprocket. Now double that number to 13.846 degrees to get the crankshaft rotation degrees due to the camshaft turning at half the speed of the crank. The resulting number is very close to the lab scope and scan tool readings of the Bank 1 intake camshaft being 13 - 15° retarded in relation to the crankshaft.

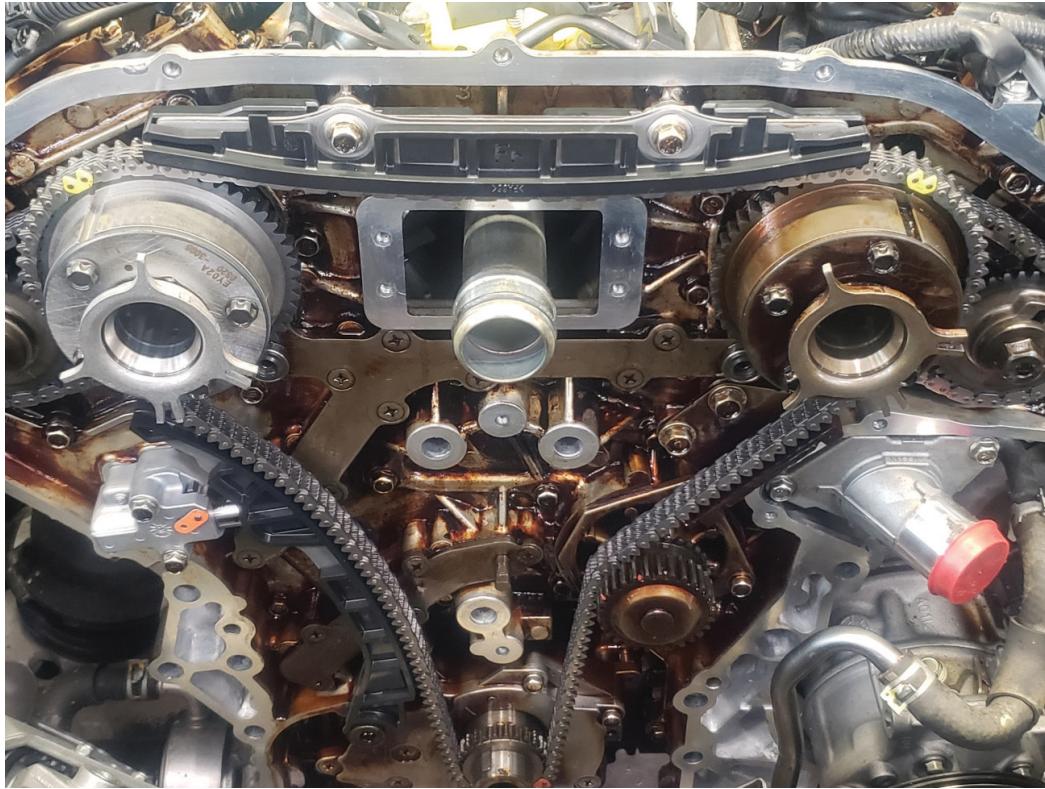
New timing chains and intake cam gear

The VQ37 engine was reassembled with new chains, guides, tensioners, and the new intake cam gear. After carefully cleaning the old liquid gasket from the mating surfaces of the engine block and timing cover, a 3.5 mm bead of silicone RTV gasket maker was applied. The timing cover was reinstalled and properly torqued. Then the oil was changed, adaptations reset, and the code cleared.

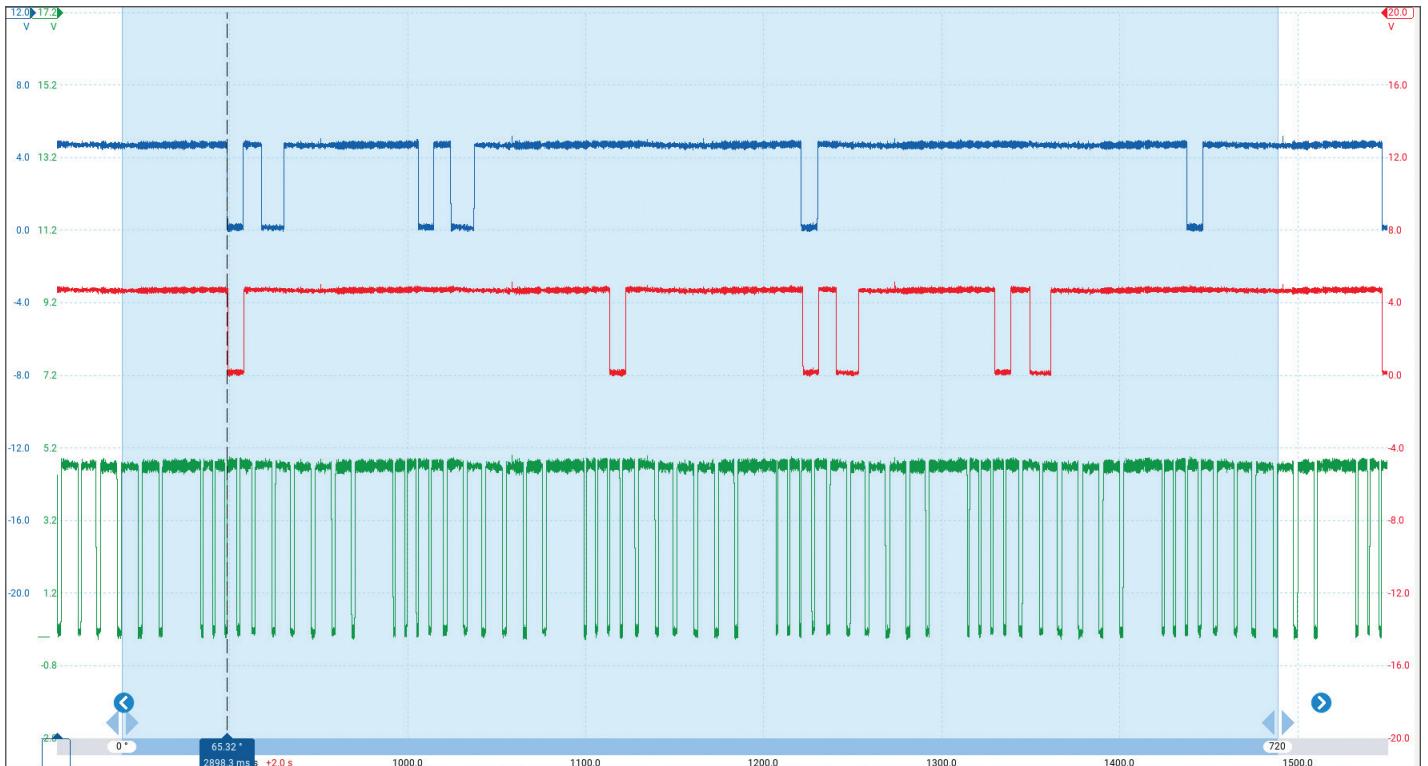
on the drive and the Q50 was running beautifully. Back at the shop a follow up cam crank waveform was captured and analyzed. Now the camshaft

signals lined up with each other just as service information indicated they should.

Post repair waveform
