TOYOTAtech

Diagnosing Prius Hybrid Battery Pack

Sometimes They Come Back...

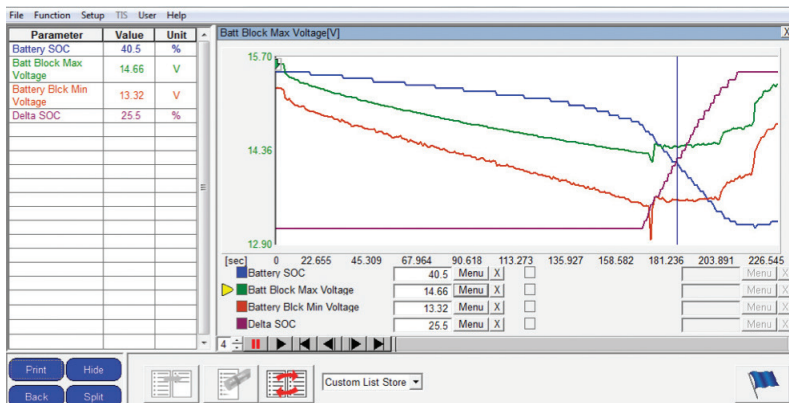
High Voltage Battery Test

As the SOC decreased, the Delta State of Charge began to rise and the disparity between Battery Block Minimum and Maximum voltages rose as well.

Delta SOC% is the difference in state of charge between the highest and lowest blocks and should read 0% on the Gen 2 Prius and all later Toyota hybrids. The Min. and Max. Voltages are typically within 300 – 400 millivolts of each other on a good battery pack.

The fact that the difference between the minimum and maximum block voltages was about 1.4V, and that the Delta SOC% began climbing during testing, confirmed the battery was bad. Jim documented his findings for the front office so they could create an estimate and get approval.

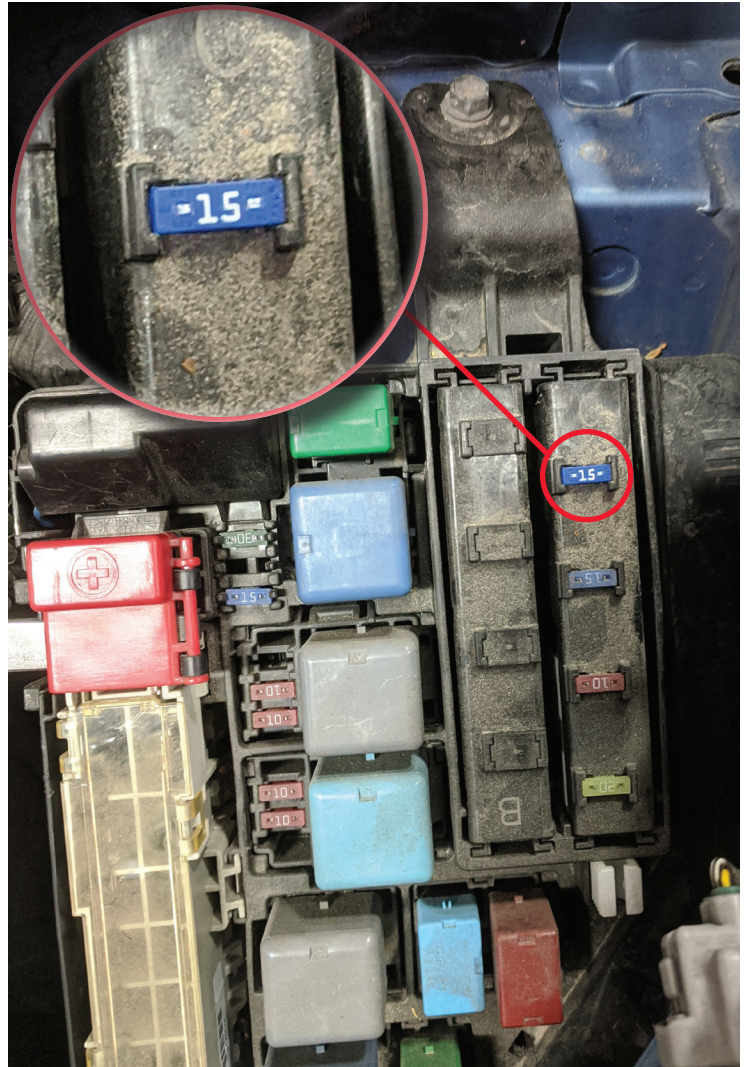
15 AMP EFI Fuse

Even though he was flustered, Jim started by checking the basics. He went through all the fuses in the under-hood power junction block and the in-dash fuse panel. Checking the basics first paid off! The 15 Amp EFI fuse was blown.

Jim installed a new fuse and started the Prius. This time the ICE started up after a few moments and the new battery pack began charging. While he was glad the engine was starting and the fuse had not blown again, he still needed to figure out what was going on. He couldn't release the Prius just to have it come back again.

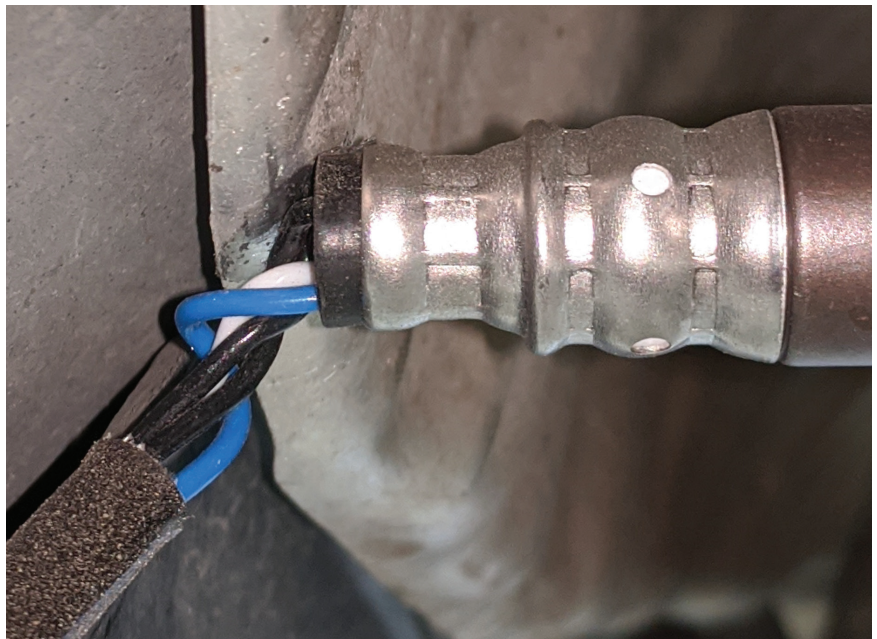
Downstream Oxygen Sensor

With bated breath Jim set the lift arms under the Prius and raised it up into the air. Once the vehicle was all the way up, he inspected the downstream oxygen sensor and found exactly what he was hoping to see. The wiring for the O₂ sensor was rubbing on the underbody heat shield. The aftermarket catalytic

converter had been poorly installed and set too far to the right so the wiring was pressed up against the sheet metal.

The cause of the blown EFI fuse was identified and thankfully, it was unrelated to the hybrid battery installation. Jim applied liquid electrical sealant to the wire and removed a small section of the heat shield to prevent the harness from rubbing again. The best repair would be to install an OE catalytic converter, but this would do for now. The repair was explained to the owner and in the end, he was grateful to have his Prius back road worthy again. ■

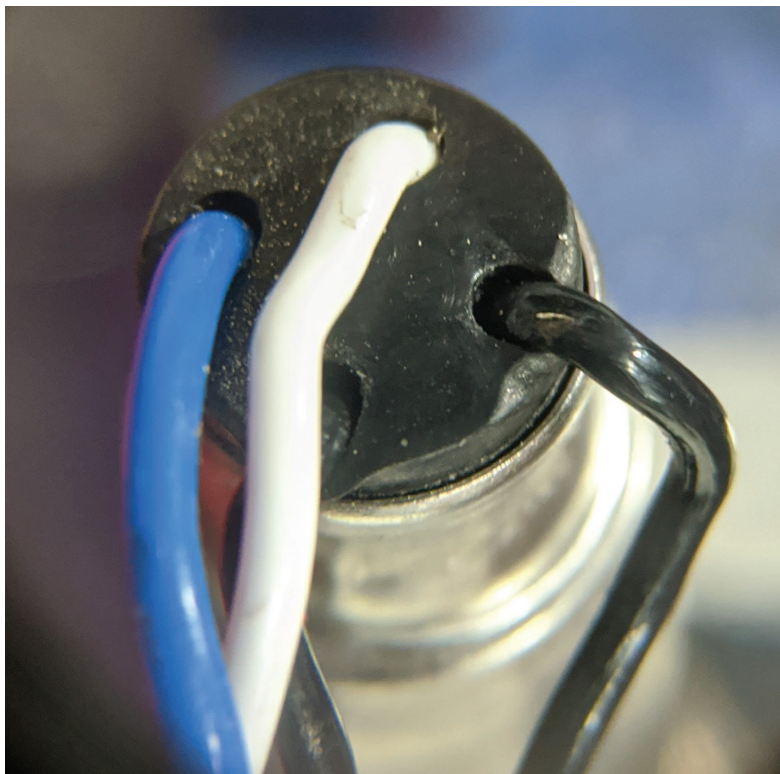
Wiring Damage

With the oxygen sensor removed, Jim checked the wiring harness. At first, there was no obvious exposed wire. Ultimately, he needed some magnification to see the tiny bare spot of copper, but it was there. That tiny bare spot of wire that caused so much turmoil.
