IMPORT SERVICE

Troubleshooting a Hyundai Tucson No Start with Variable Valve Timing (VVT)

by Agostino (Augie) Ferron

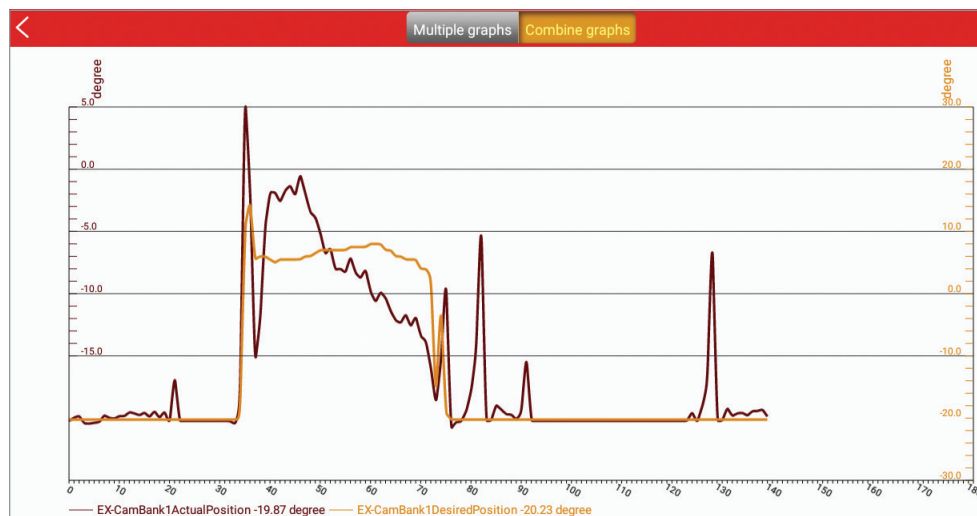
Correlation 1

Within the service bay conditions, it was quite obvious the intake cam was operating normally, but the exhaust cam definitely exhibited the incorrect position in degrees between the actual and desired angles. At idle or under load in gear, the expectation should be close between the two and should follow. This engine varied the angles between 1.67 and 2.24 degrees at idle. It would appear the timing chain is stretched or the VVT mechanism is damaged.

Each spike within the graph indicates a slight throttle burst while also held under slight load in gear. In other words, both angles should follow each other with slight load.

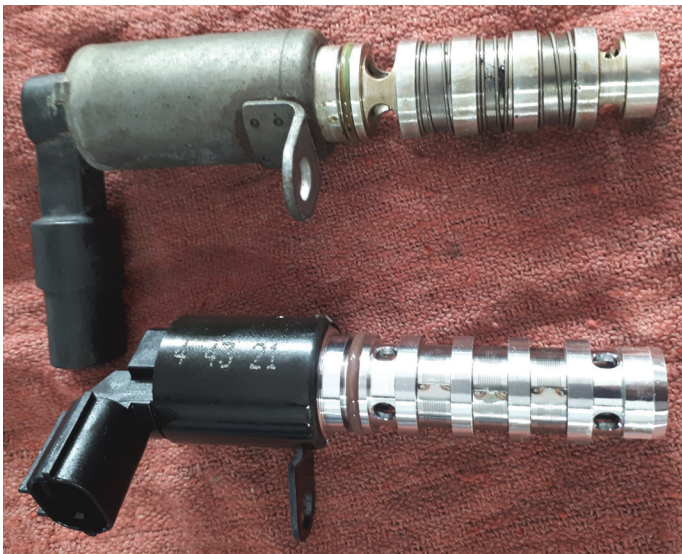
Wrong part

The incorrect aftermarket part was sent. The fastening bracket was not in the correct position, the solenoid was too short, and the connection to the harness did not fit.

The replacement component had to be reordered and, in the meantime, the original was reinstalled to get it out of the bay. It would appear that the incorrect part was in the box that matched the aftermarket listing.

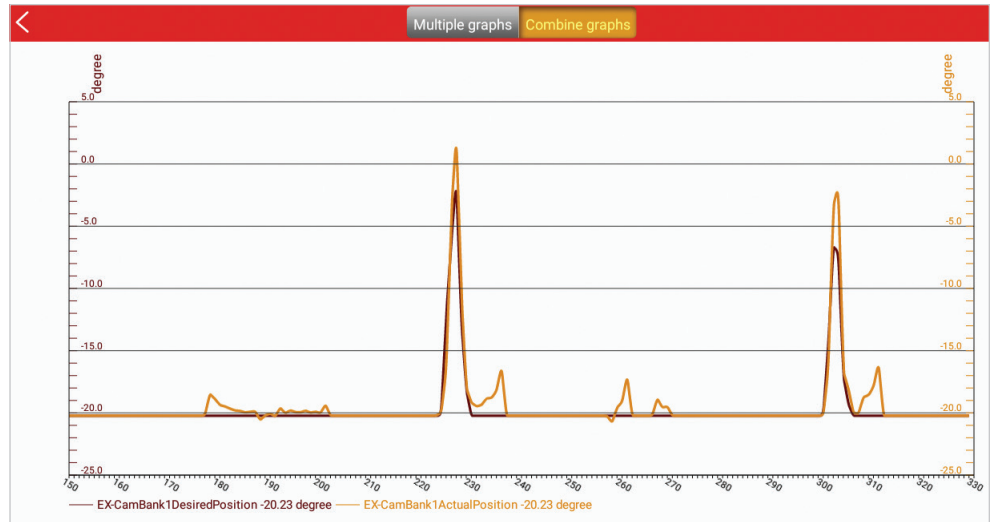
New test

The image “New test” indicates that the engine management system recognizes the desired and

actual position in degrees following each other while in the service bay.

No noticeable noise was recognized at the knock sensor data.

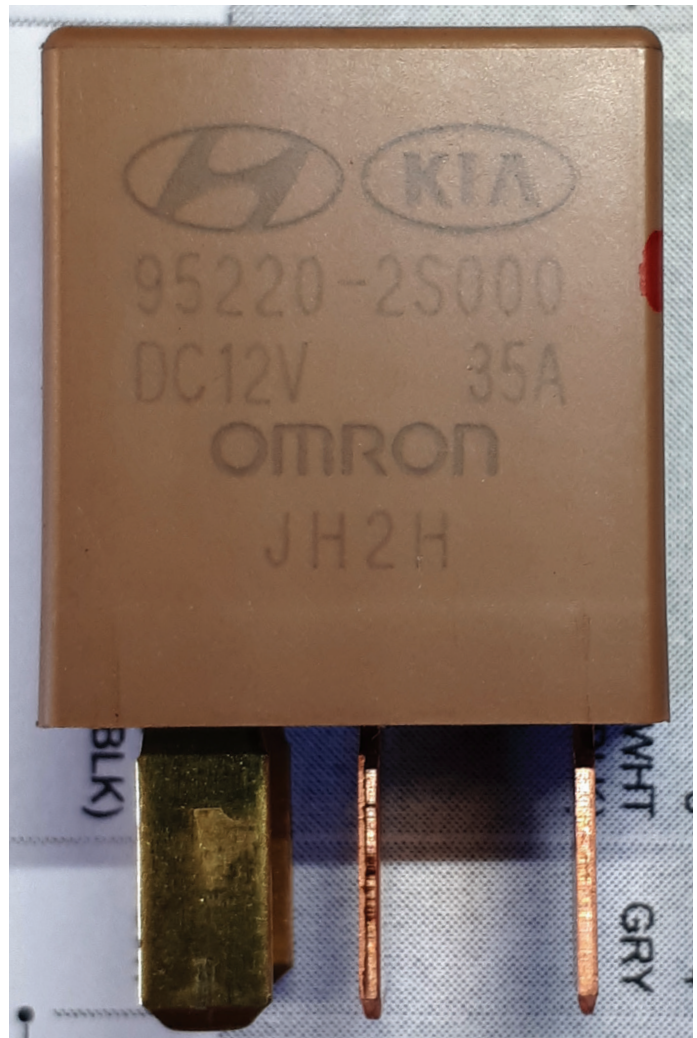
Start relay

Armed with a schematic, the starter relay was found and oddly, when moving the relay in its mount, the starter would engage with the ignition key removed.

Circled in red is the temporary relay taken from a scrap BMW. A new Hyundai relay was ordered because of its amperage rating.

Required is a 35 amp version; the BMW is only 20 amps. It is temporary because the original was not trusted any longer.

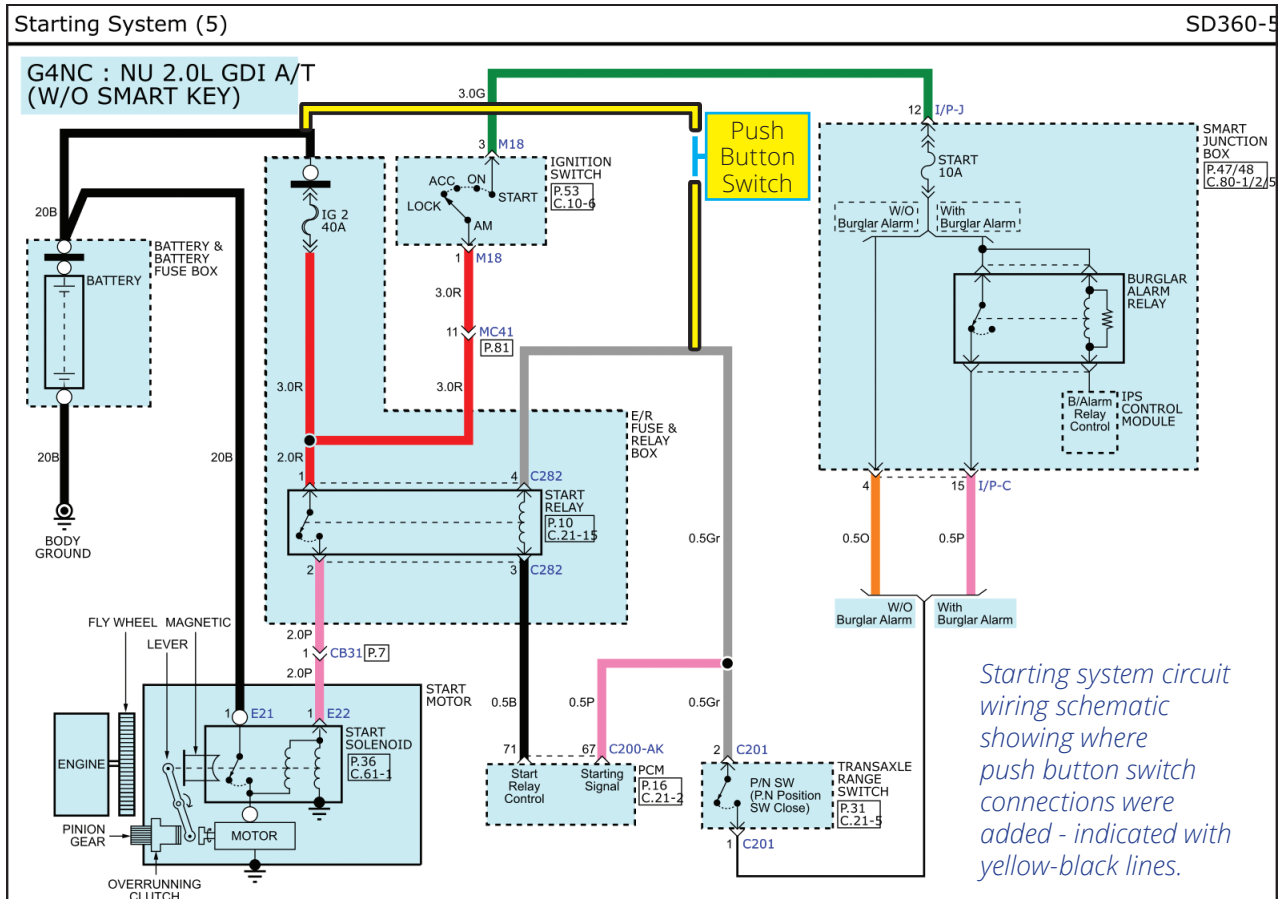
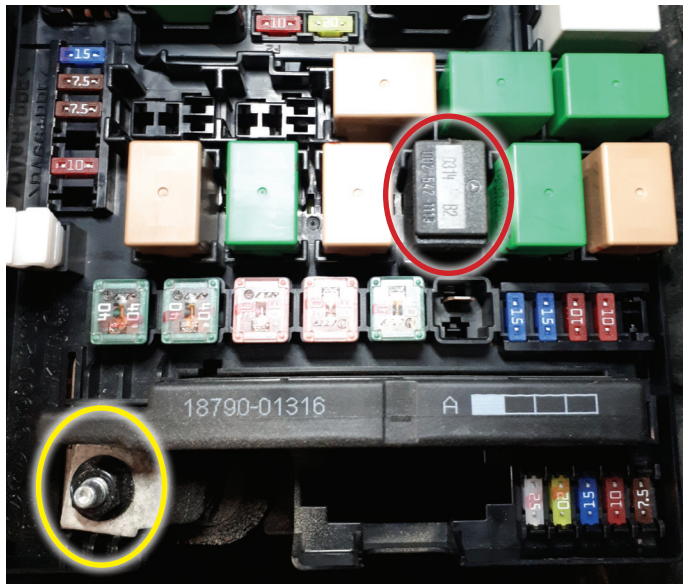
Relay panel

We opened and separated the under cover of the fuse panel to safely expose the harness. A temporary/extended wire was also attached between

the fuse panel and the battery positive cable so we could turn the panel on its side. The connection is illustrated in yellow. (See "Relay Panel," next page.)

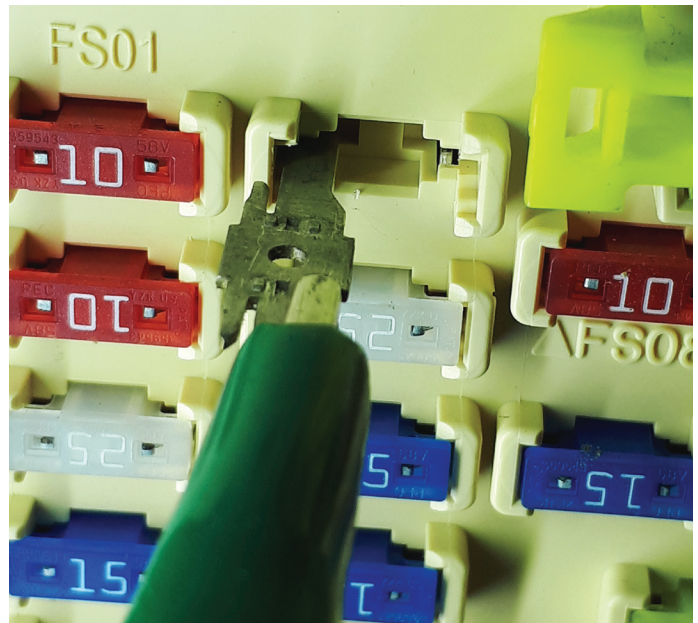
The fuse identified as START 10A is within the Smart Junction box and is powered with the ignition key in the On position. The fuse was removed and we applied a blade to the "hot" side. These blades are scavenged from defective GM fuse panels, desoldered, and all kept in a special stash.

Test 1: Power source with the fuse removed. The power source with the attached blade, allowed the power source to be applied to Test 2 (next page).

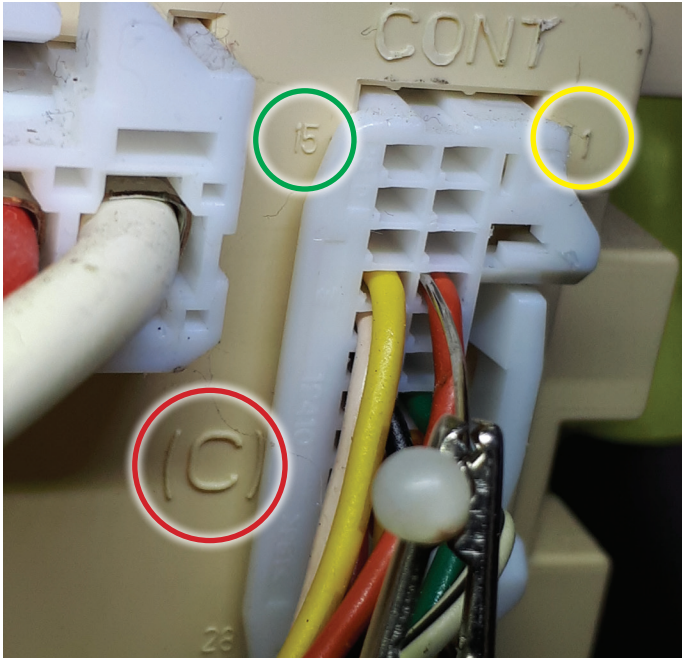
The red circled “(C)” (see image “Test 2”) is indicated in the schematic as I/P-C, and the orange wire is at Pin 4. The yellow circle indicates Pin 1. The schematic also indicates Pin 15 and is in green. That wire does not exist on this car because this version does not have a burglar alarm. The ignition switch start command is read at Pin 4.

Test 2: The orange wire at Pin 4 (Connector C) with the green jumper wire attached to the needle as in Test 1. That jumper wire between Test 1 and Test 2 applies the voltage through the Smart Junction box to prove or disprove the available control of the starter relay.

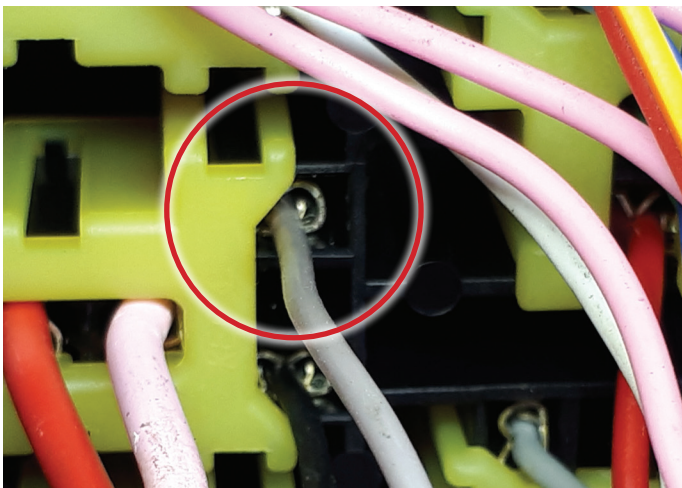
The red circle in Test 3 is Pin 4 C282 of the starter relay. With the jumper wire attached as in Test 1, follow the voltage path. With this test, there was no

Test 3: Pin 4 C282 of the starter relay, with the jumper wire attached.

voltage. At Pin 3 C282 of the starter relay, the circuit was intact.

The connection between Pin 4 of the Smart Junction box and the connection coming out of the transaxle range switch in Park or Neutral was intact. The ECM recognizes the P or N signal to authorize a start at ECM Pin 67 C200-AK. The range selector and data within the scan tool will display all gear ranges correctly. ECM Pin 71 C200-AK (Pin 3 C282 of the starter relay) was active as mentioned earlier. Therefore the ECM had to be defective and finally failed.
