# the bimmer pub

## X Marks the Spot, Part 1

We examine several common repairs  
needed on BMW X3 and X5 models

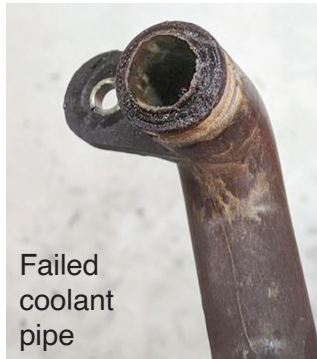
One of the more involved cooling related repairs is the coolant pipes beneath the intake manifold on the M54 3.0L engine. These two plastic pipes are prime locations for leaks on older or higher mileage vehicles. The ends of the pipes will crack and break off as the plastic deteriorates.

Replacing these pipes requires the removal of the intake manifold. This is a rather straightforward job, but use care to not lose any of the nuts that secure the manifold, as they are not a usual metric thread pitch and can be difficult to find replacements for. Be sure to disconnect the battery as the starter cables are well within range of a ratchet handle or wrench. This repair is a good example of replacing related parts as well. The quick connect coolant hoses that attach to each of the plastic pipes should also be replaced to prevent future leaks.

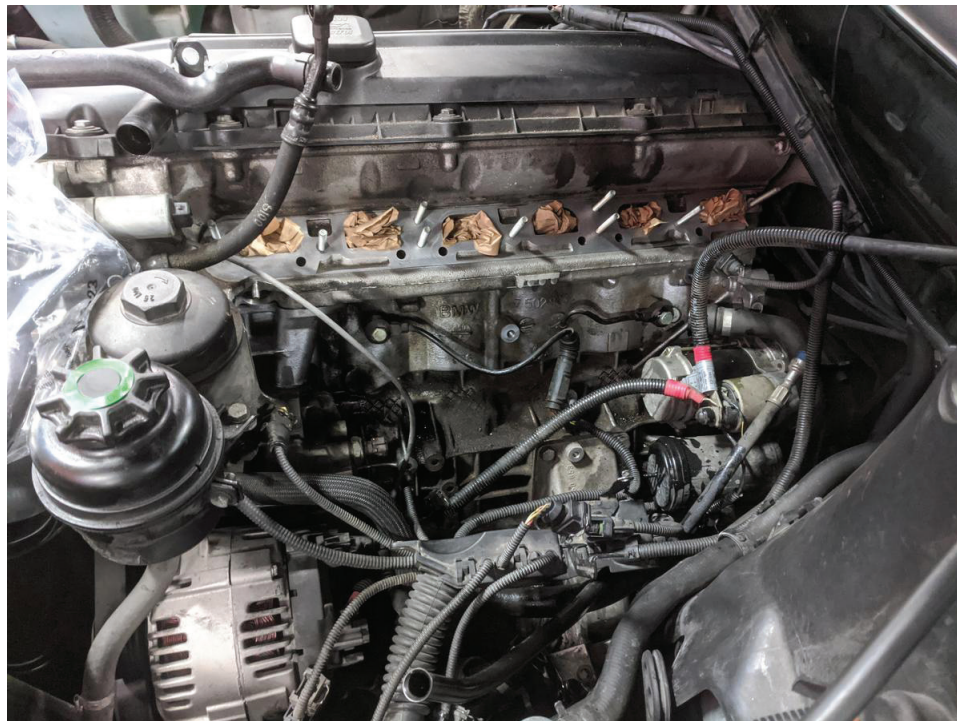
2004 X3 M54 with intake removed

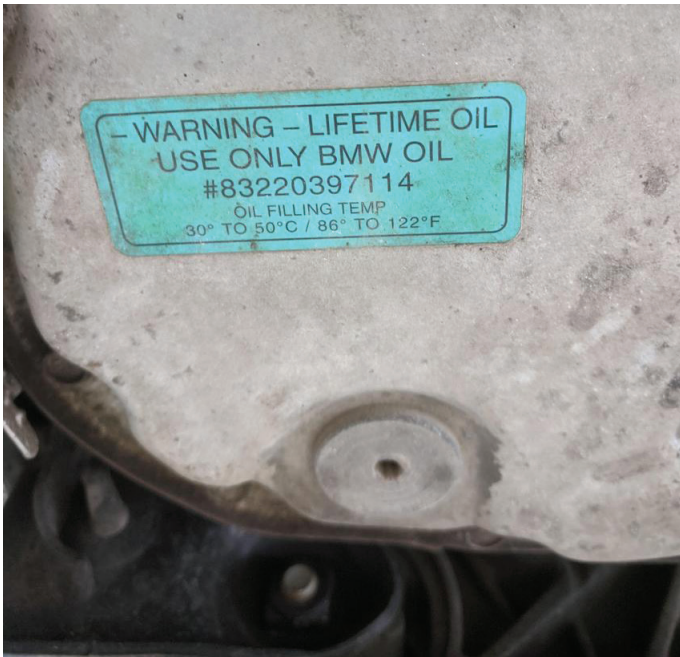
Anyone who regularly scans BMW vehicles is likely familiar with the 578E Gearbox Oil Wear fault as well as its companion fault 54C6 VTG Oil Wear for the transfer case fluid. Both of these faults are time based and use software to determine when the fluid has surpassed its life expectancy. Neither of these faults will illuminate a warning light so they should not be used as part of a diagnosis other than to recommend maintenance. The Gearbox Oil Wear fault is slightly contradictory though, since most BMW transmissions use lifetime fluid. Best practice on lifetime fill transmissions is to change the fluid only when required for a repair.

Lifetime oil warning sticker

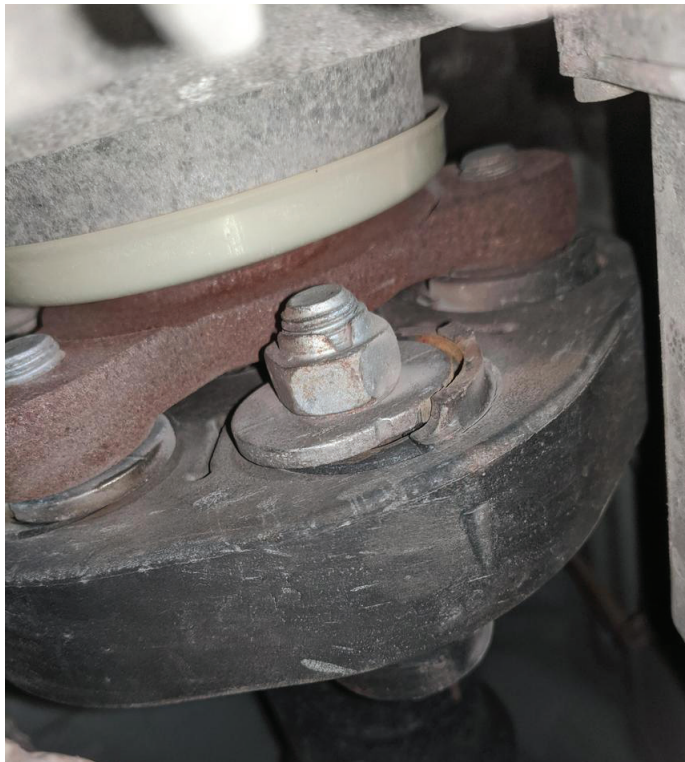
A complete visual inspection of the suspension and drivetrain uncovered the cause of the higher speed vibration. The technician found that the flex disc coupler and u-joints on the rear drive shaft were very loose with excessive play. The rear driveshaft assembly would need to be replaced.

X3 flex disc coupler

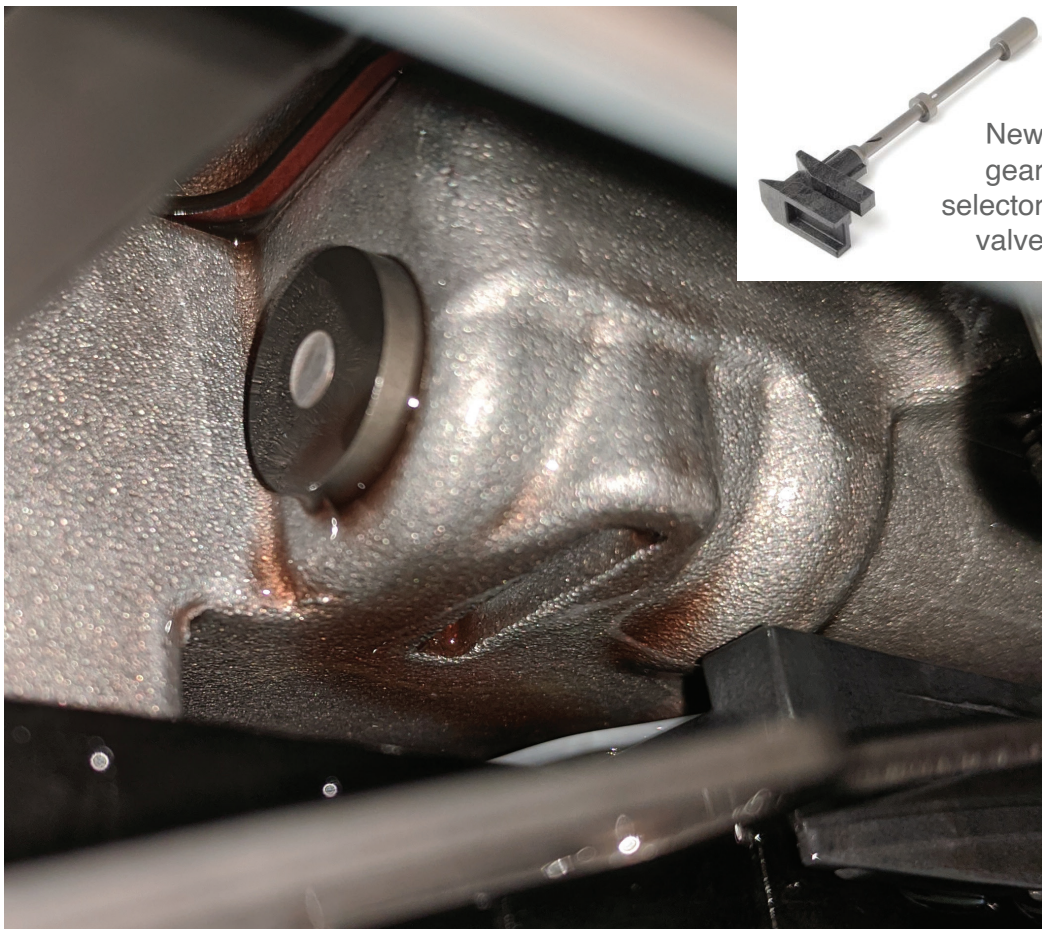
The BMW service bulletin stated there was a gear selector valve in the valve body that can break and cause multiple fault codes and loss of gears. The gear selector has been made available separate from the valve body assembly, which is good news since the valve body or Mechatronic is an expensive component.

The cause may be due to a broken gear selector valve on transmissions with a serial number less than 593323.

The transmission pan was easily removed and some of the fluid was collected for analysis. Inspection of the gear selector confirmed it was broken just as described in the BMW service bulletin. Despite the high mileage on this vehicle (173K miles) the fluid looked normal; the pan magnet was free of any substantial debris, as well as the filter.

Broken gear selector valve

The test plan for these faults normally will provide a diagnostic code to replace the Mechatronic; however, the gear selector valve is now available as a replacement part.

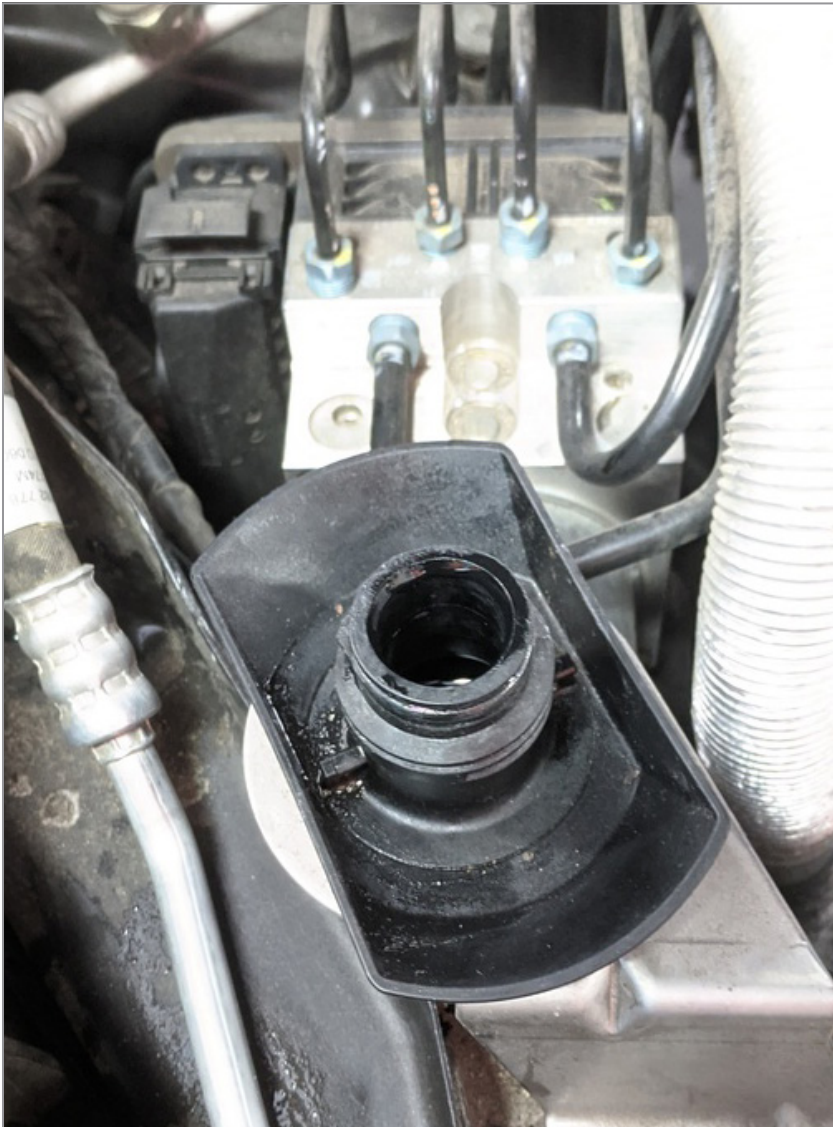
One of the underhood DEF filler necks

Using BMW software is very helpful when dealing with diesel engines and any of the later model gasoline engines as well. The final step on this X5 was to top off the diesel exhaust fluid in both of the underhood filler necks.
