TOYOTAtech

15-Minute Diagnostics on Toyota Vehicles, Part 2

By Jordan Hill

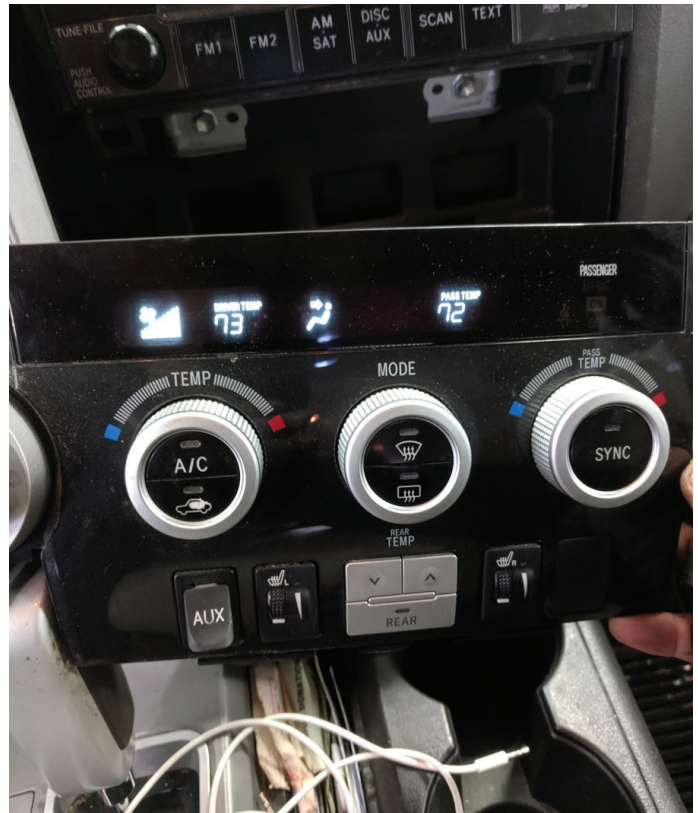
Sequoia HVAC Control Panel

Let's kick things off with a 2008 Sequoia with an unusual HVAC issue. The air conditioning and blower had abruptly stopped working on this SUV. The settings last selected on the HVAC control panel were displayed, but the system didn't operate and the settings couldn't be changed.

The technician's first thought was that the control panel must be bad, but he knew that thinking would likely get him into trouble.

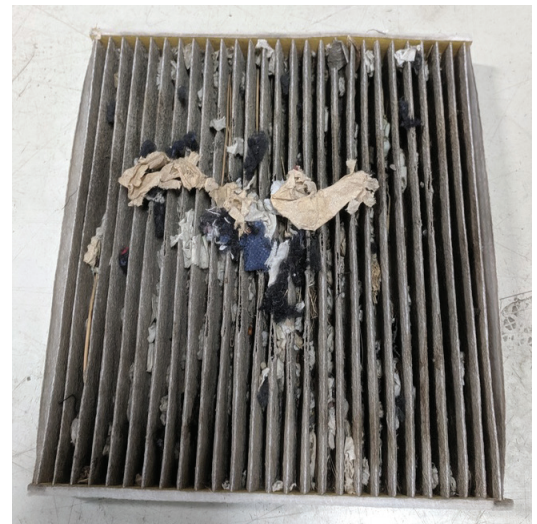
Sequoia Cabin Filter

down the module, or perhaps wiring damage in the dashboard somewhere as there was evidence of rodents in the cabin air filter.

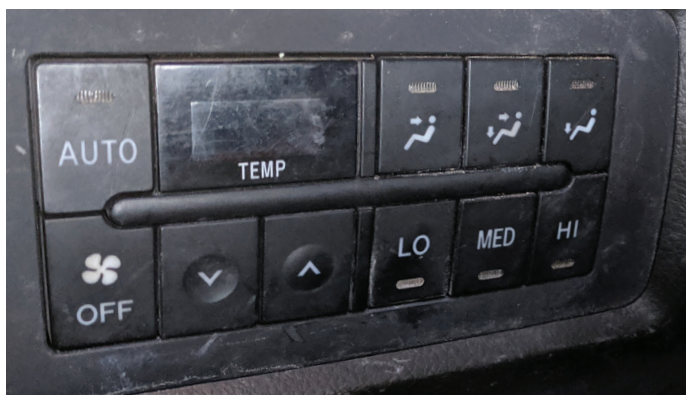
Rear HVAC Control Panel

He believed in always starting with the easiest to access components when looking for an input or network problem, and the rear controller would be the easiest place to start. The rear controller was on the back of the center console and was easy to overlook, but right away he could see an issue. The 'LO' button appeared to be pressed in further than the rest of the buttons. Upon further inspection it was clear that a liquid had been spilled onto the control panel as all the buttons were hard to press and would stick in various positions.

The buttons on the rear control pad work as momentary switches which should return to a rest state after being pressed once. The rear controller is also connected to the AC Amplifier by LIN, and having a button being stuck in the ON position froze the logic in the module. A generous amount of contact cleaner was able to free the sticky buttons and normal operations were restored to the air conditioner, blower motor, and display.

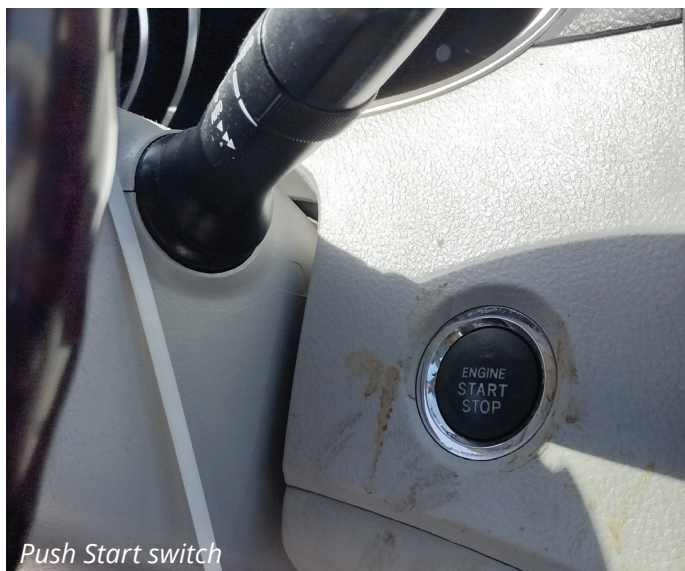
Push Start switch

Some customers may experience a no crank condition or a start and immediate stall condition when starting the engine using the "Push Start" switch. A new "Push Start" switch is now available to address this concern.

The tech verified that the bulletin applied to this vehicle by checking the VIN number against the table in the bulletin. The bulletin fit the symptoms exactly, even describing the possibility of the engine starting and then immediately stalling. The corrective measure was to install an updated Push Start switch, part number 89611-30020.

Worse it did get, and finally his stubborn resistance subsided. We ordered the updated part from a Lexus dealer and installed it. After a week the owner called to report the symptoms hadn't recured and that he considered the problem fixed.

One installation note for the push start switch is to be very gentle with the dash and use only plastic panel tools. There was a Lexus service campaign for several models and year ranges for dash boards issues of cracking and becoming soft in direct sunlight. So, use great care, and don't replace the switch right after the vehicle has been sitting in the sun for hours.

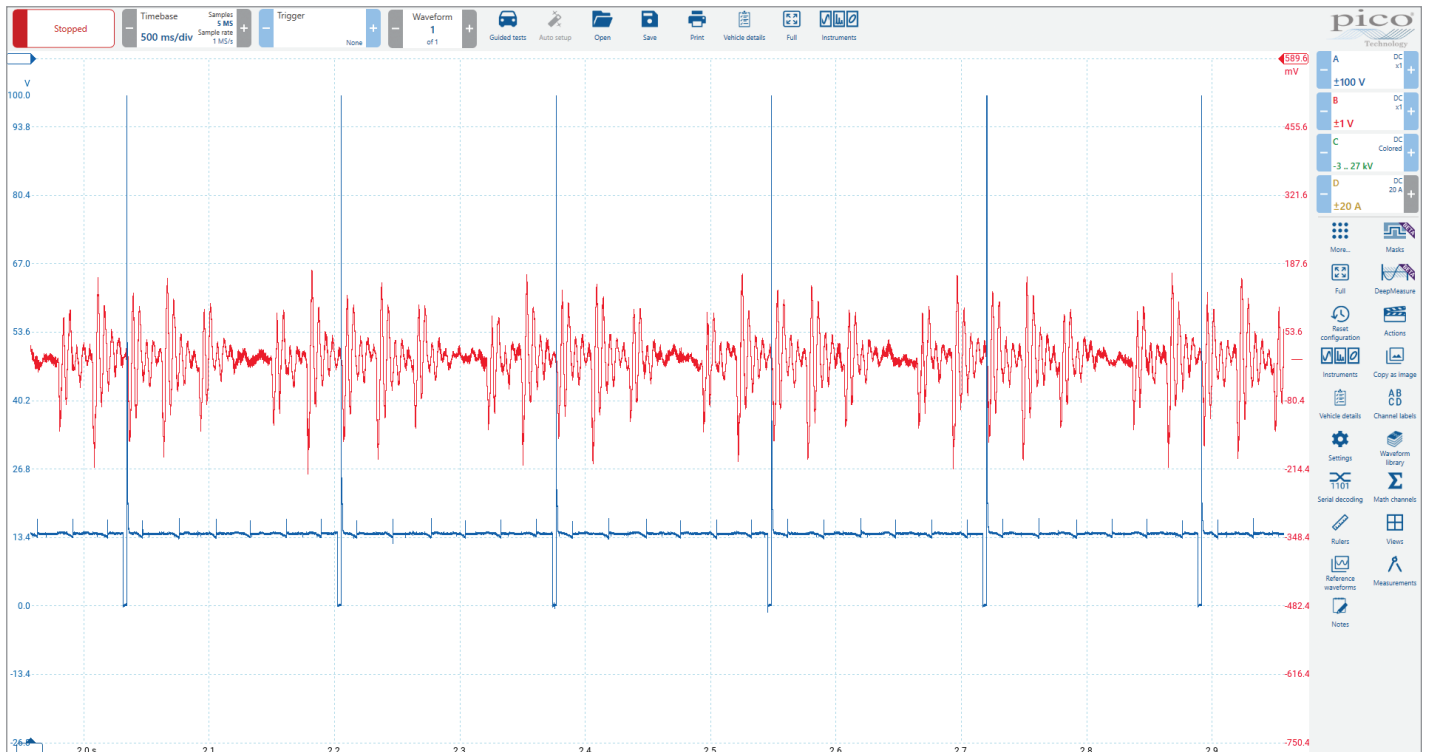
Injector Waveform

engine revolutions on the screen a repetitive pattern emerged. Zooming in and using phase rulers with six partitions makes the offending cylinder clear. There was no response from the pulse sensor when the cylinder four fuel injector was fired.

The owner of the 4-Runner decided to replace all six injectors due to the high mileage. After the injectors were replaced with new O-rings and plenum gaskets the codes were cleared and the hot soak condition was recreated once more. This time the SUV started after sitting for 15 minutes and didn't misfire at all.
