# Volvo TechTips

Summer 2022

# Two Vexing Volvos Violate Validated Valvetrain Viewpoints

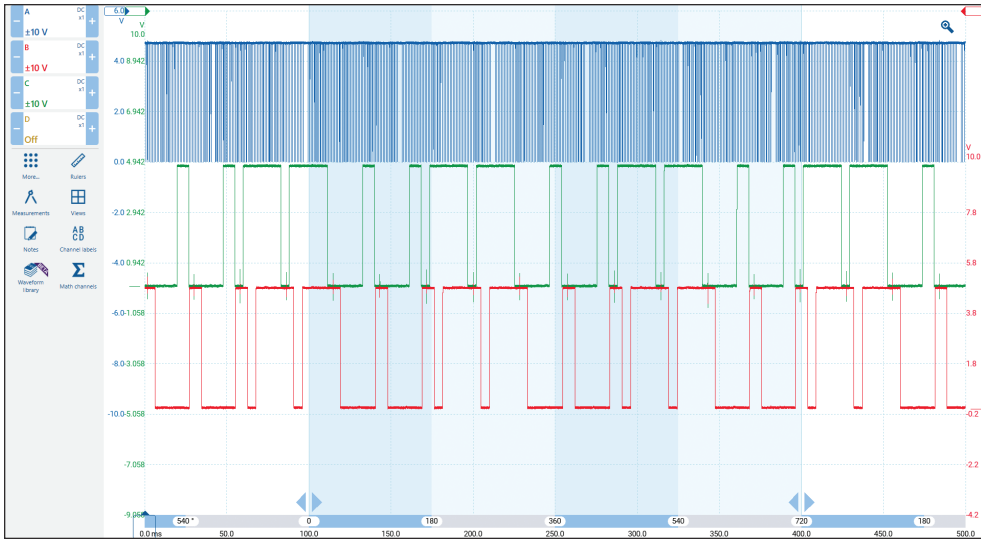
Think about this; a set of crankshaft sensors and camshaft sensors are reading the rotating shafts via toothed wheels or reluctors, calibrated to the camshaft and crankshaft's true position, and the ECM's misfire algorithm essentially analyzes crankshaft speed variations to determine misfire (see Figure 1A). What happens when twice or three times (at the cost of many arduous hours), we test over and over to find that, beyond a shadow of a doubt, these mechanical timing marks and sensors are indeed lined up properly, synchronized, and functioning perfectly, yet we still have the issue?

Figure 2: A typical camshaft-crankshaft sensor modulation signals with the mechanical engine running. The engine itself is the modulator for the ECM's control of the engine.

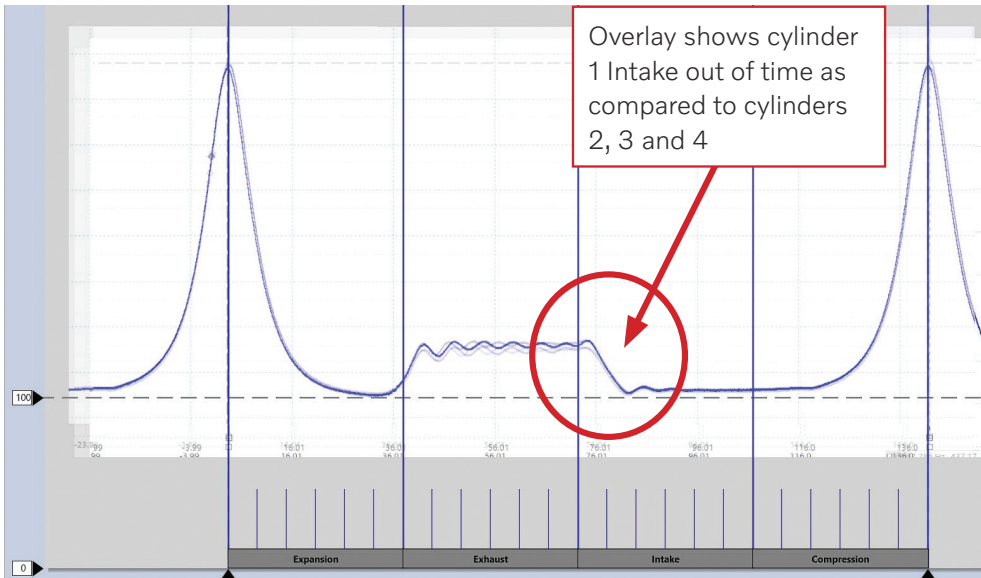
Figure 3 shows the next test, which was an individual cylinder overlay of cylinders 1, 2, 3 and 4 for comparison.

Figure 3: This overlay shows cylinder 1 with a valve timing problem caused by incorrect valve adjustment procedures.

If we grind the valve stem instead of using the camshaft tools for measuring and setting up the lifter buckets properly to adjust lash, we necessarily change the valve installed height. Doing the valve adjustment this way led directly to the problem on our S60 T5; the machine shop, thinking only in terms of valve lash adjustment, and lacking the Volvo camshaft jig for valve clearance adjustment, actually ended up changing the camshaft's timing on the opening and closing of the valve in that one cylinder, as shown in Figures 3 and 4.

The fix for this vehicle was to replace the valves and set the valve lash properly using Volvo special tools.

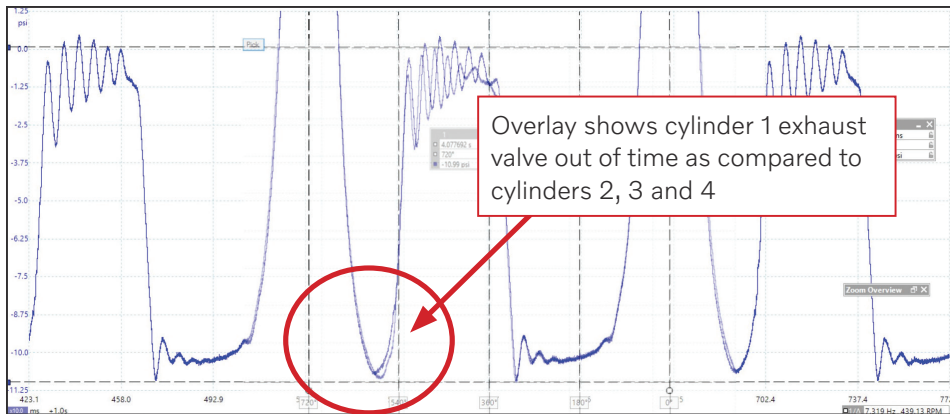
the Volvo's four cylinders, so that a comparison could be made across the entire engine. This test is what we often use to determine several engine characteristics that can definitely diagnose things like broken or worn valve springs, valve leakage, and tough-to-find conditions too, like a worn camshaft lobe on one cylinder. But in this case, we were using the overlay test to check the gas exchange section (where the valves are opening and closing to exchange air) and making sure all four cylinders had exactly perfect overlays as compared to the others. Here, we saw our problem relatively quickly, but solving it would be the challenge. Figure 4 shows the variance of the exhaust valve opening on cylinder 1.

Figure 4: In this overlay zoomed view, we can see the difference in exhaust valve timing in this one cylinder contributing to the crankshaft speed imbalance. This was a direct result of tipping the valves. Had the tappet adjustment procedure been done using Volvo special tools and tappet swaps, this failure would likely not have been installed in the vehicle.

This is exactly what the ECM was seeing in the form of a slight difference in crankshaft speed due to the difference in valve opening times, which triggered a misfire DTC in cylinder 1 and the cylinder next to it while the engine was running.

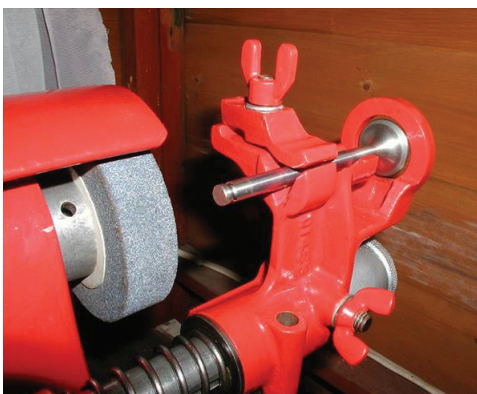
Figure 5: A valve grinding jig for valve stem tips. This procedure must be done properly, or all manner of problems can result.

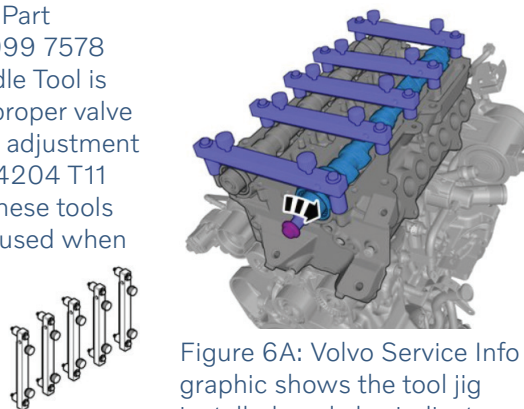
Upon disassembly of the head for the umpteenth time, it was discovered that the machine shop, in rebuilding the head, had used a technique called "Tipping the Valves," which allows the machine shop to quickly set valve lash when setting up the head. Tipping the valves involves grinding down the tip of the valve stem itself so as to adjust the valves to the lifter buckets in the head. This of course, is a risky way to adjust valves in most production engines, but

Figure 6: Part number 999 7578 Cam Cradle Tool is used for proper valve clearance adjustment on this B4204 T11 engine. These tools were not used when machine shop tipped the valves.

Once we performed the in-cylinder pressure waveform overlay and identified the issue, we advised the shop owner to remove the cylinder head once again, to see what the trouble was. This time, we had the shop disassemble it themselves, and purchase the Volvo special tools setup jig for the cylinder head valve adjustment. See Figures 6 and 6A for tool callout.

The instructions show that once the cam jigs are set up, the cams are rotated clockwise, and valve lash is to be obtained by using the tappet (out of the set) that provides the proper lash. This procedure was clearly
