Toyota A-40 Series Automatic Transmissions

We're going to concentrate on the three-speed A40, A41, and A43 transmissions in this article. As we go along, we'll point out the differences between them and any problems that are peculiar to each. The photographs of an A40 that follow outline the important areas to look at on all three transmissions during the course of an overhaul.

—By Karl Seyfert

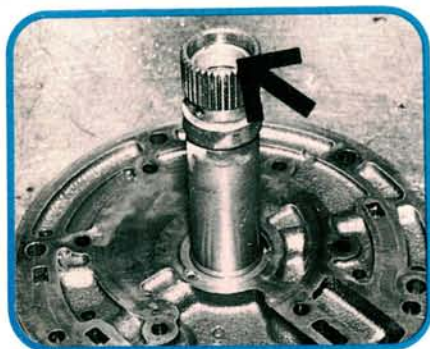
**3**

Check the bushings (arrow) inside the oil pump stator support. The bushings support the input shaft which is attached to the forward clutch. The maximum wear limit is 21.577 mm. Excessive bushing wear may cause stator support breakage. Inspect the pump body for scoring caused by the pump gears.

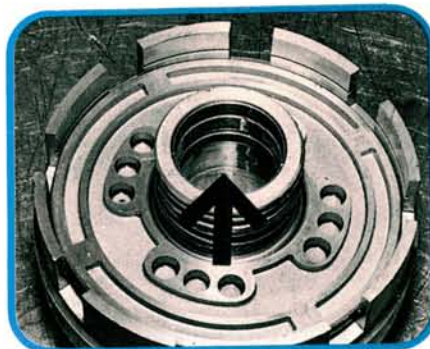
**4**

The bushings on the inside of the center support (arrow) are the most prone to wear. The bushings support the end of the sun gear shaft and handle the input torque from the forward and direct clutch units. Wear limit for the bushings is 36.461 mm. Inspect the sun gear mating surface also.

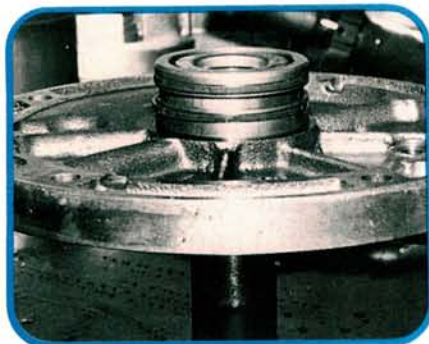
**5**

Check the rings and ring lands at the rear of the oil pump which seal the oil passages to the forward clutch. When replacing these rings on an A40, avoid confusing them with the three sealing rings on the center support. They have different wall dimensions. All rings have the same dimensions after August 1981.

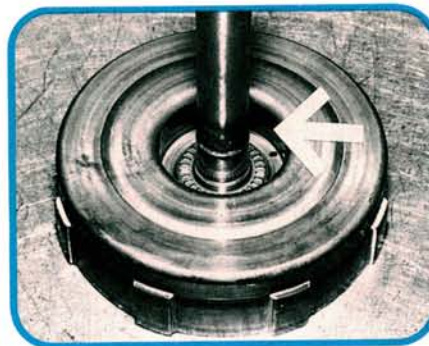
**6**

Inspect the mating surface of the forward clutch in this area (arrow) for seal ring wear. While most oil pumps used steel sealing rings, you may find a few that used Teflon rings. Leakage in this area would cause transmission slippage during acceleration.

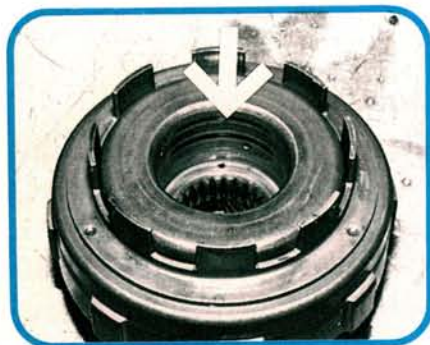
**7**

Check the sealing surface of the direct clutch (arrow) for wear. The center support uses three steel sealing rings because of the double piston setup on the direct clutch. One piston is applied in third gear drive range. Both pistons are applied in reverse for increased holding ability.

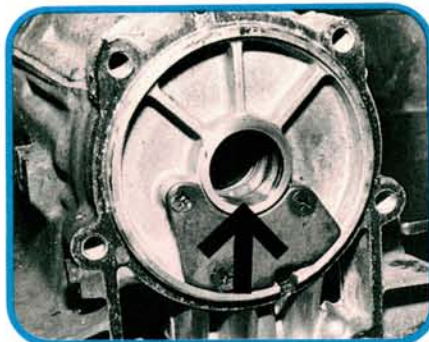
**8**

The rear of the case contains the oil passages (arrow) for the governor circuit. The metal sealing rings on the output shaft can groove the bushing. The output shaft bushing has the same inside diameter as the converter bushing in the oil pump. Maximum diameter wear limit is 38.188 mm.

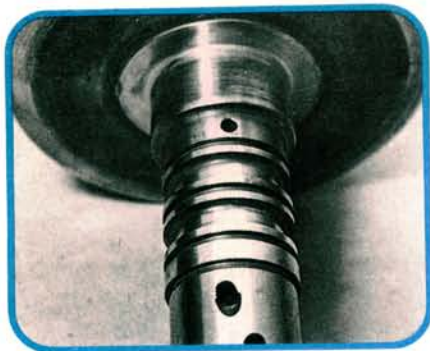
9

Inspect the area around the governor seal lands for bushing wear. The governor passages must be clean and free of any debris. The governor clips to the output shaft and covers the two large passages. Disassemble and clean the governor; they've been known to stick.

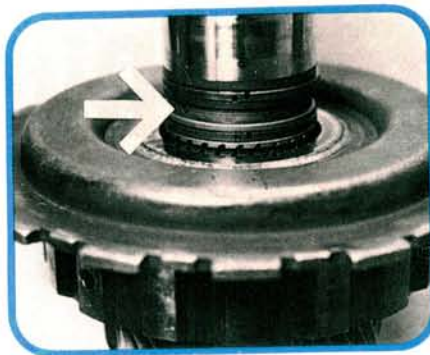
10

The hollow sun gear shaft is backed out so that you can see where the seal rings fit. Oil passes through this opening (arrow) to lubricate the rear one-way clutch. Check the inside surface of the one-way clutch assembly for wear. The A43 uses larger diameter seal rings.

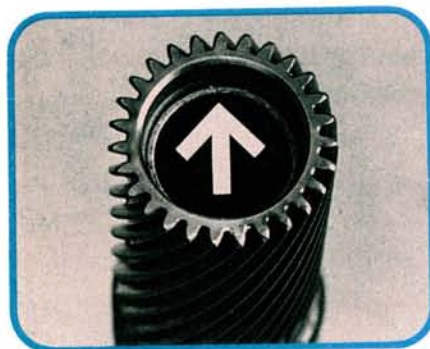
11

The bushings inside the sun gear shaft often wear. This bushing (arrow) and its mate at the other end of the sun gear support the intermediate shaft which is splined to the rear internal ring gear of the planetary gear set. New bushing inside diameter is 21.501-21.527 mm. The wear limit is 21.577 mm.

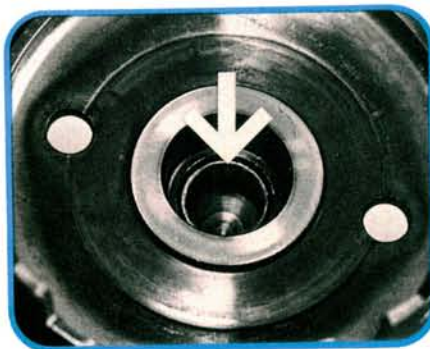
12

This bushing (arrow) in the output shaft centers the end of the internal ring gear on the rear half of the compound planetary gearset. It's a small bushing with a big job to do. New bushing dimensions are between 18.001 and 18.025 mm. The maximum wear limit is 18.076 mm.

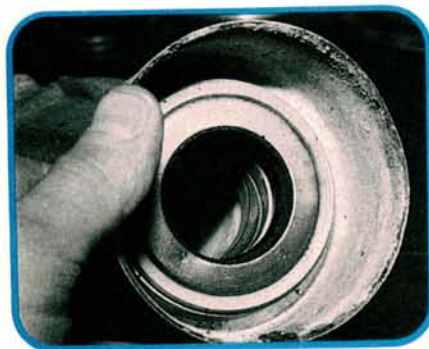
13

An out of balance or damaged driveshaft may have caused excessive extension housing bushing wear. Inspect the driveshaft yolk for roughness or seal grooving. Maximum bushing wear limit is 38.075 mm. Replace the extension housing seal and polish minor abrasions on the driveshaft before reinstallation.

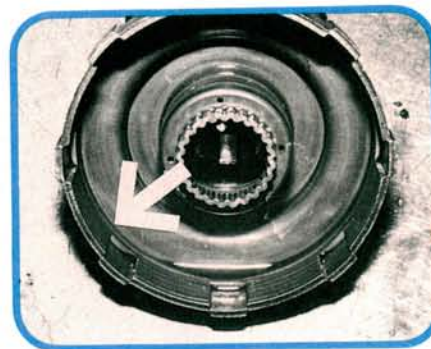
14

Transmission specialists tell us that the A40 family of transmissions is really pretty sturdy. If there is a weakness, it would be the o-ring seals used in each of the clutch packs. Outer o-ring seals on both the for-

ward and direct clutches on the A40 were known to roll out of their grooves, causing fluid pressure leakage. Toyota corrected this problem by increasing the cross sectional dimension of the o-rings on the A41. This was done in August 1981.

The direct clutch is splined to the end of the sun gear shaft. Check the internal splines for wear. Also check the internal sealing area (arrow) of the clutch drum for roughness. O-ring seal failure was a problem on A40s. O-ring dimensions on the A41 and A43 were changed to correct this problem.

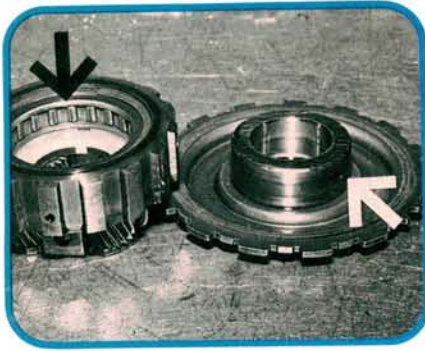
15

Inspect the inner surface (right arrow) of both one way clutches carefully. As this surface and the sprags that grip it become worn, the one way clutch may not hold properly. When dismantling the sprag assembly (left arrow), note the proper direction of the sprags for reinstallation.

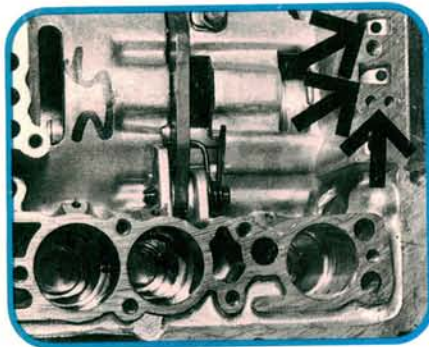
17

Inspect the accumulator bores for any signs of wear. Use these passages (arrows) in the case for air-checking before installing the valve body. Starting at the top are: the discharge passage for the governor, governor supply passage, and low-reverse inner and outer piston supply passages (right and left).

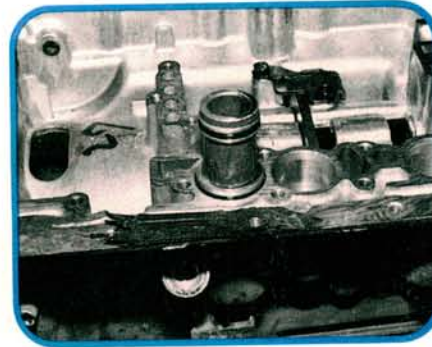
18

Check each accumulator piston's fit in its bore. Turn it upside down to check the fit of the larger diameter seal first. Two of the three pistons are very close in o.d. size. Make sure that you install the correct new o-ring on each piston. Lubricate the o-rings with transmission fluid to prevent damage.

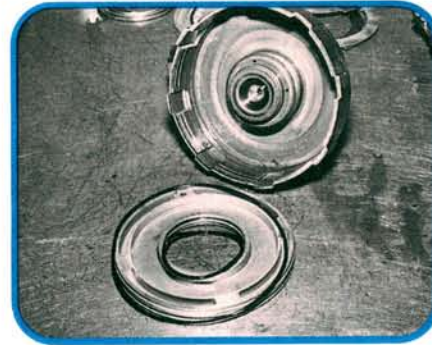
24

The outer o-ring seal cross section, clutch piston groove diameter, and clutch piston groove width on both the forward (shown) and direct clutches were changed in August 1981. The earlier, smaller o-rings will not seal properly on the later A41. Later, wider o-rings will bind the clutch piston if used on an A40.

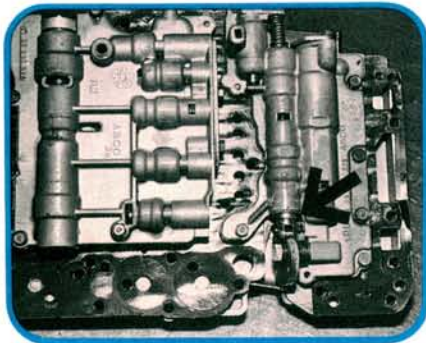
25

Different spacer plate gaskets were used for different models. Always compare the new gaskets to the old ones. Steel check balls may wear the separator plate openings. A leaking second gear ball will cause a hard shift to second. The lack of vacuum modulator makes throttle valve (arrow) adjustment very important.

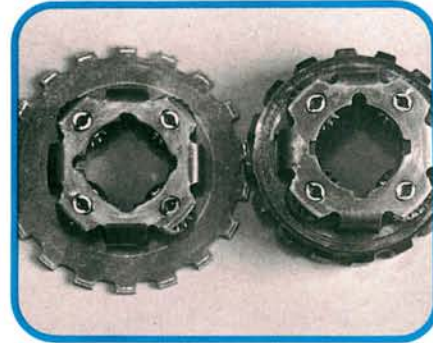
26

The A40 had some planetary gear failures, especially when it was installed in trucks. The A43 was developed to correct this problem. It featured an enlarged planetary set to handle the increased load and was used only in truck models from August 1981 until they went to four-speed automatics in 1984.
