Import Distributor Service

—By Karl Seyfert

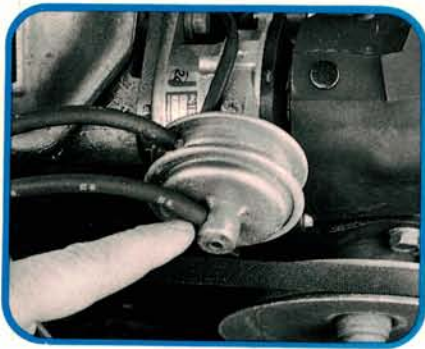
The dual advance diaphragms used on 22R-E Toyota engines can cause problems. One diaphragm receives manifold vacuum while the other runs off ported vacuum. Test each with a vacuum pump before setting ignition timing. Leaking diaphragms will affect base and total advance settings.

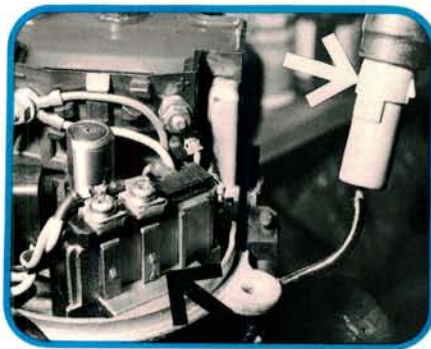
Toyota had some problems with igniter (black arrow) failures on their Integrated Ignition Assembly (IIA). This unit can be found in 83-86 Tercels and Corollas. It's also found in early model Camrys and Vans. Use a compatible tachometer when using Toyota's test connector (white arrow).

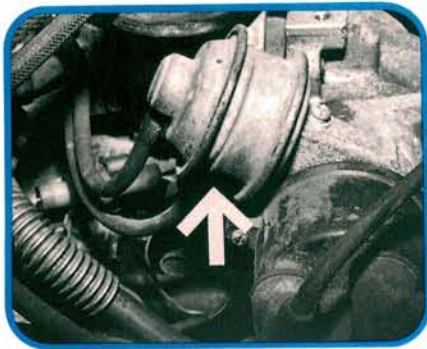
3

Overadvancing the timing to compensate for a bad vacuum diaphragm or advance mechanism on 1984 and later Honda models with dual diaphragm distributors (arrow) can cause detonation induced piston damage. Use the following procedure to check all distributor parts before setting the timing.

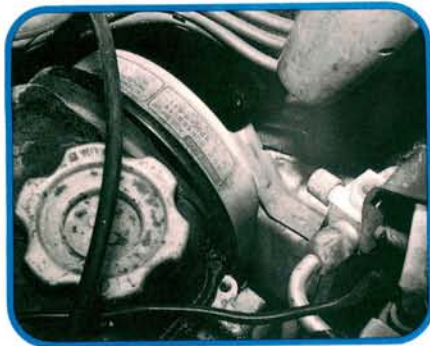
5

Check the timing, but don't adjust it. It should be 3-4 degrees before TDC. If it's not, check the distributor for a sticking advance mechanism or a faulty advance diaphragm. If either one has been broken for awhile, someone may have already misadjusted the timing to compensate.

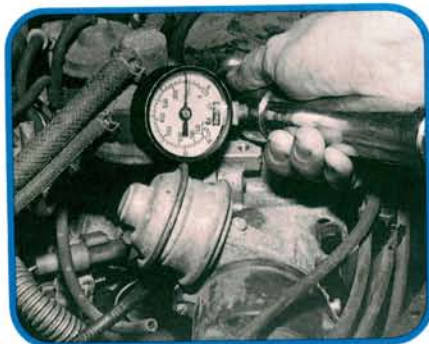
7

We tested both vacuum diaphragms with a vacuum pump. The outer diaphragm held vacuum but the inner one leaked down. Inner diaphragms fail more often because they are constantly supplied with vacuum. A leaking diaphragm can prevent full advance. Replace it and retest the system.

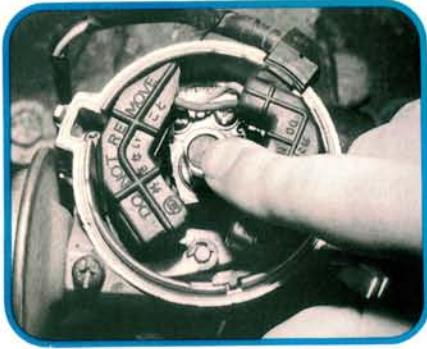
9

Air gap is adjustable on this 1983 Subaru ND distributor. The specification is 0.2-0.4 mm. If it needs adjustment, check the distributor bushings first. The bushings on this distributor were so sloppy, we could touch the reluctor to the pickup coil. The pickup coil and igniter are an assembly.

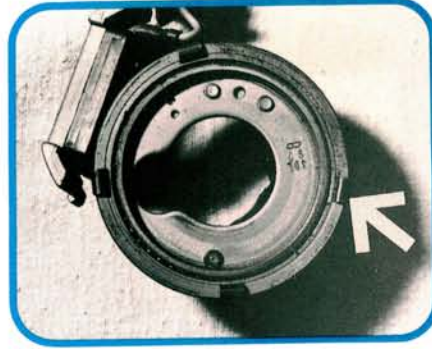
10

The distributor gear pin must be drilled out to remove the distributor shaft. The advance plate can be removed without removing the distributor shaft. Metal from the bushings was hanging up the advance plate operation. Align the advance plate clips (arrow) with the distributor housing slots.

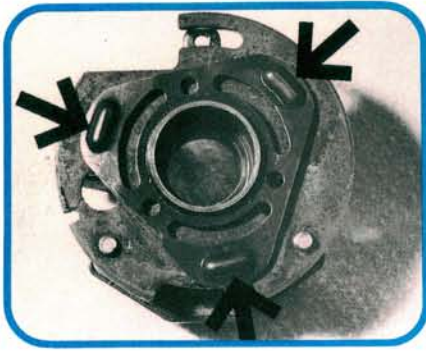
15

This Hitachi advance plate is from a 1982 Nissan Sentra, but you'll find them in some early '80s Hondas and Subarus too. Some internal parts will interchange. The advance plate pivots on ball bearings under three dimples (arrows). The bearings can fall out and affect distributor operation.

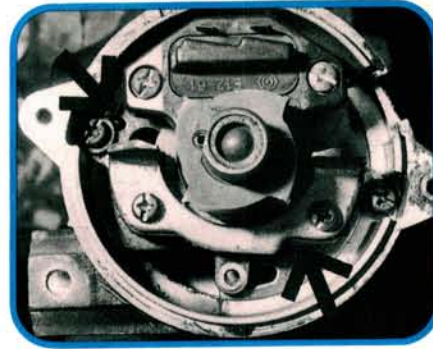
16

Check inside the distributor if you suspect problems. Loose bearings will often cling to the stator magnet (right arrow). Wiggle the stator plate to check for looseness. Index the notch in the advance plate (left arrow) with its mate in the distributor housing when replacing the plate.

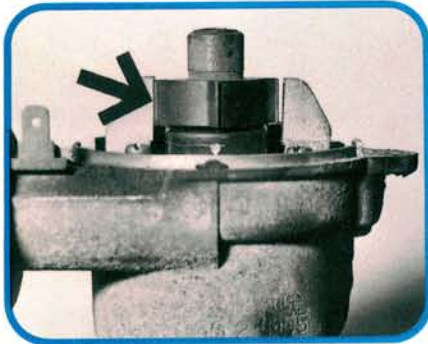
17

A loose advance plate forces the stator against the reluctor (arrow), causing an intermittent miss. Pry off the reluctor, then replace the damaged advance plate. Adjust the air gap to 0.3-0.5 mm on both sides of the stator. Reinstall the reluctor with the letter facing up.

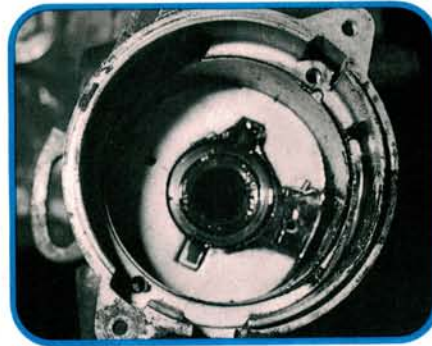
18

This is a horizontally mounted distributor on Hondas and Nissans. Look for telltale signs of oil near the breather holes or on the outside of the distributor that would indicate a shaft seal leak. Leaks this bad usually indicate problems with the distributor shaft bushings.

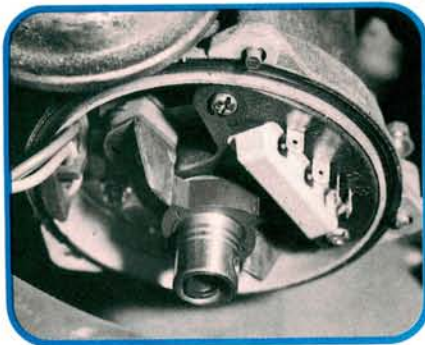
19

The dual plug ignition found on 1982-86 Nissan Stanzas is similar in operation to the single plug Hitachi unit above. The module is the weakest link in the system. Half of the module can fail and the engine may still run. Operating symptoms will vary depending on which side of the module is blown.

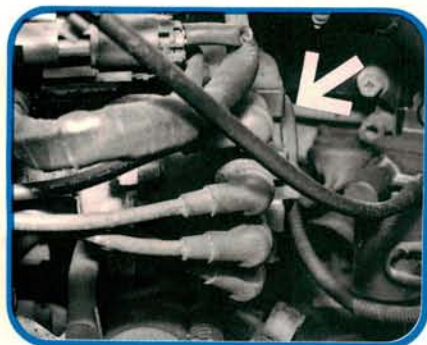
25

Trust me, there's a distributor under there (arrow). Nissan moved the distributor to the left end of the camshaft on 1987 and later Stanzas. Problems with early Mitsubishi distributors caused the engine to cut out intermittently at about 2500 RPM. The only fix is to replace the distributor.

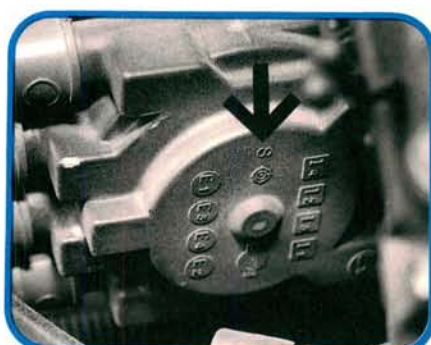
26

The trademark on the O.E.M. cap indicates whether it's a Hitachi or Mitsubishi distributor. The caps don't interchange. Letter "S" caps are a vented, moisture resistant design. Oil leakage in late model horizontal Stanza distributors can clog the shutter wheel and cause driveability problems.
