TECH TIPS

Here are the editors' choices for this month's **Tech Tips**. Each of these contributors will receive a case of Fast Orange hand cleaner compliments of **Loctite Corporation**.

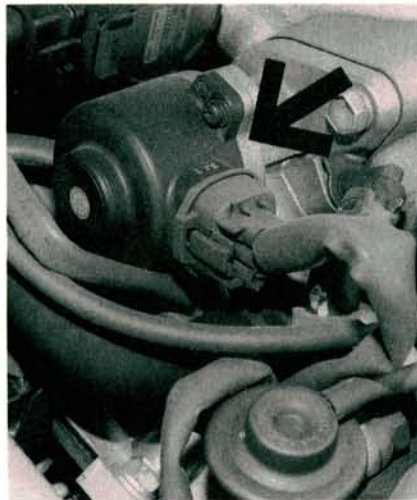
Here are three Toyota tips:
• **Air stabilization valves on Toyota Cressidas sometimes decide to stick shut.** Crankcase fume

deposits can build up in the valves and make them sluggish or totally inoperative. Usually, the car idles just fine at shut down, but won't even try to idle after it's restarted. Instead of simply replacing the valve, I've had success with cleaning it. Remove the air hose from the valve and flood the inside of the valve with a good quality carb cleaner. It has taken a couple of flushings to clean some of the valves, but it has always worked.

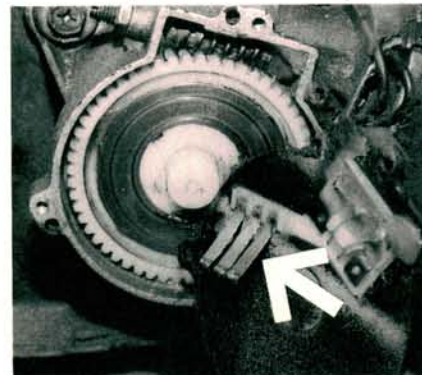
• **Since the freezing weather hit us this winter, we've seen a number of wiper motors that won't work on the intermittent setting, or refuse to park.** This usually hap-

pens when the customer turns on the wipers with the wipers' blades frozen to the windshield.

Before spending a lot of time and money replacing the motor, remove the cover plate on the motor that holds the contacts for the park position. High current draw through the contacts may have heated one of the contact strips enough to distort it and bend it away from the strips on the gear. I have saved many of these motors by bending the contact strip back in place.

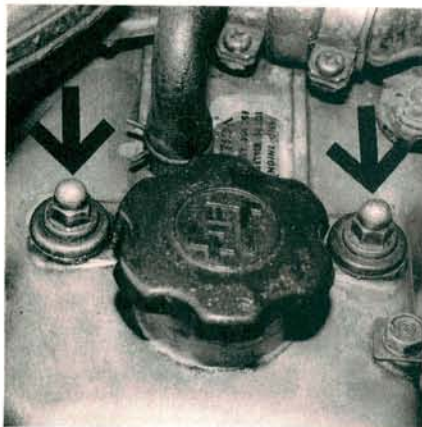
Some Toyota engines, especially 20R and 22R engines may have a valve noise similar to the noise made by a cam follower with too much lash. If you've readjusted the valves several times, or maybe even replaced adjusting screws to eliminate the noise, but still hear that tapping, there's a chance that you are overtightening the valve cover cap nuts.

Overtightening these nuts can pull the valve cover down just far enough that the followers will come in contact with the valve cover. To diagnose such a sound, simply back off the nuts. If the noise goes away, you've found your

problem. Install a new gasket and torque the nuts to the factory specification and no more (10-15 Nm or 7.5-11 ft-lb).
