# Electrical Service

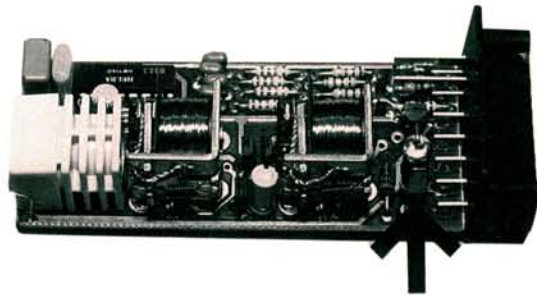
## BMW Central Locking System

A melted fuse connection can wipe out the central locking system on late model BMWs. The small strap-type fuse that's soldered into the edge of the locking system's control unit seldom blows. But the solder attaching the fuse to the board may melt instead, causing an open circuit. Soldering the fuse back onto the circuit board may only be a temporary fix. Always check the master switch in the driver's door. High master switch resistance probably melted the fuse solder connections in the first place.

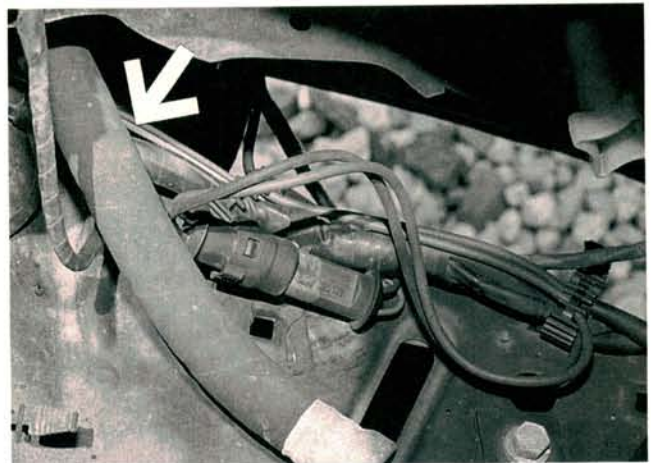
## BMW Headlight Wiring

The combination of sharp sheet metal edges and engine vibration may disable the right side headlights and turn signal bulb on 3 series BMWs. The wiring harness supplying the right side lights runs under or next to the A/C high pressure hose, between the receiver drier and condenser. Tight quarters often put the harness between the hose and jagged sheet metal. Repair, then reroute the damaged wiring. There's no hose on the left side, so the wiring is seldom affected.

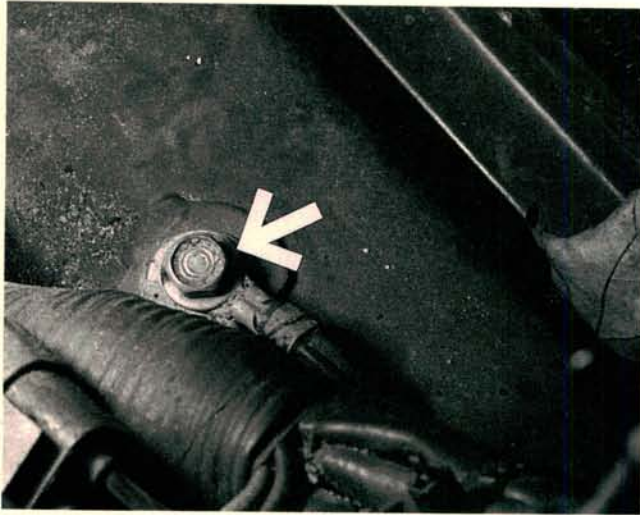
### BMW Trunk Lighting

The trunk light feed wiring may be damaged by sharp edges on the left trunk lid hinge of 3 series BMWs. Most of the red/green feed wire is protected by heat shrink tubing. But the two inches or so that's often left exposed can short to ground on the trunk hinge when the car hits bumps, when the trunk is opened or closed, or any other time it decides to. Other electrical components that share this circuit include the interior lights, radio memory, on-board computer module, and multi-function clock.

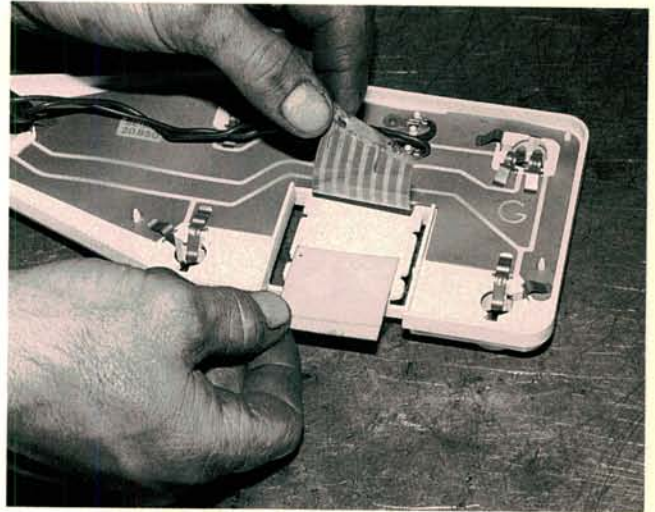
### Renault Tail Light Wiring

Erratic tail light operation on Renault 18i and Fuego models may be caused by poor or damaged connections at the tail light printed circuit, license plate light socket, or fuse block. A plastic shim is available to tighten the connection between the tail lamp printed circuit and wiring connector. Corroded license plate light sockets can also increase circuit resistance, causing damage to the left tail lamp printed circuit. The extra resistance and heat may also damage the tail light section of the fuse block.

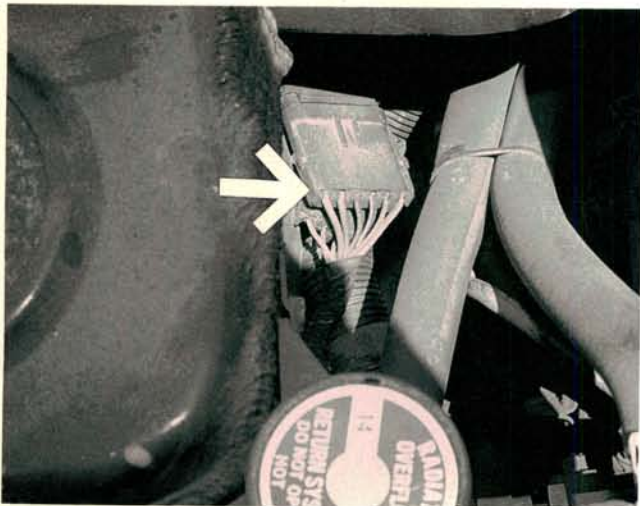
### Renault ECU Damage

The battery on early Renault Alliances and Encores is mounted directly above the ECU wiring harness. Battery acid can collect on the ECU harness, penetrate the harness seals, and then follow the wiring harness to the ECU. Once the acid gets inside, it's good-bye ECU. The overflowing battery may be caused by extra water entering through loose vent caps or overcharging caused by voltage regulator problems. Check for proper alternator charging voltage.

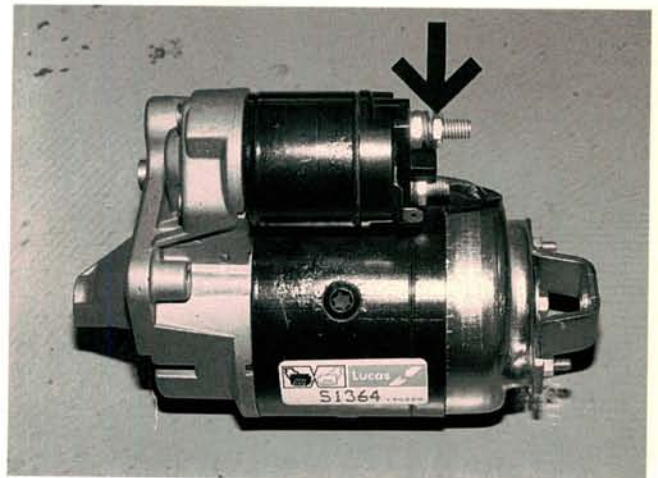
### Renault No Start

A no-crank condition on Renault Alliances and Encores may be misdiagnosed as a faulty starter. The actual cause may be a voltage drop between the battery cable and starter connection. The starter nut may appear tight, but still have poor current flow. Measure the voltage drop between the battery cable and starter terminal with a DVOM. The voltage drop should be less than 0.2 of a volt. Clean the cable and starter terminal, then install a star washer to ensure a good electrical connection.

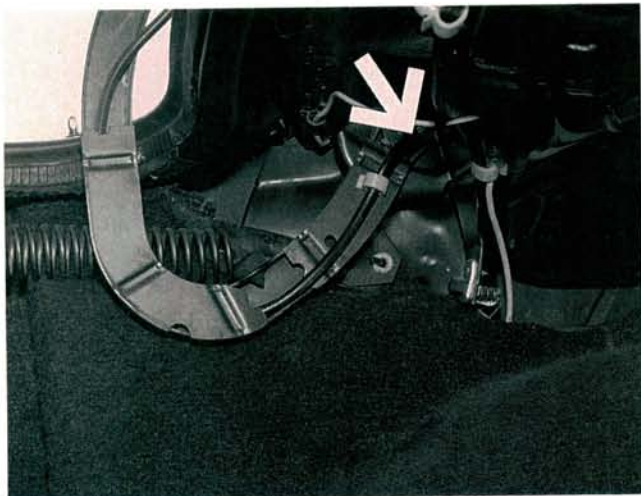
### Audi 5000 Tail Lights

Frayed wiring in the tail light wiring harness may cause erratic tail light operation on 1984 and later Audi 5000s. The harness is attached to the trunk hinge, and bends slightly each time the trunk is opened or closed. The wiring insulation wears through, allowing neighboring wires in the harness to short against one another. Brake lights that light when the parking lights are turned on is one example of the problems frayed wiring can cause. Wires may also short to ground and blow a fuse.

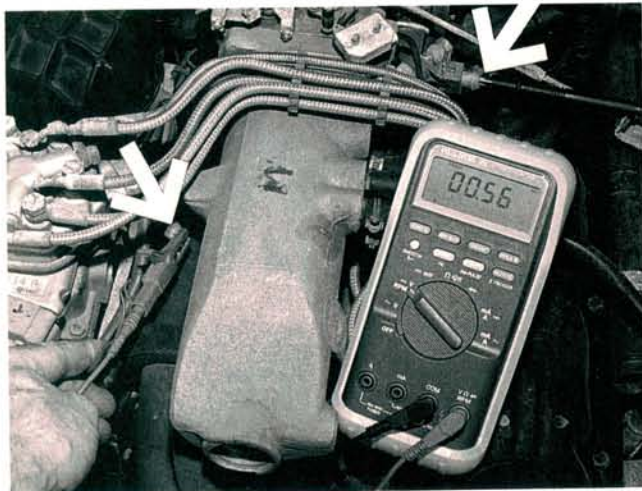
### Lean Running Volkswagen Jetta or Quantum

Stray voltage in the oxygen sensor circuit may cause a lean running condition on CIS-E equipped Jettas and Quantums. Disconnect the oxygen sensor to test the circuit. Install a DVOM between the oxygen sensor's harness side connector and the ground terminal at the cold start valve. With the ignition on, the ECU bias voltage should be 0.55 volts or less. Remove the ECU harness connector if your reading is higher. Clean any grease from the connector with rubbing alcohol. Air dry the connector before reinstalling it, then repeat the test.

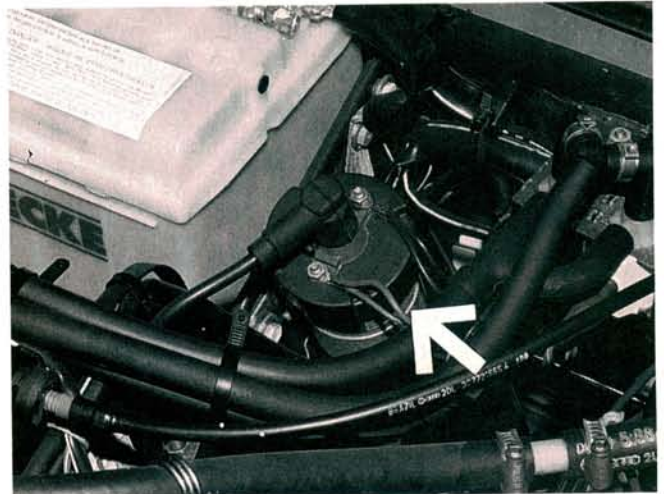
### Volkswagen/Audi Ignition Coils

Coil tower and coil wire burnout problems on 1985-86 Audis and 1985 and later Volkswagens may be caused by ignition coils with black part number labels. Symptoms of this problem are hard starting, poor performance, or a no-start condition. Replace damaged Volkswagen and Audi black label coils with updated green label coils, P/N 211 905 115 D. Make sure the engine also has non-resistor ignition wires and spark plugs installed to prevent future coil tower and coil wire burnout.

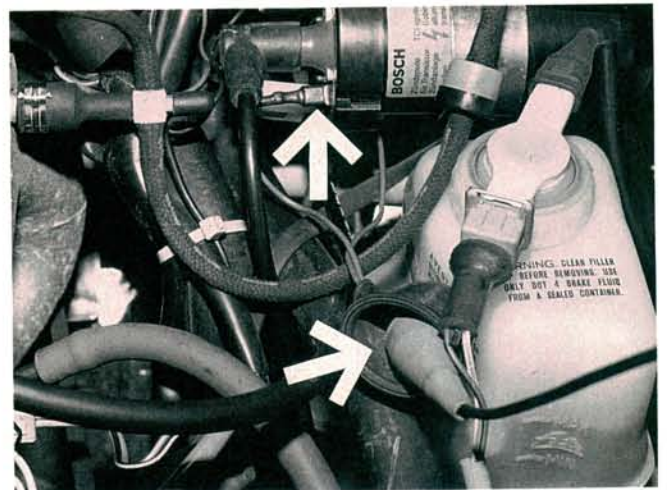
### Golf and Jetta ECU Failure

Use extra caution when working near the ignition coil or attaching test equipment to ignition coil terminal 1 on 1988 and later Volkswagen Golfs and Jettas. Accidentally shorting terminal 1 to ground will permanently damage the Digifant II ECU used on these models. Don't attach test equipment directly to the coil. Attach a jumper wire with a well shielded terminal end to the coil terminal first. Then attach your test equipment to the shielded test lead. Better safe than sorry.

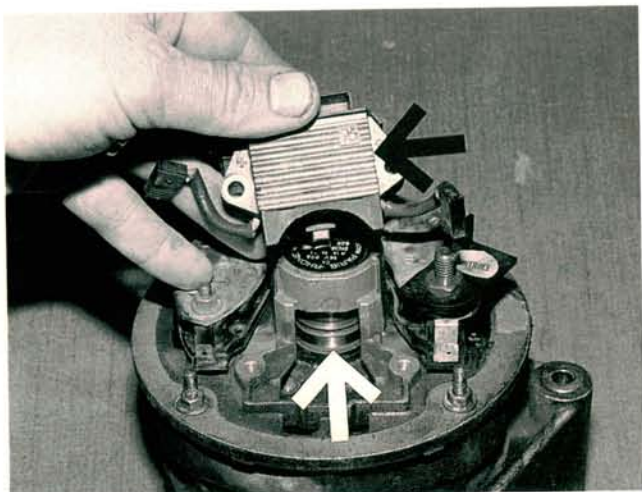
### Porsche 911 Overcharging

A defective voltage regulator may cause overcharging and rapid alternator slip ring and brush wear on Porsche 911s equipped with Paris-Rhone alternators. Resurface or replace deeply grooved slip rings, then install an updated voltage regulator. The updated regulator's large cooling fins also help cool the internal regulator. Overcharging may cause any number of problems. Common symptoms include abnormally high tachometer readings and a dash board with every warning light except the alternator warning light blazing away.

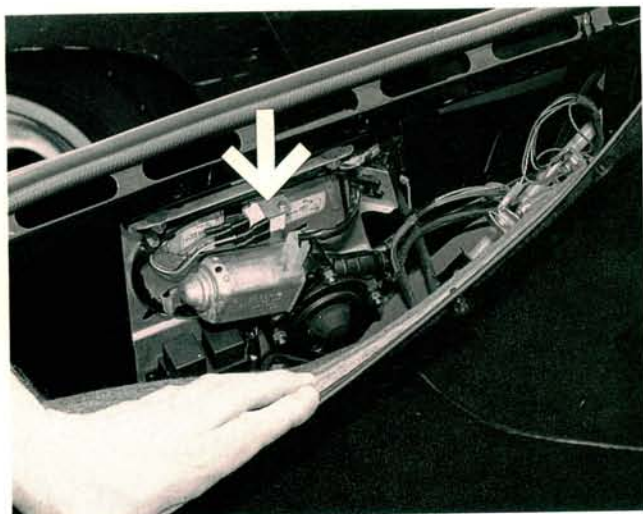
### Porsche 944 Sunroof Operation

Improper sunroof operation may be caused by mis-adjusted limit switches on Porsche 944s. The sunroof uses three microswitches; one at each rear corner of the sunroof panel, and one at the rear of the sunroof track on the left side of the luggage compartment (shown). The microswitches limit the fore/aft and tilt movements of the sunroof. Remove the trim panels to inspect the microswitches' L-shaped metal mounting brackets. Straightening twisted mounting brackets should restore the sunroof to normal operation.

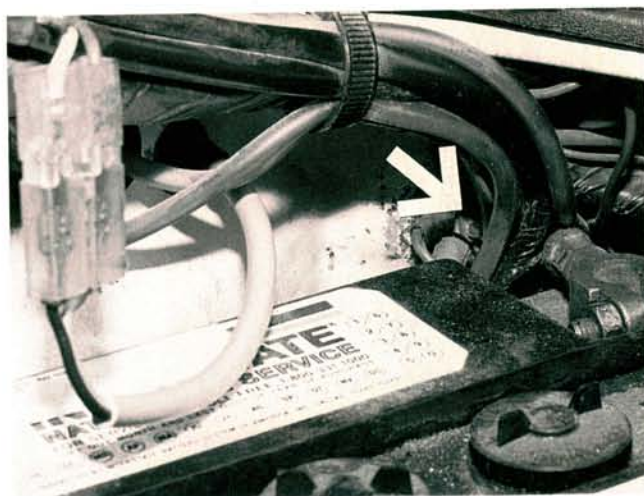
### Porsche 911 Battery Ground Strap

Pay extra attention to the ground wires and battery ground strap during electrical diagnosis, or while changing a Porsche 911 battery. The main grounding point for the strap and other electrical system ground wiring is a brass piece with mounting stud that's attached to the left inner fender area. This poor character always seems to get a coat of paint if the car has had any left front fender bodywork. It can also corrode from battery leakage and fumes.

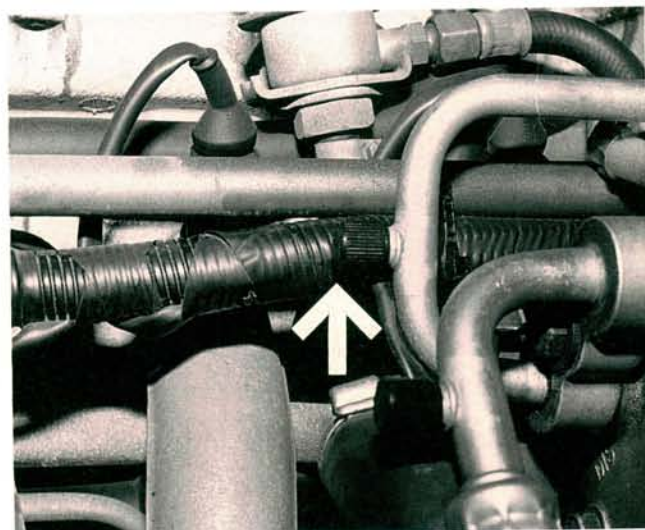
### Saab 900 A/C Fuse

If you've got a short in the manual air conditioning system on a 1983 or later Saab 900 that's got you at the end of your rope, try testing the surge suppression diode wired between the compressor's power supply lead and ground. The A/C fuse will blow every time the compressor tries to engage if the diode has continuity in both directions. You'll find the diode wrapped in tape inside the wiring harness that runs next to the fuel rail, between the two cylinders nearest the flywheel.

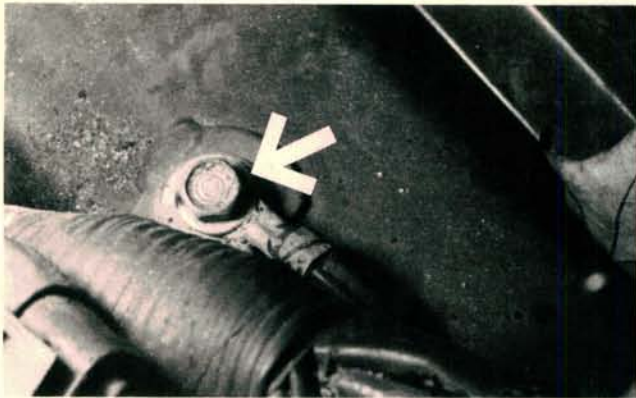
### Ground Control to Major Tom

We wrote about Saab 900 ground connections in the very first issue of *Import Service*, and they're still causing problems. Saab calls the grounding point on the radiator crossmember under the battery "Earthing Point 7." Corrosion and high resistance at this ground connection can cause problems with the headlights, turn signals, fog lights, A/C and radiator cooling fans, and windshield washer motor, to name just a few. Make sure all wires attached to this ground point are clean and tight.

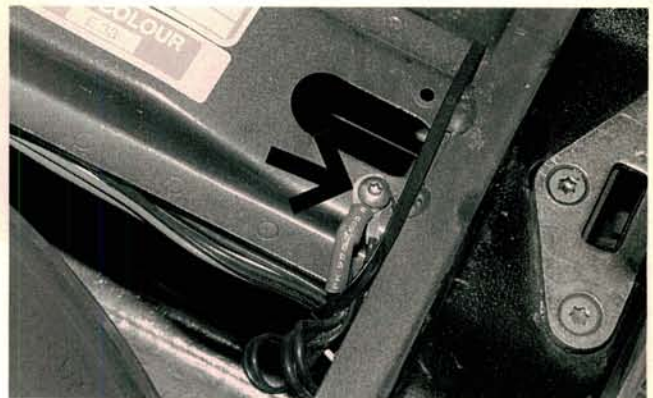
### Grounds for Separation

Many of the ground connections for electrical circuits at the rear of the car on Saab 900s are located under the trunk floor lid in the luggage compartment. Saab calls this "Earthing Point 9." Number 9 isn't exposed to quite as much abuse as its cousin Number 7 at the front of the car. It's more likely to suffer from neglect since it's hidden away in its dark dungeon. If you're having problems with the rear lighting, raise the trunk floor lid, then make sure all wires at Number 9 are clean, unbroken, and tight.

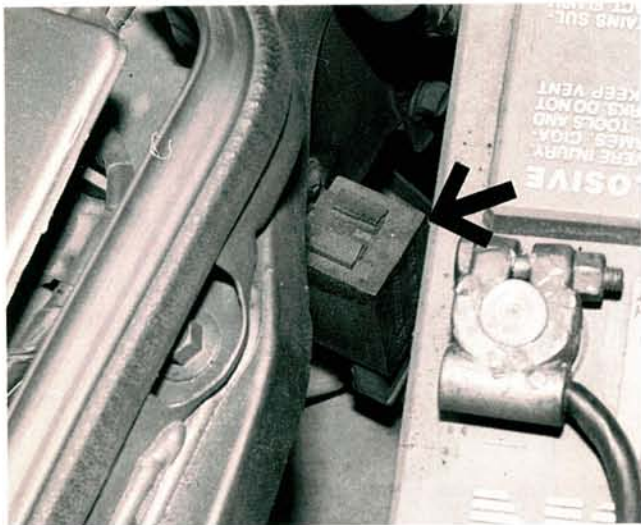
### Phantom Mazda Headlight Warning Buzzer

The headlight warning buzzer on 1981-85 Mazda RX-7s may buzz for no apparent reason. Carefully inspect the warning buzzer relay, mounted in front of the battery on the left side of the core support. If the relay fills with water, it can short the contacts and cause the warning buzzer to go off at random or moan half-heartedly. Replacement warning buzzer relays have better waterproofing which should eliminate the phantom buzzer syndrome.

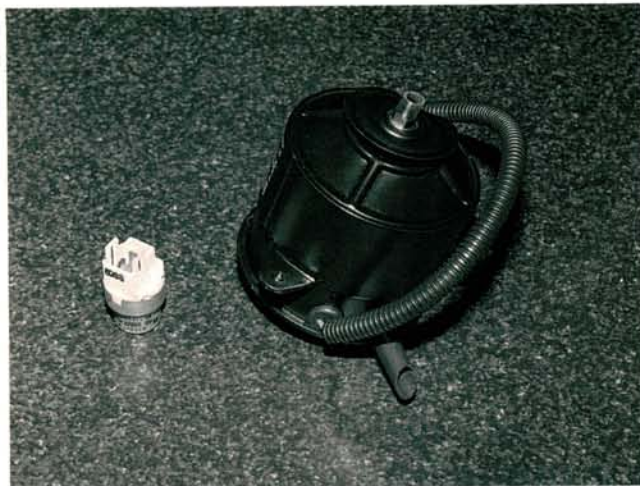
### Toyota Tercel Cooling Fan

The radiator cooling fan motors used on 1983-88 Toyota Tercels often overheat and fail. Always determine the wattage rating (80 or 120 watts) before replacing the motor. Check the sticker on the motor, or measure the motor case diameter (120 watt motor cases are larger). Always replace the fan relay and fusible link at the same time. Both parts may have also been damaged when the motor failed. Most fan motors use a pink 30 amp fusible link that looks like a large plastic fuse with female terminals.

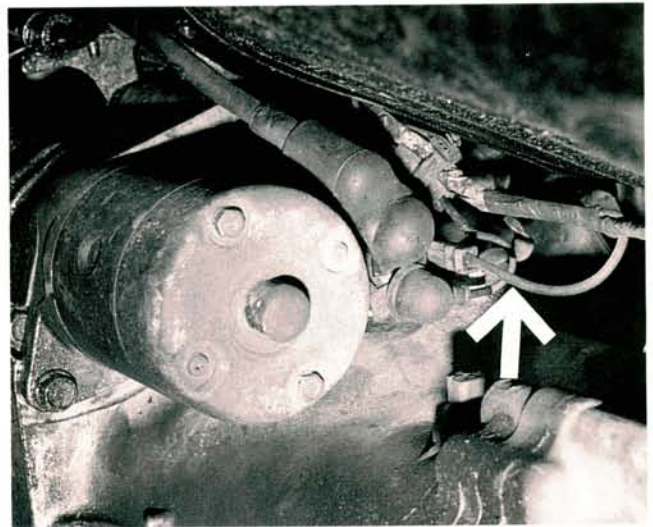
### Mazda No Start

Starter solenoid wire corrosion may cause a no-crank condition on Mazda RX-7s. The connection between the solenoid wire connector and starter solenoid terminal may appear clean and tight. Corrosion inside the solenoid wire about two inches away from the connector causes a voltage drop that's big enough to keep the starter solenoid from engaging. A voltage drop test between the ignition switch and the solenoid terminal will reveal this wiring corrosion.

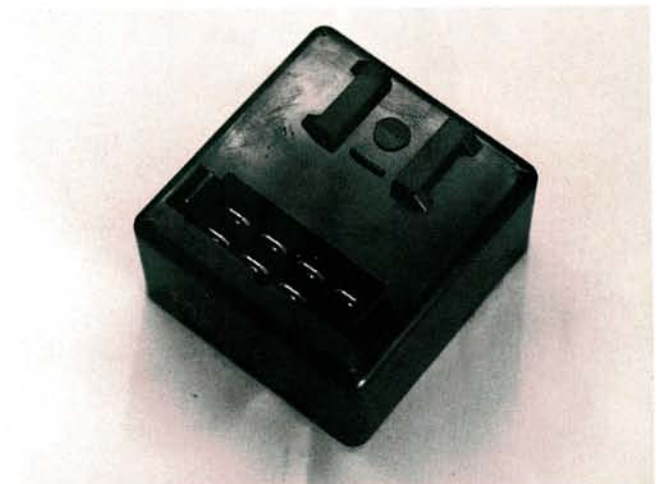
### Toyota Headlight Control Relay

The headlight control relay used on 1985 Toyota Celicas and Supras may fall out of its mounting bracket, allowing the relay wiring to short against the inside of the body. This may blow the headlight fuse or cause erratic headlight operation. The relay is mounted inside the left rear quarter panel. A shorted relay may cause the concealed headlights to open by themselves. This can drain the battery if it happens after the car has been parked and left unattended. Also check for frayed or exposed wiring in this area.
