TECH TIPS

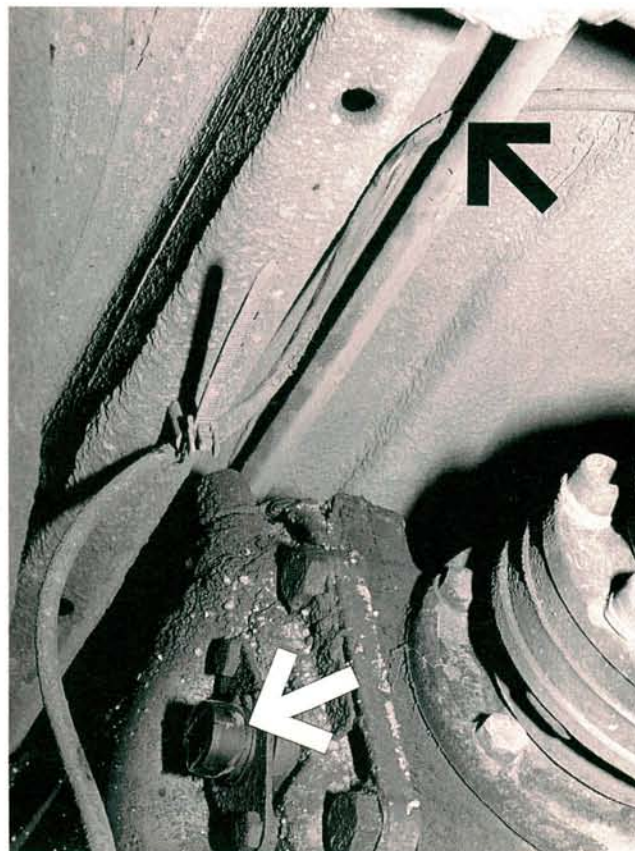
DEAD BMW SPEEDOMETER

An inoperative electronic speedometer on 1984 and later 3-series BMW cars may be caused by water that has collected in the vehicle speed sensor wiring harness. The moisture bridges the harness connectors to the speed sensor.

To check for this, raise the vehicle. Then unplug the speed sensor harness connector at the differential housing (lower arrow). If water pours out of the speed sensor harness connector, look for a hole in the insulation in the area of the harness near the rear sway bar (upper arrow). The harness passes above the rear sway bar on its way to the front of the car, and can rub on the sway bar. This wears a hole in the harness insulation.

This hole catches water in wet weather. Draining the water out of the harness will bring the speedometer back to life, but probably only for a short time. For a more lasting repair, dry out the wiring, clean the harness terminals, and seal the hole in the harness with shrink tubing. Then reroute and support the harness away from the sway bar.
