Toyota and General Motors set up shop together in 1985 at a manufacturing plant in Fremont, California. They called their new joint venture New United Motor Manufacturing Incorporated, or NUMMI for short. NUMMI's first project was producing Toyota Corollas and Chevrolet Novas.

One more thing that many of these fraternal twins had in common was a hesitation on acceleration. Depending on the car, the engine might hesitate a little or a lot. When, how, and how often the car hesitated also varied from car to car. Some owners never noticed the hesitation, while others beat a path straight back to the dealer. For those owners who did notice the hesitation, a carburetor modification kit has been available for several years from both Toyota and Chevrolet dealers. Neither manufacturer announced a full recall to correct the hesitation problem. Cars have been repaired on an individual basis.

-By Ken Styer

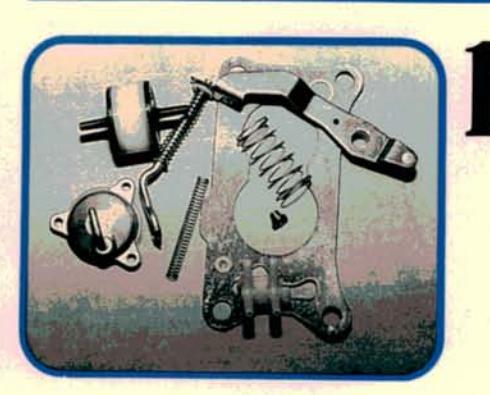
There are several different kits available. Determining which kit you need requires the vehicle model year, production date, and transmission type. Due to the variations, kit part numbers must be obtained from service department technical service bulletins. Parts departments do not have complete listings.

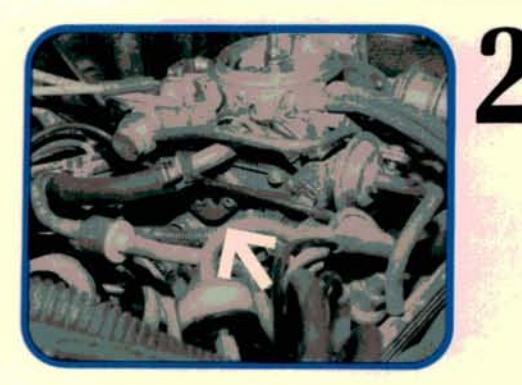
Check the fuel level in the bowl sight glass before removing the carburetor. If the fuel level is below the center of the sight glass, the float will need to be readjusted when we have the carburetor disassembled. Mark all of the vacuum lines for identification during reassembly, then remove the carburetor.

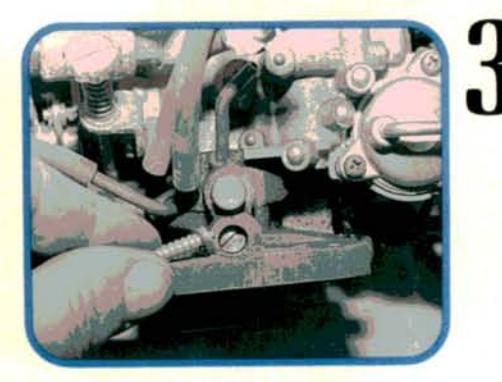
Remove the MAS (Mixture Adjusting Screw) plug from the carb base. Gently center punch the plug. If the plug is hit too hard it will slide inward and hit the MAS. Drill through the plug using a ¼-inch drill bit, being careful not to drill too deep and hit the MAS. Use a sheet metal screw to remove the plug.

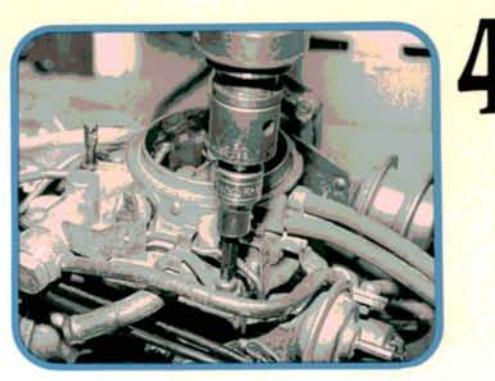
Remove or loosen any linkage or other part connected to both the carb body and the air horn. Loosen the air horn screws with an impact driver. Don't hit the impact driver too hard or you could damage the carburetor. These screws will be tight, and are almost impossible to remove once the screw heads are stripped.

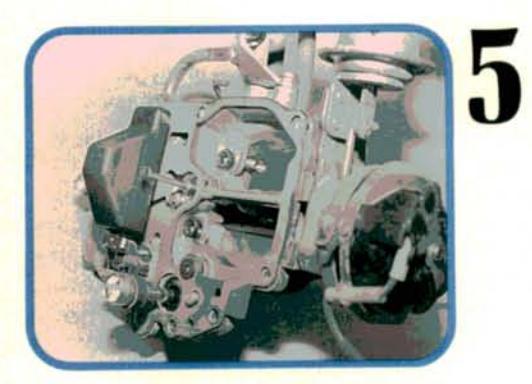
Lift the air horn slowly, taking care not to damage the air horn gasket. This gasket is not included in the repair kit and must be reused. Use a screwdriver or small scraper to separate the gasket from the carb body. The gasket must be removed with the air horn to prevent it from being torn by the float assembly.

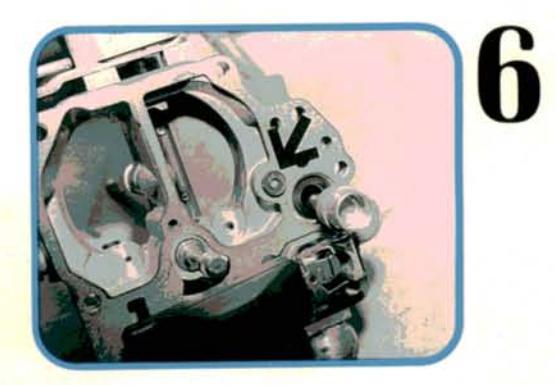
Once the air horn is off, check for the accelerator pump discharge weight seal. A replacement seal is not included in the kit. The accelerator circuit will leak if the seal is damaged or missing, reducing acceleration enrichment. Our seal stuck to the air horn gasket. We left it there, but kept a close eye on it.

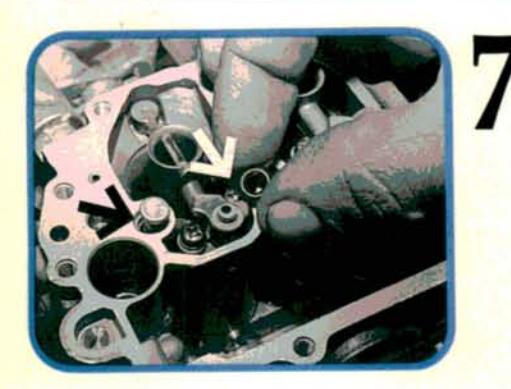
Remove the o-ring seals from the primary and secondary venturi assemblies (white arrow). The o-rings are tapered on the top edge and can't be replaced with standard o-rings. Remove the accelerator pump discharge weight (black arrow), spring, and check ball. These parts are easily lost during repairs.

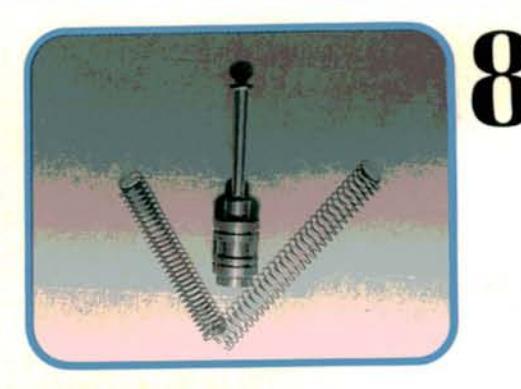
Remove the power piston from the air horn and replace the power piston spring. The new spring (left) is stronger then the original, allowing the power enrichment piston to overcome a greater manifold vacuum. This allows the power enrichment circuit to respond more quickly to engine loads.

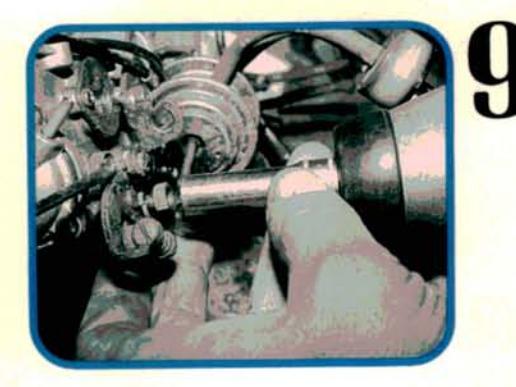
Remove the throttle position lever from the throttle shaft. We found the throttle position lever nut to be quite stubborn. Removing the nut with hand tools may damage the lever and/or twist the throttle shaft. A quick jolt from our $\frac{3}{4}$ -inch impact gun removed the lever nut easily.

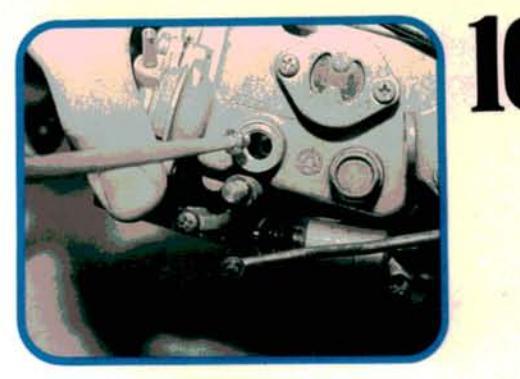
Remove the float bowl plug in-line with the primary jet. Reach through the hole with a screwdriver to remove the jet. Reinstalling the jet can be tricky. To make things easy, grind the end of a chopstick to a point and stick the jet on the pointed end. The chopstick will hold the jet firmly enough to start the threads.

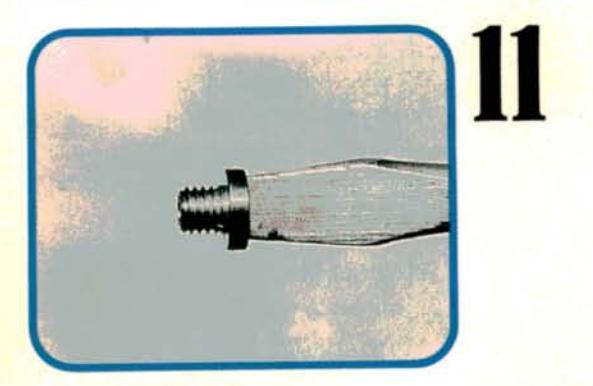
Replace the 103 primary main jet with the 105 jet in the kit. The larger jet allows increased fuel delivery through the primary venturi at all throttle ranges past the transition circuit. Be sure to use the correct size screwdriver to prevent damage to the jet. The jet should fit snugly on the screwdriver.

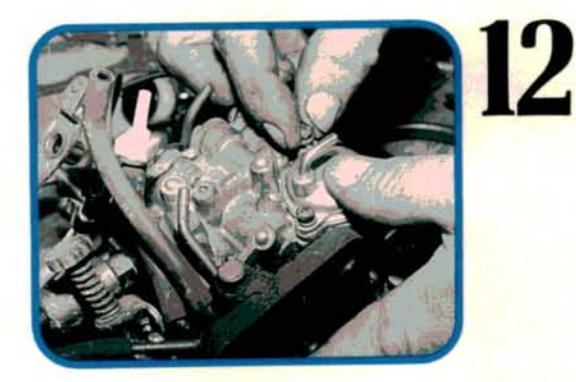
Replace the AAP (auxiliary accelerator pump) housing. The AAP is a spring loaded diaphragm that responds to decreasing manifold vacuum through a thermo vacuum switch to supply additional fuel to the accelerator pump circuit during cold operation. The new housing changes the cold AAP enrichment volume.

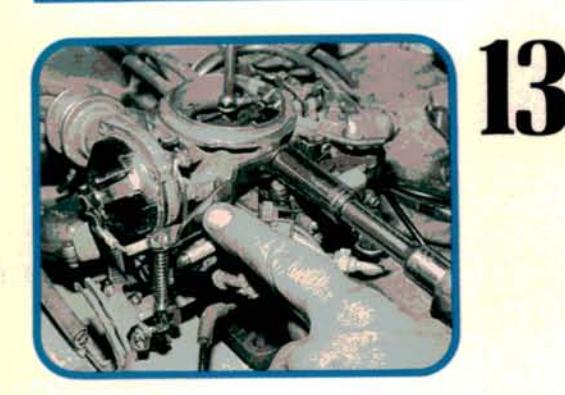
Reassemble the carb body and install the air horn. Many kits include a new accelerator pump arm and rod. The replacement linkage changes the accelerator pump stroke. The revised stroke provides additional enrichment to help overcome a lean bog during rapid throttle opening. Reconnect all remaining linkages.

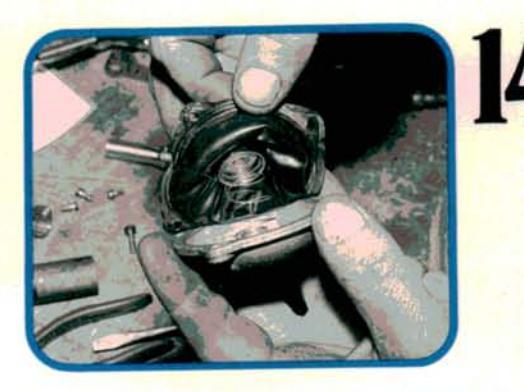
Remove the secondary throttle diaphragm and replace the diaphragm spring with the weaker diaphragm spring supplied in the kit. The weaker spring requires less venturi vacuum to operate the secondary throttle. This changes the secondary throttle opening which eliminates the secondary lean bog.

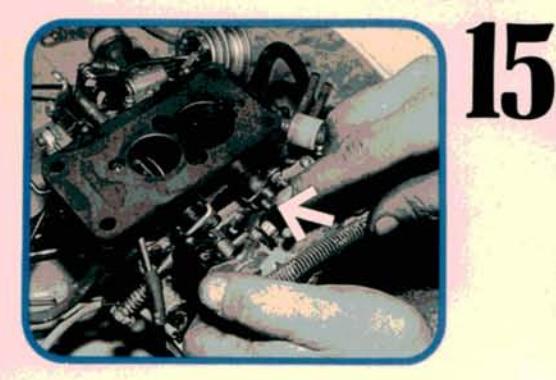
Reinstall the secondary diaphragm. Fully open the primary throttle. Use pin gauges to measure the secondary throttle valve kick up clearance (secondary throttle opening). Clearance should be 0.55 to 0.65 mm (0.022-0.025 in). Bend the secondary kick up lever to adjust the clearance.

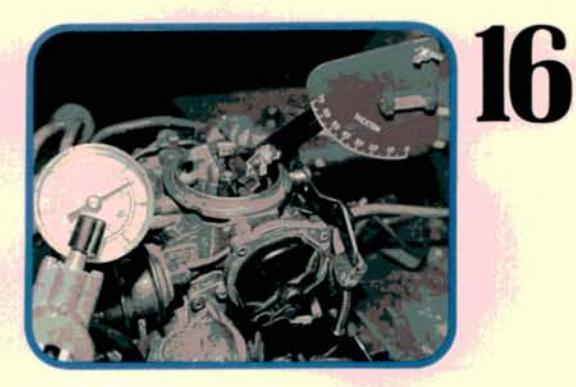
Mount an angle gauge on the choke plate. Apply vacuum to the dual vacuum choke break. Use the screw in the choke break to adjust the choke pull off. Specifications may vary between kits, and angles are measured from carburetor level. We had to modify the base of this angle gauge to fit the small choke plate.

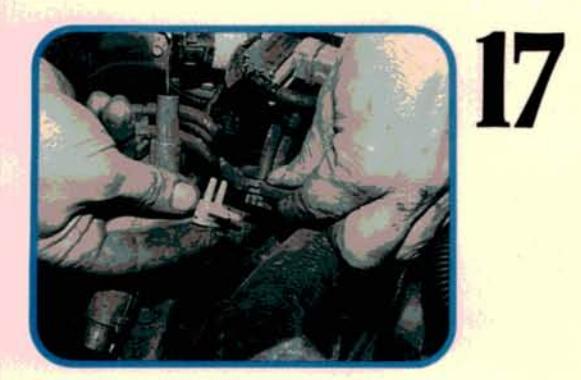
Reinstall the carburetor. Replace the green altitude compensator jet with the white jet from the kit. The jet has six vacuum connections and is mounted near the altitude compensator. One of the vacuum lines supplies venturi vacuum to the EBCV, so any vacuum leaks will drastically affect driveabilty.

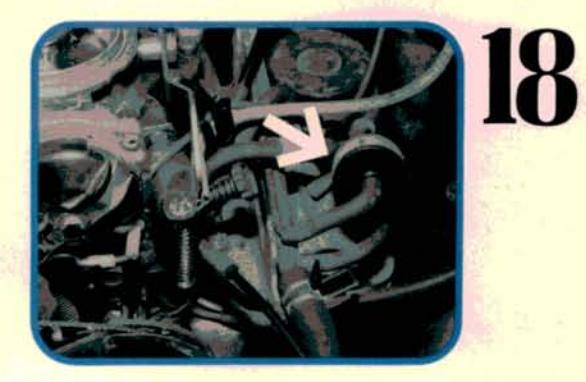
Install the VTV (vacuum time-delay valve) in-line between the EGR modulator and EGR valve. The VTV delays vacuum to the EGR. The VTV valve included in our kit was not the same color as the VTV described in the instructions. A quick check with a vacuum pump identified the correct vacuum flow direction.

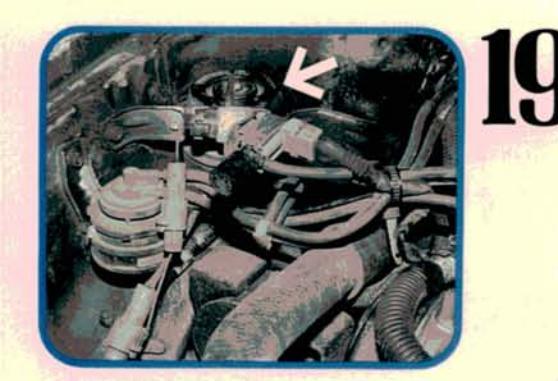
Install the air cleaner and warm up the engine. Use the lean drop method to adjust the fuel mixture. Peak the fuel mixture at 700 RPM, then lean the mixture to 650 RPM. Don't worry about the oxygen sensor. The ECU won't activate the EBCV (arrow) with the engine at idle.

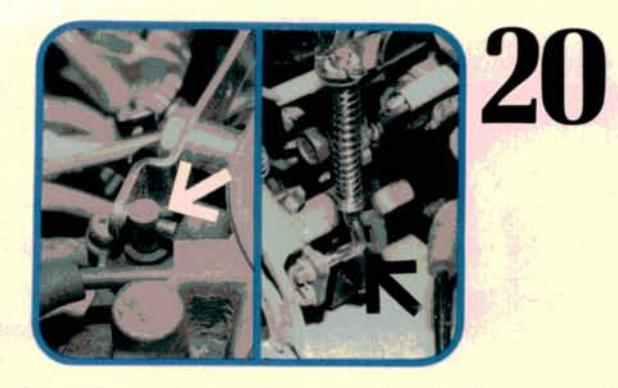
Stop the engine and remove the air cleaner. Recheck the accelerator pump stroke at the pump shaft. The stroke may change after properly setting the idle. The stroke should be 4.0 mm (left photo). If the adjustment is off, bend the accelerator pump connecting link (arrow) to readjust the stroke to specifications.

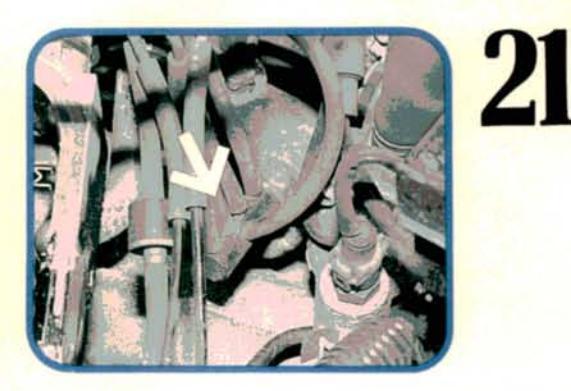
Remove the vacuum line from port M (arrow) of the thermo vacuum valve. Plug the port and the disconnected line. With the engine off, open the throttle, close the choke, release the throttle, then start the engine without touching the throttle. Adjust the fast idle screw to 3000 RPM.

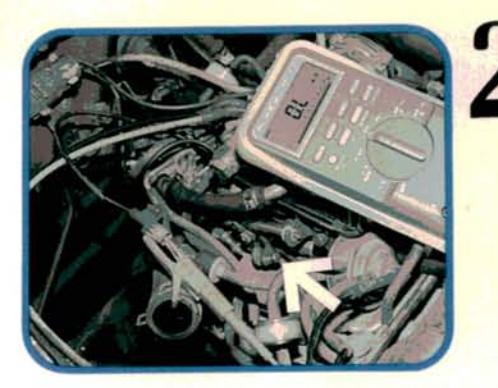
Return the engine to normal idle. Disconnect the throttle position (TP) switch and connect an ohmmeter to the TP. Slowly raise the idle speed while watching for continuity. The TP switch should close at 1800 RPM. Adjust the switch as needed. A bad TP switch can cause surging at highway cruising speed.

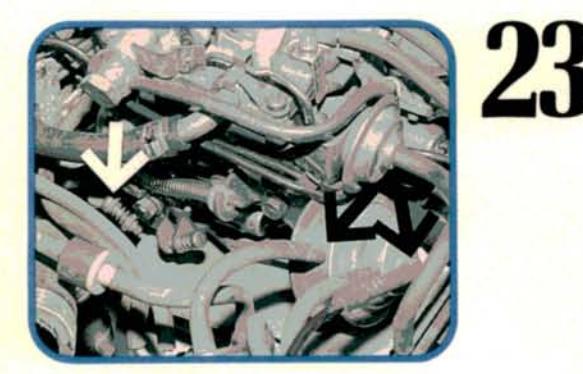
Disconnect the outer vacuum line from the throttle positioner and adjust the idle up idle screw to 800 RPM. Reconnect the vacuum line. Disconnect the inner vacuum line, set the throttle positioner on the second step and check for 1400 RPM. Reconnect all vacuum lines, including port M.

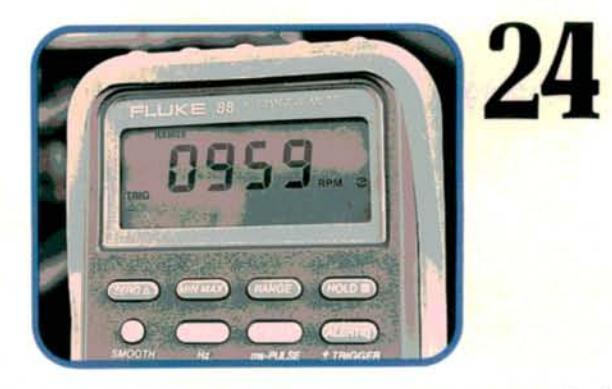
Turn on the air conditioner. Engine speed should increase to between 900 and 1000 RPM. Adjust the air conditioner actuator screw if necessary. Install a new plug over the mixture adjusting screw and reinstall the air cleaner assembly. Repeat the test drive for a comparison and final check.
