# Two For One

## KE-Jetronic

## ECCS

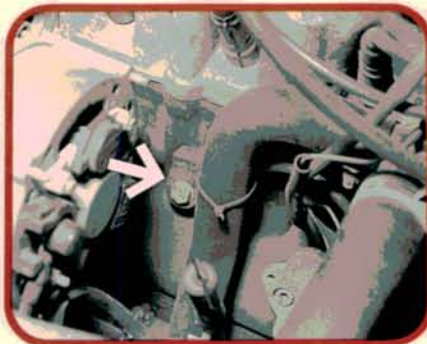
**1** The ignition signal is a very important KE sensor input. Detonation or poor low speed performance on models with knock sensor control units may be caused by a detonation sensor that is installed either too loose or too tight. The proper sensor installation torque is 10-12 Nm (7-9 ft-lb) for Type I sensors (wiring enters sensor off center) and 20-25 Nm (15-18 ft-lb) for Type II sensors (wiring connection enters from the side).

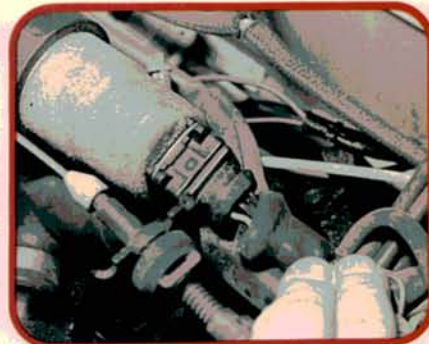
**2** Backed out wiring connector terminals can cause intermittent component operation. This idle air stabilization valve worked intermittently. After removing the harness connector's rubber boot, we found that the center wiring terminal had never been properly seated in the harness connector. Peel back the protective wiring boots and give the wires a light tug. Bend back loose terminal locking tabs, then make sure they are locked in place.

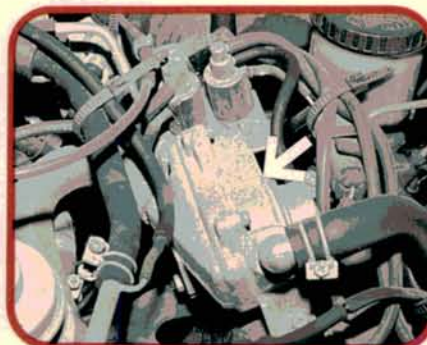
**1** On most ECCS systems, extra air is drawn into the exhaust system through a passage in the air flow meter. The air injection valve (AIV) uses reed valves and the engine's negative exhaust pulses to make sure the air flows only toward the exhaust. The reed valves can fail, allowing exhaust and moisture to attack the inside of the air flow meter. Corrosion inside the aluminum air flow meter housing or other air flow meter problems are usually caused by a damaged AIV.

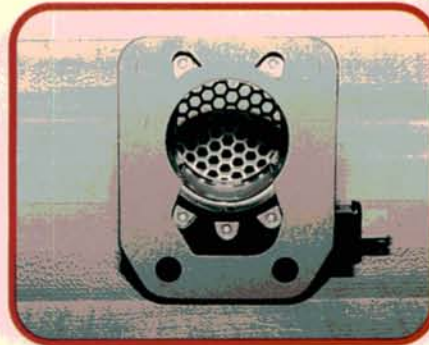
**2** The mixture heater used on ECCS equipped 1988 Sentras and Pulsars is not interchangeable with the mixture heater used on 1987 models. Interchanging these parts will cause a no idle-up condition from the idle speed control valve (ISCV). The 1988 mixture heater can be identified by an extra ISCV air passage at the rear of the heater. 1987 models do not have this passage and will block the idle-up passage.

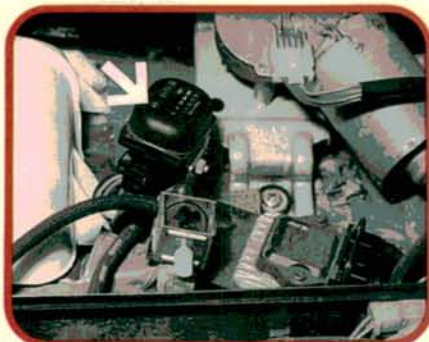
**3** Some KE systems are equipped with an altitude sensor (arrow). The altitude sensor helps the ECU decide the correct milliamp current to send to the differential pressure regulator (DPR), based on barometric pressure. The ECU should decrease the DPR's milliamp signal approximately 1 milliamp for every additional 1000 feet of altitude above sea level. At sea level, the altitude sensor has no effect on the DPR reading or fuel mixture.

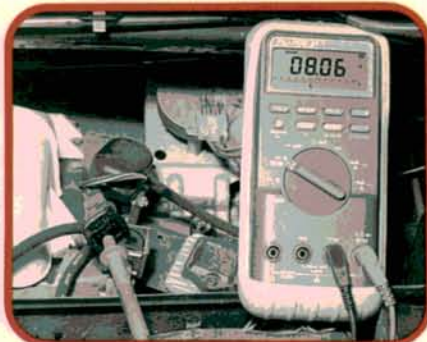
**4** Disconnect the altitude sensor connector. With the ignition on, check for an 8 volt reference signal from the ECU at terminal 2 (middle terminal) of the harness sensor connector. Terminal 3 goes to ground, and terminal 1 sends the sensor's return signal to the ECU. Disconnect the coolant temperature sensor. Use a shunt harness to connect a DVOM to the DPR, then jumper terminals 1 and 2 (zero sensor resistance) to simulate high barometric pressure. DPR current should increase about 3 milliamps.

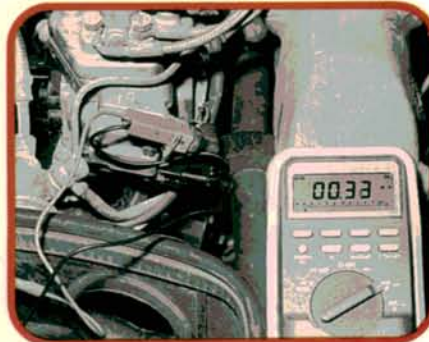
**5** Now jumper terminals 1 and 3 to simulate low barometric pressure (high sensor resistance). The DPR current should decrease to approximately 0-4 milliamps. The low DPR milliamp current leans out the fuel mixture to match the thin air at high altitude. If your readings in the previous tests are correct, the altitude sensor may be at fault. Reconnect the sensor's harness connector, then apply vacuum to its vent hole. DPR current should drop.

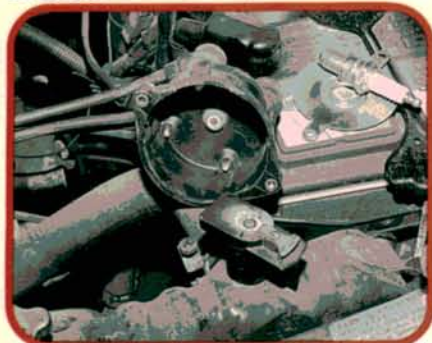
**3** A burned distributor cap rotor button may damage the LEDs and photo diodes inside E16 Sentra and Pulsar distributors. The stray secondary spark works its way down the distributor shaft and "blinds" the distributor's photo diodes. Then the diodes may fail intermittently, and cause driveability problems by sending incorrect engine speed and crank angle position signals to the ECU. Always check cap and rotor condition during maintenance work.

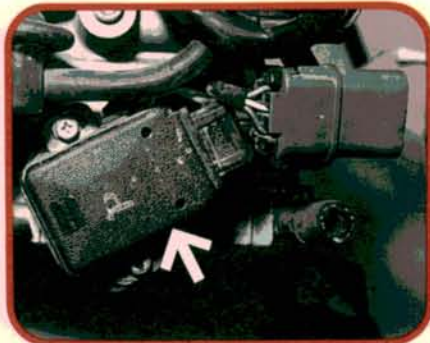
**4** A defective throttle sensor on 1986.5 Trucks, 1987 Pathfinders, Vans, Sentra Coupes and 4WD Wagons, and 1987 Pulsar NXs can cause an intermittent engine hesitation or surge under load (it feels like the ignition is being shut off for less than a second at a time). The sensor tells the ECU the exact throttle position. Measure the sensor's resistance while slowly opening the throttle. Watch for opens or dead spots.

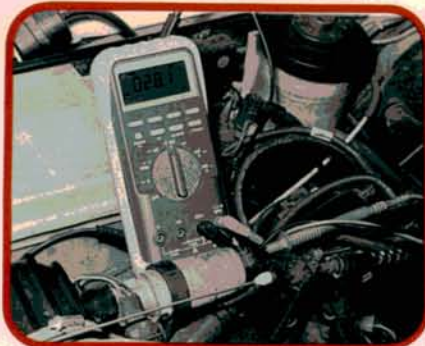
**6** If the engine has an unstable or incorrect idle speed, use the following procedure to test the idle air stabilization system. The engine oil temperature must be above 80 degrees C, ignition timing must be set to specs, and the A/C switch should be off. With the oxygen sensor connected, duty cycle measured at the idle air stabilization valve's test connector should be 28 percent ( $\pm 2$  percent).

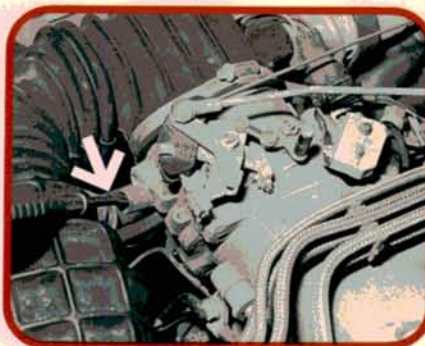
**7** If the duty cycle is incorrect, adjust it by slowly turning the idle screw (not the idle stop adjustment). If duty cycle still reads 33 to 40 percent, make sure the A/C is off. Also make sure the ECU is getting a closed throttle switch signal at ECU terminal 13. If the duty cycle still can't be adjusted to specs and varies between 20 and 25 percent, check for an RPM signal from the ignition control unit at ECU terminal 25.

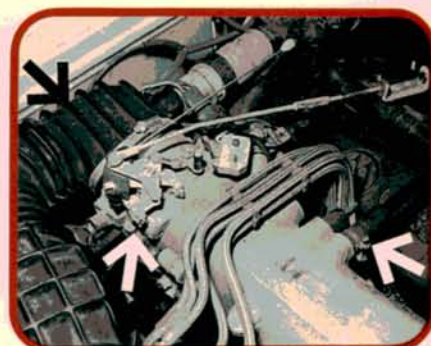
**8** If the duty cycle is a steady 25 percent, the idle speed is incorrect. Check for vacuum leaks at the throttle body gaskets, seals, and all hoses in the intake system. Idle fluctuation or hunting can also be caused by a vacuum leak in the air shrouded injection system. Revised air shrouded injection parts are available to replace a distorted o-ring and a distorted or cracked plastic connecting flange which may cause vacuum leaks and an unstable idle.

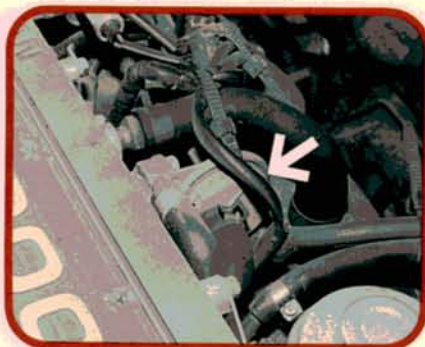
**6** Cold engine fast idle speed on 1985-88 Maximas is not directly controlled by the ECCS control unit. Maximas (and several other ECCS systems) have separate electrically heated bi-metal auxiliary air regulators like those found on earlier L-Jetronic systems. The air regulator's shutter wheel can stick in the closed position, causing a hesitation and no fast idle when the engine is cold. Since the regulator is outside the ECCS system, no trouble codes will be stored.

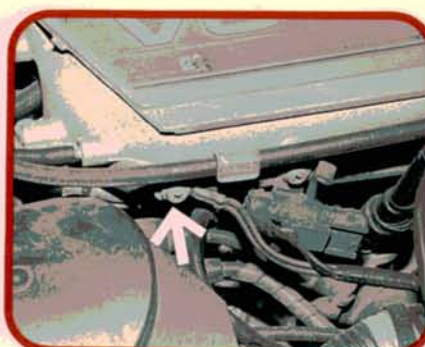
**7** A loose engine ground bolt at the front corner of the intake manifold on 1985-88 Maximas can keep the engine from idling, cause it to run rough, and make the exhaust smell bad. Even though the ECCS control unit is located under the passenger seat, wire 19F at the engine grounding bolt supplies the ECU's main ground circuits. The ECU can't accurately control the system without a good ground. Clean and tighten the ground connection as necessary.

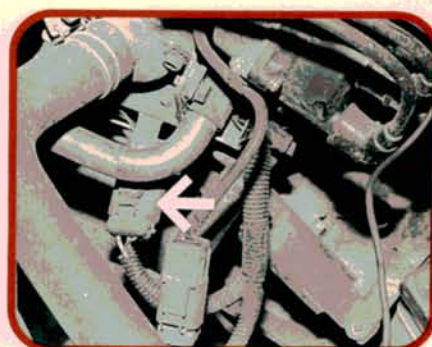
**8** A damaged oxygen sensor connector can cause an intermittent surge or hesitation at 1500-2000 RPM on 1987-88 Sentras after the engine is warmed up. Check the routing of the oxygen sensor harness. The connector may be distorted if the harness is pulled too tight. This can cause an intermittent connection, especially at the connector's middle pin. Also make sure the tight harness hasn't chafed any of the oxygen sensor wiring.

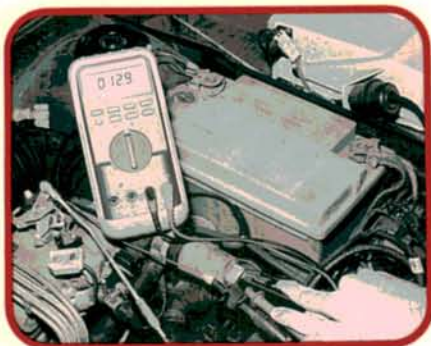
**9** Check the idle air stabilizer valve's windings for continuity. Resistance should be 24-30 ohms between the outside terminals and 12-15 ohms between either of the outside terminals and the center terminal. Resistance between any of the terminals and ground should be infinite. A carbon-clogged valve may be slow to respond to changes in engine load. Updated valves (identified by a green or yellow dot) are available for 1986 models.

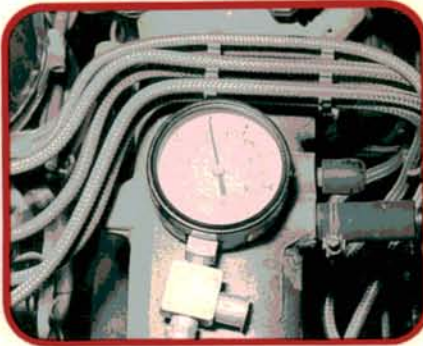
**10** A loss of residual fuel pressure will cause hard starting problems. KE systems should maintain a minimum of 2.6 bar (38 PSI) residual fuel pressure for at least 10 minutes after the engine is shut off. If lost residual pressure is caused by a failed fuel pump check valve, the check valve can be replaced separately. The fuel reservoir check valve on Jetta/Golf models is also available separately. Ensure that only one spring is installed under the reservoir plunger.

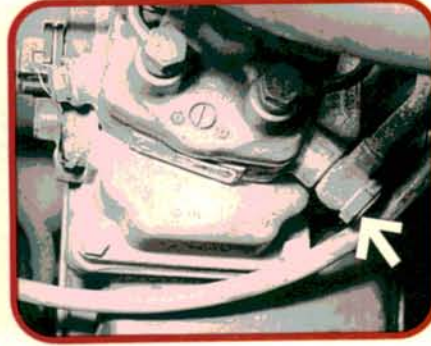
**11** Here's a KE tip that's worth repeating. Some KE systems have a mini-filter built into the banjo bolt at the inlet side of the fuel distributor. The filter was designed to trap any debris left over from production. The filter can become clogged over time, reducing fuel pressure and volume, and affect system operation. The filter bolt can be identified by a flat crown on its head. Remove the bolt and replace it with a hollow, non-filter type bolt.

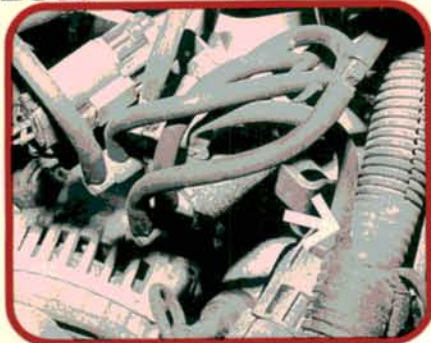
**9** A blown engine control fuse and a no-start condition on a 1984-86 Sentra may be caused by the engine wiring harness shorting against the alternator adjusting bracket. This can be hard to find because the bare wires are on the underside of the harness and may only touch the bracket when the engine moves in its mounts under load. You can replace the fuse and it probably won't blow immediately. Repair shorted wires as necessary, then insulate the harness from the bracket.

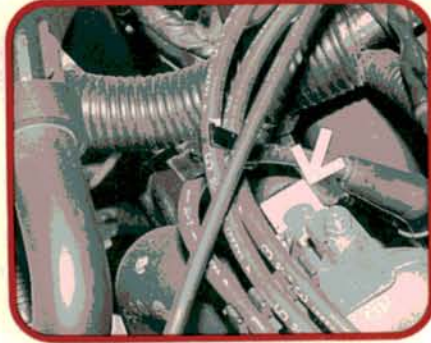
**10** On 1989 Maximas, the branch of the ECCS harness that connects to the coolant temperature sensor may be misrouted. The misrouted harness can stretch the wiring, damaging it at the temperature sensor connector. Broken or loose wiring to the coolant temperature sensor may make the engine run rich and very hard to start when cold. The Check Engine light may also light on California models. Re-route or repair the harness to prevent future stretching.

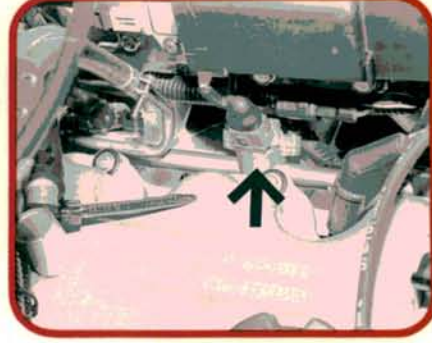
**11** Port injected ECCS systems use injectors manufactured by either DKC or JECS. When replacing injectors, always check the original injector's metal ring color and replace it with one of the same color. Ring color indicates the injector's flow rate characteristics. DKC or JECS injectors can be mixed on the same engine, but must all have the same color ring as the original injectors.

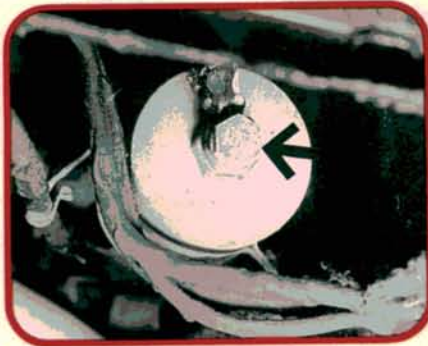
**12** Some replacement fuel filters may restrict fuel flow and cause a loss of power on Volkswagen Quantums. The recessed inlet boss on these filters may have insufficient clearance for the original fuel filter banjo bolt. Threading the original bolt into these replacement filters can cause the bolt to bottom out inside the filter. A shorter (25 mm) replacement banjo bolt is available from Volkswagen parts departments for use with these filters.

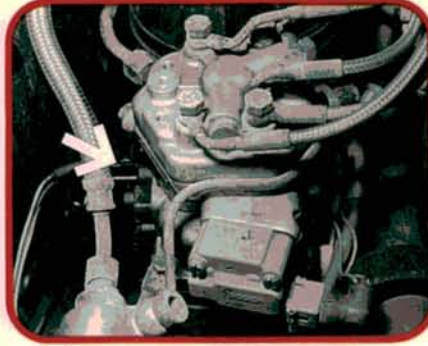
**13** Worn air flow position sensor (APS) wiper contacts may cause fuel enrichment problems. The APS potentiometer reports the sensor plate's position to the ECU. Resistance across APS terminals 1 and 2 should be 2.8-4.0 ohms when the sensor plate is at rest. Resistance between terminals 2 and 3 should be less than 1.2 K ohms at rest and increase smoothly to a maximum of 4 K ohms as the sensor plate is lifted.

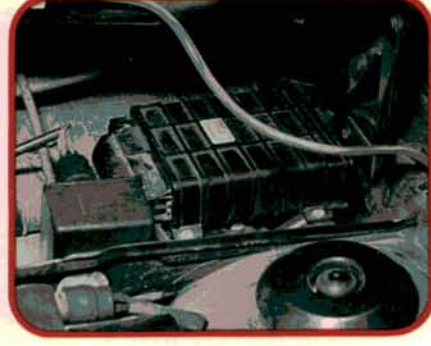
**14** Grease inside the ECU connector can cause stray voltage and a lean running condition on some Jetta and Quantum engines. To test the oxygen sensor circuit for voltage leakage, disconnect the sensor. Install a DVOM between the oxygen sensor's harness side connector and the ground terminal at the cold start injector. With the ignition on, the DVOM should read 0.55 volts or less. Clean the ECU connector if your reading is too high, then repeat the test.

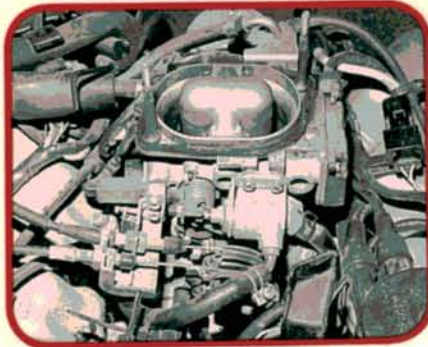
**12** The VG30i and Z24i engines used in 1986.5 through 1989 Trucks, Pathfinders, and Vans have a throttle body injection ECES system with two separate injectors. The engine should run on one injector if the other fails mechanically, but the engine will lack power during acceleration and may have a rough idle that forces you to keep your foot on the gas to keep the engine running. Use the following procedure to check the operation of both injectors.

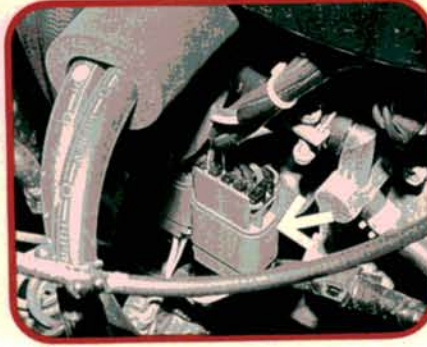
**13** The ECES self-diagnostic system can't identify mechanical injector failure, and won't register a trouble code. Run through Mode Three self-diagnostics first to check for trouble codes. If any other codes are present, repair these problems first. Test both injectors by a process of elimination. Locate the injector harness connector (arrow), then disconnect the red wire on the injector side of the connector. This disables the "B" injector.

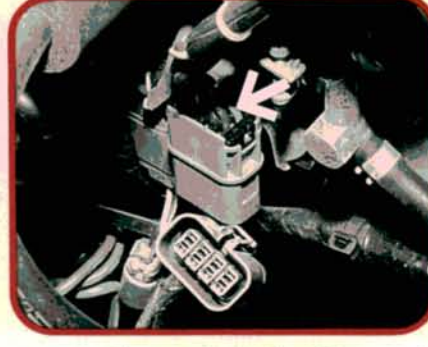
**14** The engine should run at idle on injector "A" because the ECU senses an electrical failure and switches to Fail-Safe Mode. If the engine won't idle, or idles poorly, replace injector "A". Stop the engine, reconnect the injector "B" red wire, then disconnect the green wire on the injector side of the connector to disable the "A" injector. Restart the engine. Replace the "B" injector if the engine won't idle or idles poorly.
