German Time Porsche 944 Timing Belts

Porsche 944

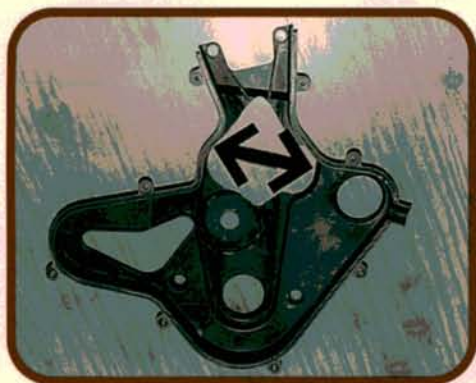
Remove the splash shields, alternator and air conditioning belt, crankshaft pulley, and timing belt cover. Timing belt cover designs have been changed several times. This cover was modified "in the field." The area marked was apparently cut away to prevent belt noise. We replaced this weakened cover.

- In photo 1, we mentioned that the cover had been modified. Some modifications were made using approved Porsche templates. What we failed to mention was that this particular cover had been weakened by an indiscriminate modification.
- In photo 3, it would have been a lot clearer if we had instructed you not only to set the engine at TDC, but that TDC number 1 was the place to be, and that the engine needs to stay there until the job is complete.

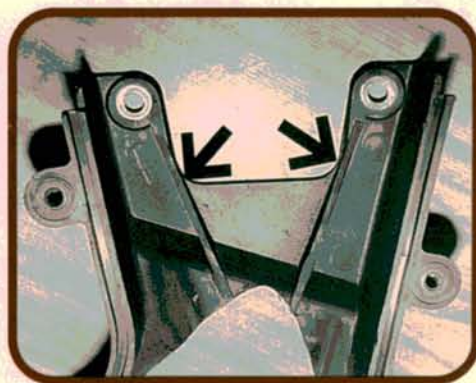
2

Check for interference in the top area of the inner cover. Some early covers had two ribs molded into the inner surface (arrows). If your cover has these ribs, grind them flush with the cover's inner surface. This prevents the timing belt from rubbing the cover. Later models use a two piece outer cover.

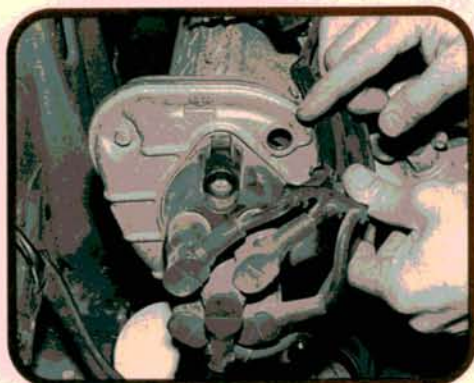
3

The engine must be set to top dead center before removing the old timing belts. Remove the access plug from the distributor housing/camshaft pulley cover. Look through the hole in the cover, then turn the engine until the camshaft sprocket timing mark aligns with the timing cover timing mark.

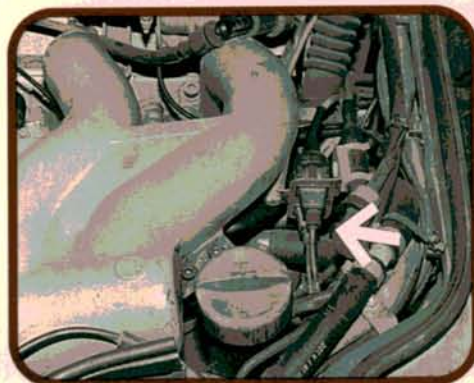
4

The crankshaft alignment marks are located at the rear of the engine, near the top of the clutch housing. Reach past the oil fill tube to remove the access plug. Make sure the flywheel timing mark is aligned with the housing mark. You may need a light to see the timing marks.

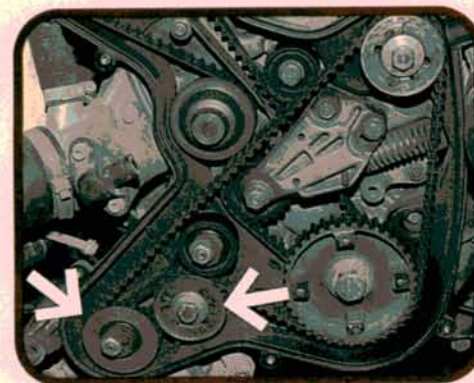
7

Loosen the balance shaft belt tensioner (left arrow), then remove the old belt. This belt has teeth on both sides because the lower balance shaft pulley is turned by the back side of the belt. This allows the lower balance shaft (right arrow) to rotate opposite the crankshaft's direction.

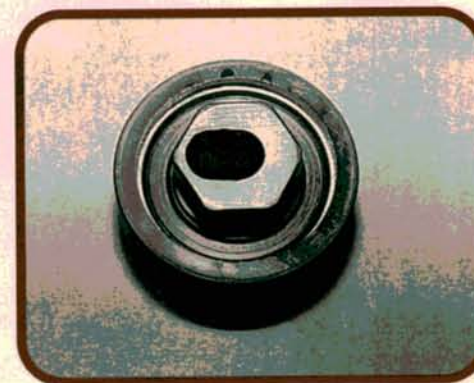
8

Remove the balance shaft belt preload tensioner. Two styles of preload tensioner have been used. Early tensioners have an offset round mounting hole (like a VW Rabbit). Unlike offset hole tensioners, newer tensioners have a slotted hole which slides against the bolt as well as pivoting against it.

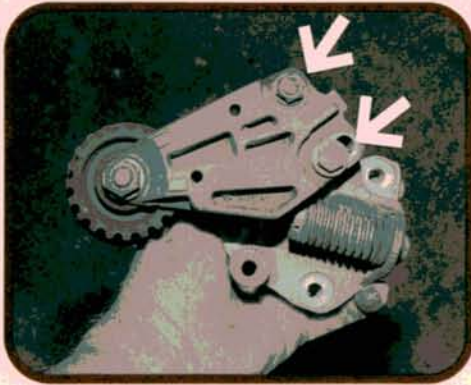
9

We removed the tensioner to show its adjustment and mounting points. Loosen the bolts holding the spring loaded tensioner in position (arrows). Push the tensioner back to compress the spring, then retighten the bolts. Remove the cam belt. Replace the tensioner if the pulley bearings are worn.

- The folks at Porsche prefer that we use the term "guide roller" instead of the word "tensioner" in photo 9. Even though a maximum deflection of 1 mm is allowed, they feel that the term tensioner is possibly misleading. Also note that the spring loaded tensioner must always be removed during a belt replacement since it straddles the belt.

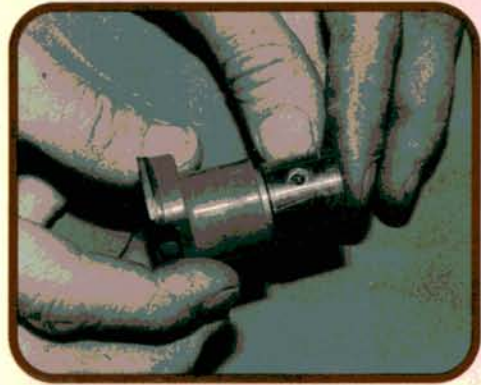
10

Remove the rotor and camshaft pulley if the camshaft seal is leaking. The rotor and stub shaft are driven by an adapter that's held in place by the camshaft retaining nut. Remove the rotor stub shaft retaining bolt, then the rotor and stub shaft. Use heat to release the stub shaft if it's stuck to the adapter.

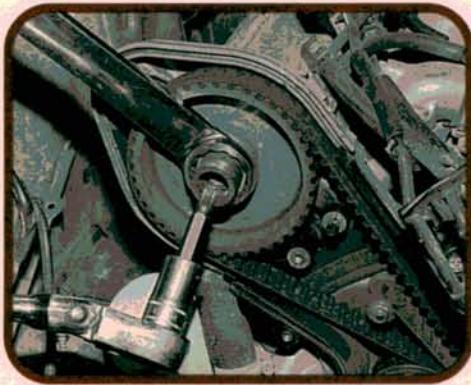
Removing the distributor rotor and stub shaft exposes a 12 point spline at the end of the camshaft. Use a 10 mm 12 point drive socket to hold the camshaft stationary, then remove the retaining nut with a box wrench. Retorque the retaining nut to 64-68 Nm (47-50 ft-lb) during reassembly.

Bob Tyrone of Bob Tyrone Automotive in Austin, Texas suggested that we had the tail wagging the dog in photo number 11 of the Porsche 944 timing belt article (page 14 of the February 1991 issue). In the photo caption we said that the 12 point socket holds the cam while the box wrench turns the nut.

It's just the opposite. You hold the cam stationary with the box wrench and unscrew the spline head bolt. Bob suggests that the spline head bolt is so stubborn that he routinely removes the entire cam tower, takes it to the work bench, and attaches the spline socket to an impact driver to break the bolt free. Removing the cam tower enables him to seal any leaks right at the tower itself.

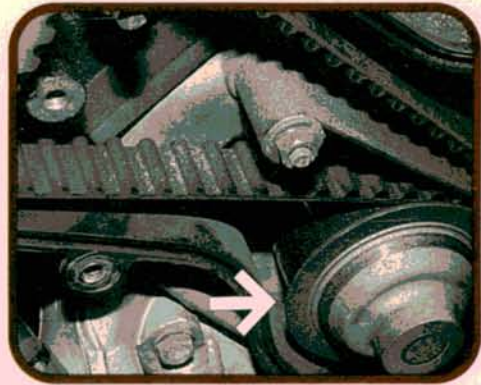
12

The water pump (arrow) is turned by the flat outer surface of the cam belt. Replace early style, worn, or leaking water pumps. Install the camshaft belt. Loosen the tensioner retaining bolts and let the spring tensioner snug the belt. Early springless tensioners should be replaced with spring loaded tensioners.

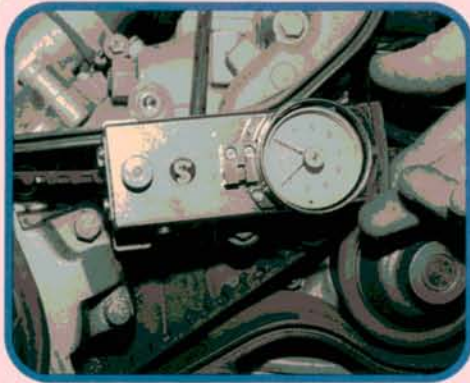
15

Release the gauge lock and check the reading on the gauge. New belts should read 2.7 to 3.2. Used belts should read 2.7 to 3.0. Overtightened belts will whine. Loose belts will rattle. If you get a low reading after releasing the spring loaded tensioner, replace the tensioner.

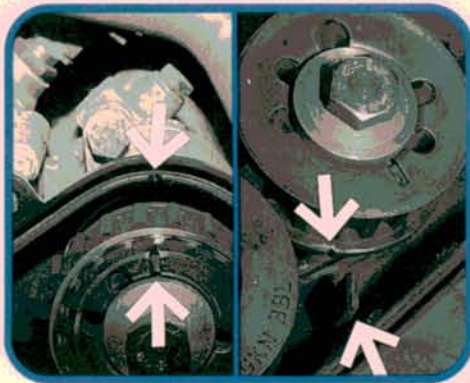
17

Align the upper balance shaft pulley notch with the pointer above the pulley (left photo). Align the lower shaft pulley notch with the pointer below the pulley (right photo). Install the new balance shaft belt. Rotate the balance shaft belt tensioner until the belt tension is between 2.7 and 3.2.

- Our suggestion that the belt gauge shoes only fit one way was incorrect. It makes no difference which way the shoes face.
- In photo 17, add the word "clockwise" to our instructions for rotating the balance shaft tensioner. Rotating the tensioner counterclockwise may lead to interference between the belt and water pump. The correct balance shaft tension specs are 4.3 +/- .3 for early style belts, and 2.7 +/- .3 for later style belts using the slotted guide roller setup. The manual tensioner timing belt specs listed in the article should be changed to a belt tension of 4.0 +/- .3 for a new belt, and 2.7 +/- .3 for a used belt.

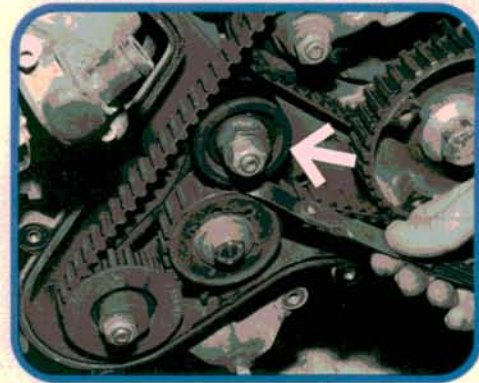
18

To adjust the balance shaft preload, place a 0.5 mm feeler gauge between the balance belt and the preload tensioner (arrow). Maintain this clearance as you pivot and slide the preload tensioner toward the belt. Keep adjusting the tensioner until it contacts the belt, then moves the belt 1 mm outward.

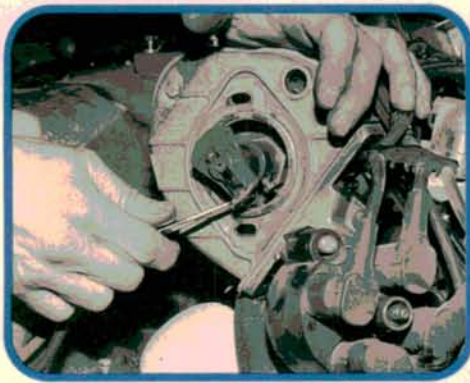
19

Reinstall the distributor housing and rotor. Don't drop the small bolt that holds the rotor stub shaft to the camshaft adapter. Install the distributor cap. Don't reinstall the timing belt cover if the preload tensioner has been replaced. We want to make sure it spins freely when the engine is started.

- Here's an added tip for Photo 19. Rotate the engine until the rotor faces up. This lessens the possibility of dropping the rotor stub shaft retaining bolt down behind the cover.

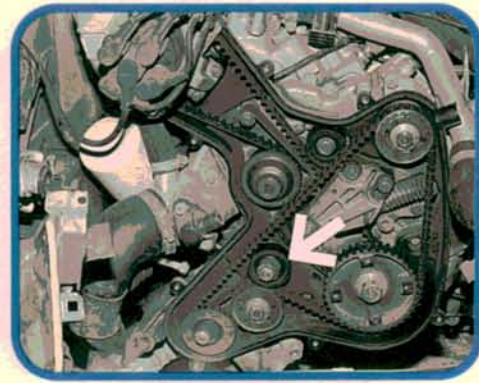
20

The tensioner barely touches the balance shaft belt, and a new one may not spin when the engine is first started. If it doesn't, carefully rotate the tensioner until it spins. Shut off, then start the engine to make sure the tensioner is turning on its own. Reinstall the timing cover, crank pulley, and drive belts.

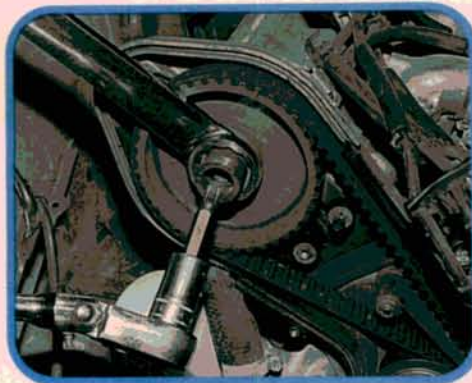
Photo 11

Removing the distributor rotor and shaft exposes the 12 point spline headed bolt in the end of the camshaft. Use a box wrench to hold the camshaft stationary, then unscrew the bolt. The bolts are stubborn and you may need an impact driver to break them loose. Retorque the bolt to 64-68 Nm (47-50 ft-lb).
