# TECH TIPS

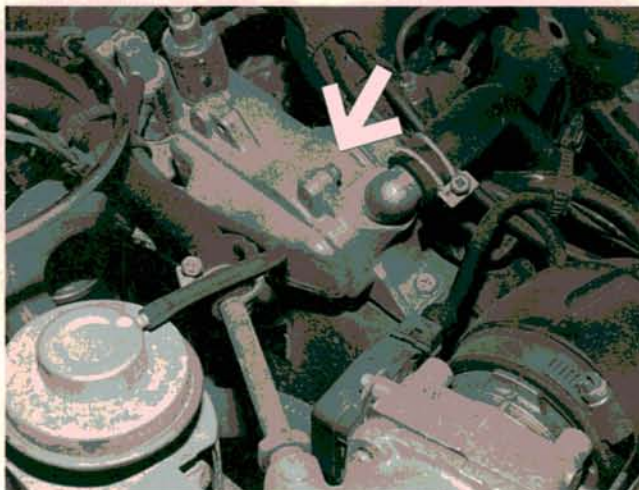
**A faulty air injection valve (AIV) may cause a hesitation or rich running condition on 1986 Nissan Maximas.** To check the AIV, remove the air cleaner cover. Look for water or corrosion in the air intake well below the air filter element directly in front of the hot wire mass air flow sensor (MAF).

When the AIV is working normally, it uses the exhaust system's negative pressure pulses to draw fresh air from the air cleaner into the exhaust system. If the reed valve inside the AIV fails, exhaust flows backwards through the AIV, and water collects in the air cleaner assembly during start ups.

While driving, the engine's intake air sucks the water through the MAF. The water intermittently cools the MAF's hot wire, causing the MAF to send false load signals to the control unit. This causes the intermittent hesitation or rich running condition. Replace the AIV if you find any evidence of water in the air filter housing.
